# Monthly Environmental Monitoring Report

## October 2009

## 1.0 Report Purpose and Scope

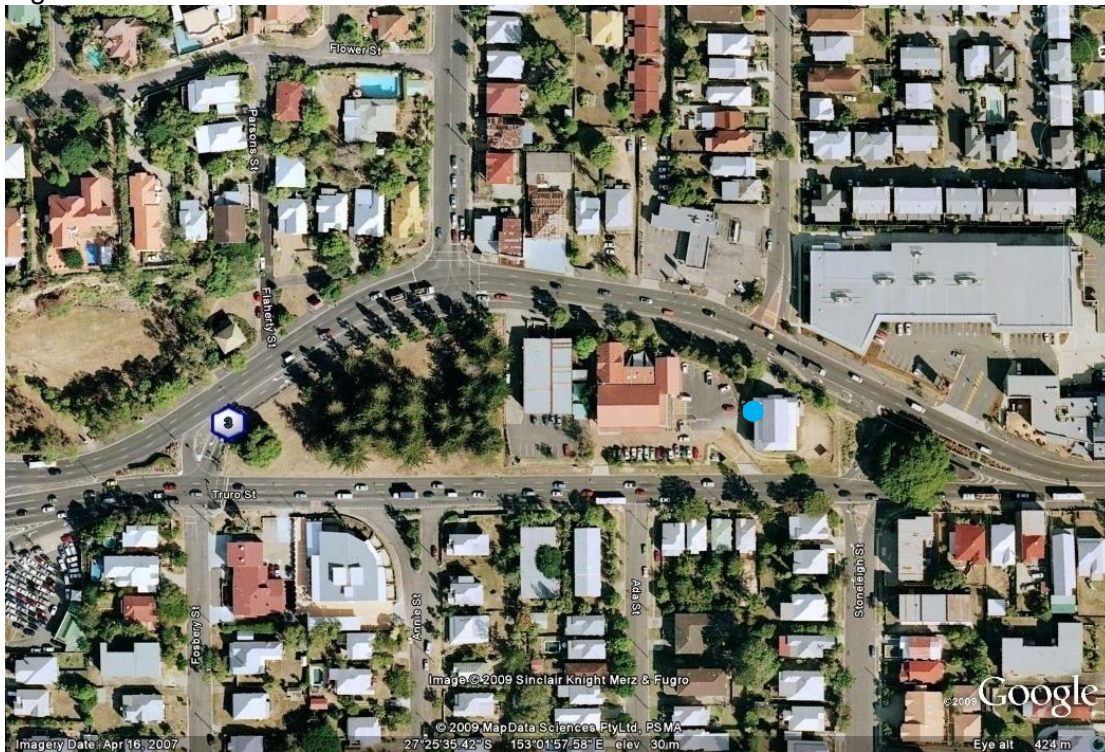
Figure 2: Truro Street

● Noise (during construction)

● Air (PM<sub>10</sub>)

Note – these locations are indicative only

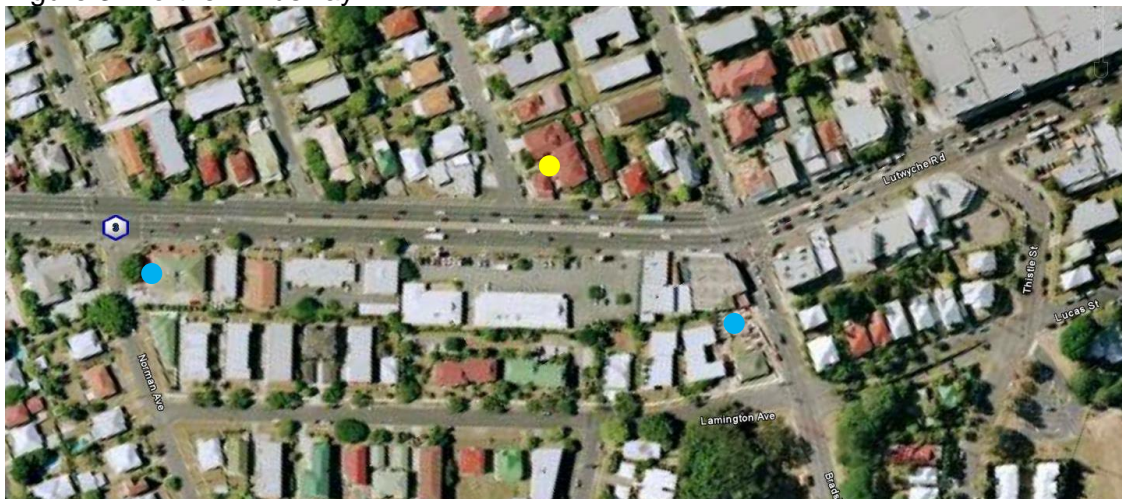
Figure 3: Northern Busway

● Noise (during construction)

● Air (PM<sub>10</sub>)

Note – these locations are indicative only

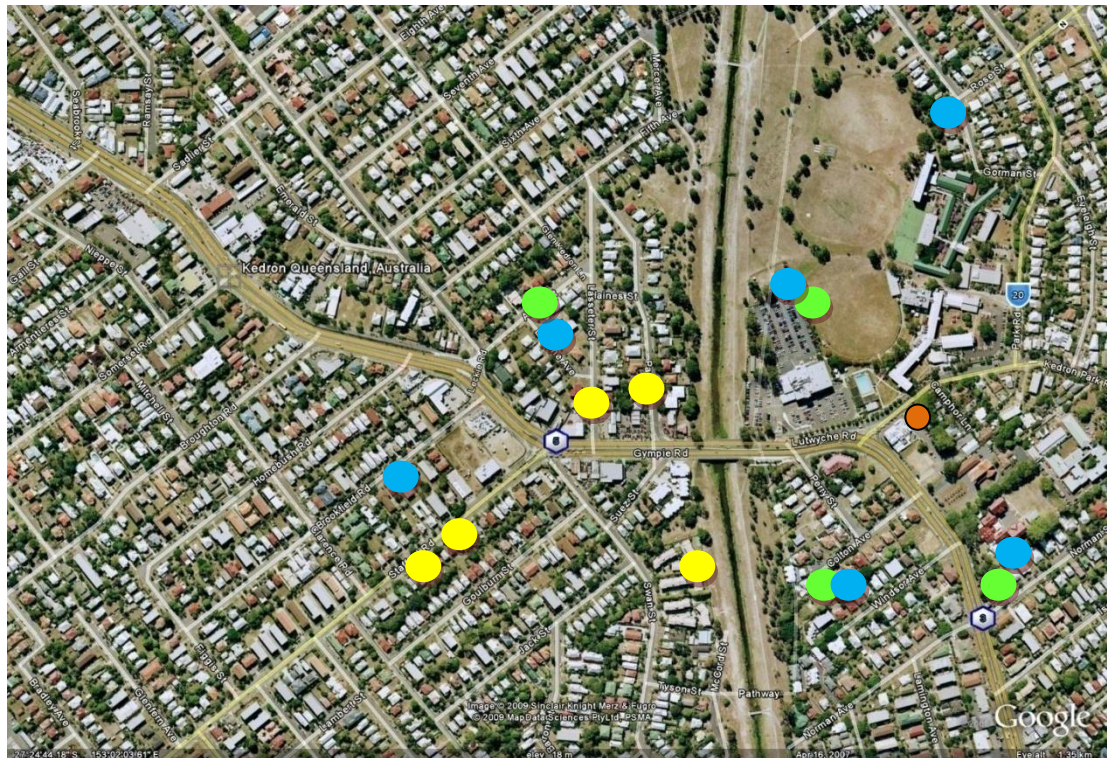
Figure 4: Kedron

- Noise (during construction)
- Vibration
- Air (PM<sub>10</sub>)
- Air (Dust Fallout)

Note – these locations are indicative only

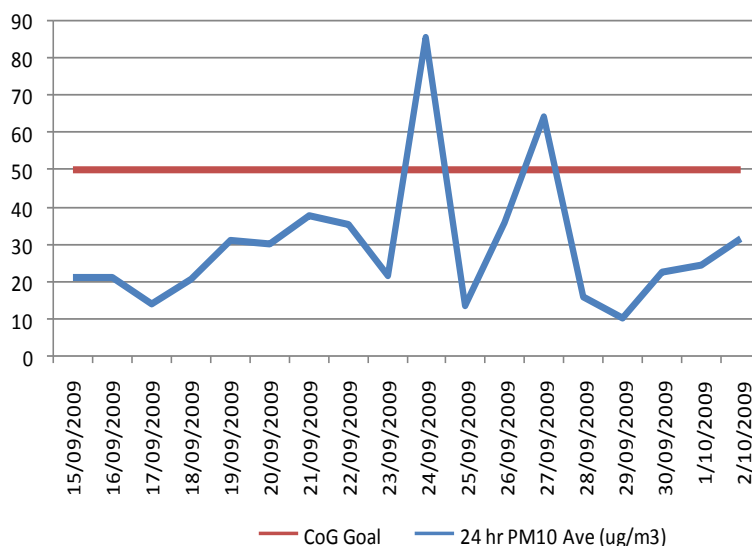
### PM10 Daily Results Truro St

Monitoring Period	Daily PM <sub>10</sub> (µg/m <sup>3</sup> /day)	CoG PM <sub>10</sub> Goal (µg/m <sup>3</sup> /day)	Comments
15/09/2009	21	50	
16/09/2009	21.1	50	
17/09/2009	14	50	
18/09/2009	20.6	50	
19/09/2009	31.3	50	
20/09/2009	30.1	50	
21/09/2009	37.9	50	
22/09/2009	35.4	50	
23/09/2009	21.6	50	
24/09/2009	85.6	50	Exceedance (Dust Storm)– NCR Raised
25/09/2009	13.7	50	
26/09/2009	35.9	50	
27/09/2009	64.5	50	Exceedance (Dust Storm)– NCR Raised
28/09/2009	16	50	
29/09/2009	10.3	50	
30/09/2009	22.8	50	
1/10/2009	24.3	50	
2/10/2009	31.4	50

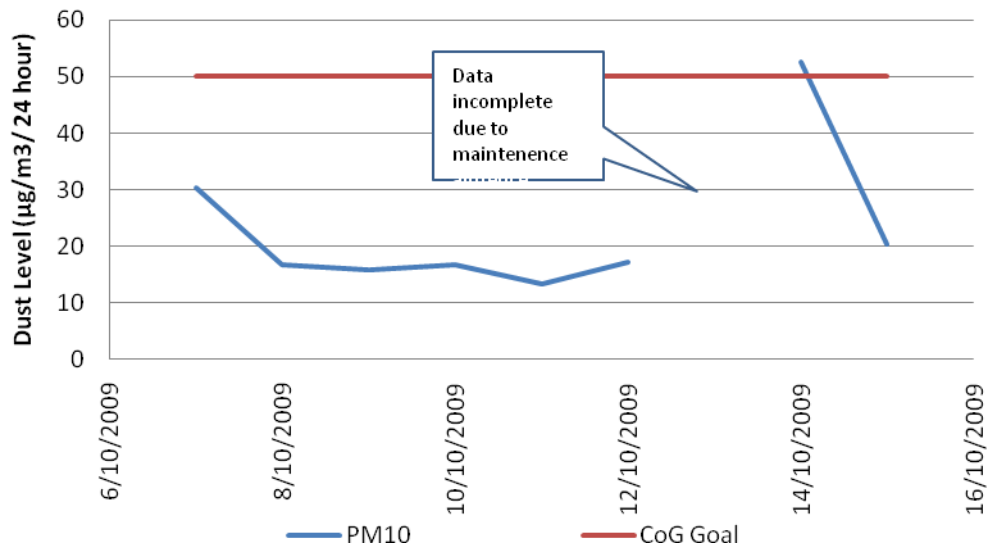
Northern Busway- Lamington Site Office PM10 Results (6/10/09-15/10/09)

Monitoring Period	Daily PM <sub>10</sub> (µg/m <sup>3</sup> )	CoG PM <sub>10</sub> Goal (µg/m <sup>3</sup> /day)	Comments
<b>Lutwyche Site Office</b>			
16/09/2009	12	50	Exceedences were recorded on 23/9/09, 24/9/09, 26/9/09, and 27/9/09. Dust storms occurred on the 23/9 and 26/9 with higher levels on subsequent days resulting from these storms. High levels (including exceedences) measured at the DERM Brisbane CBD Air Quality Monitoring Station over these 24hr periods.
17/09/2009	16	50	
18/09/2009	20	50	
19/09/2009	28	50	
20/09/2009	35	50	
21/09/2009	-	-	
22/09/2009	-	-	
23/09/2009	419	50	
24/09/2009	63	50	
25/09/2009	32	50	
26/09/2009	167	50	
27/09/2009	76	50	
28/09/2009	14	50	
29/09/2009	18	50	
30/09/2009	23	50	
<b>CC701</b>			
1/10/2009	33	50	One exceedance was recorded on 14/10/09. A considerable level of dust was present in the atmosphere throughout this day. High levels (including exceedences) measured at the DERM Brisbane CBD Air Quality Monitoring Station over these 24hr periods.

2/10/2009	33	50	
3/10/2009	-	-	
4/10/2009	-	-	
5/10/2009	-	-	
6/10/2009	-	-	
7/10/2009	30	50	
8/10/2009	17	50	
9/10/2009	16	50	
10/10/2009	17	50	
11/10/2009	13	50	
12/10/2009	17	50	
13/10/2009	-	-	
14/10/2009	53	50	
15/10/2009	20	50

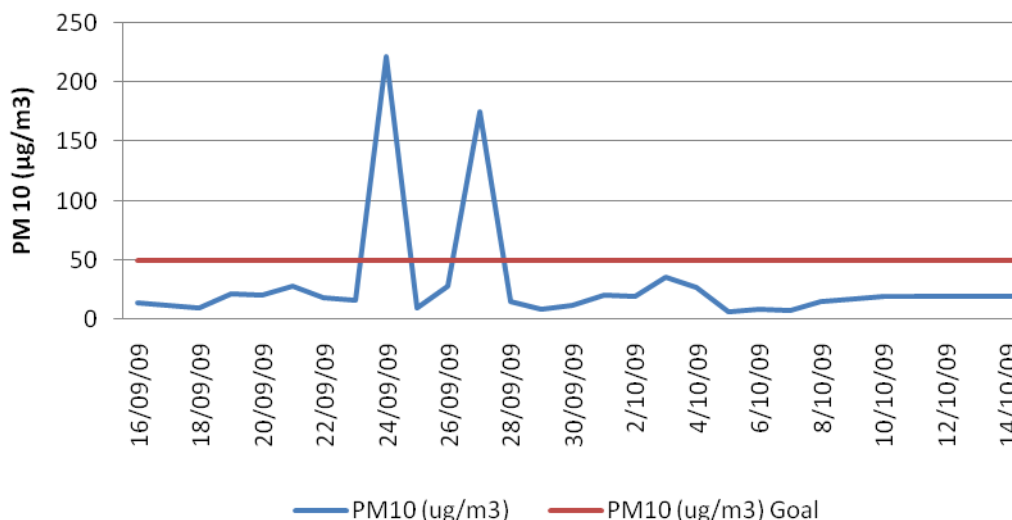
**PM<sub>10</sub> Daily Results – Kedron State High School Oval**

Monitoring Period	Daily PM <sub>10</sub> (µg/m <sup>3</sup> /day)	CoG PM <sub>10</sub> Goal (µg/m <sup>3</sup> /day)	Comments
Wed 16/09/2009	13.8	50	
Thu 17/09/2009	11.9	50	
Fri 18/09/2009	9.7	50	
Sat 19/09/2009	21.3	50	
Sun 20/09/2009	20	50	
Mon 21/09/2009	27.4	50	
Tue 22/09/2009	18.1	50	
Wed 23/09/2009	16	50	
Thu 24/09/2009	221.2	50	Exceedance (Dust Storm)– NCR Raised
Fri 25/09/2009	9.8	50	
Sat 26/09/2009	28.1	50	
Sun 27/09/2009	174.2	50	Exceedance (Dust Storm)– NCR Raised
Mon 28/09/2009	14.5	50	
Tue 29/09/2009	8.8	50	
Wed 30/09/2009	11.9	50	
Thu 1/10/2009	19.7	50	
Fri 2/10/2009	19.5	50	
Sat 3/10/2009	35.2	50	
Sun 4/10/2009	26.9	50	
Mon 5/10/2009	6.1	50	
Tue 6/10/2009	8	50	
Wed 7/10/2009	6.9	50	
Thu 8/10/2009	14.8	50	
Fri 9/10/2009	17.2	50	
Sat 10/10/2009	18.7	50	
Sun 11/10/2009	18.7	50	
Mon 12/10/2009	18.9	50	
Tue 13/10/2009	18.8	50	
Wed 14/10/2009	19	50	
Thu 15/10/2009	19.3	50

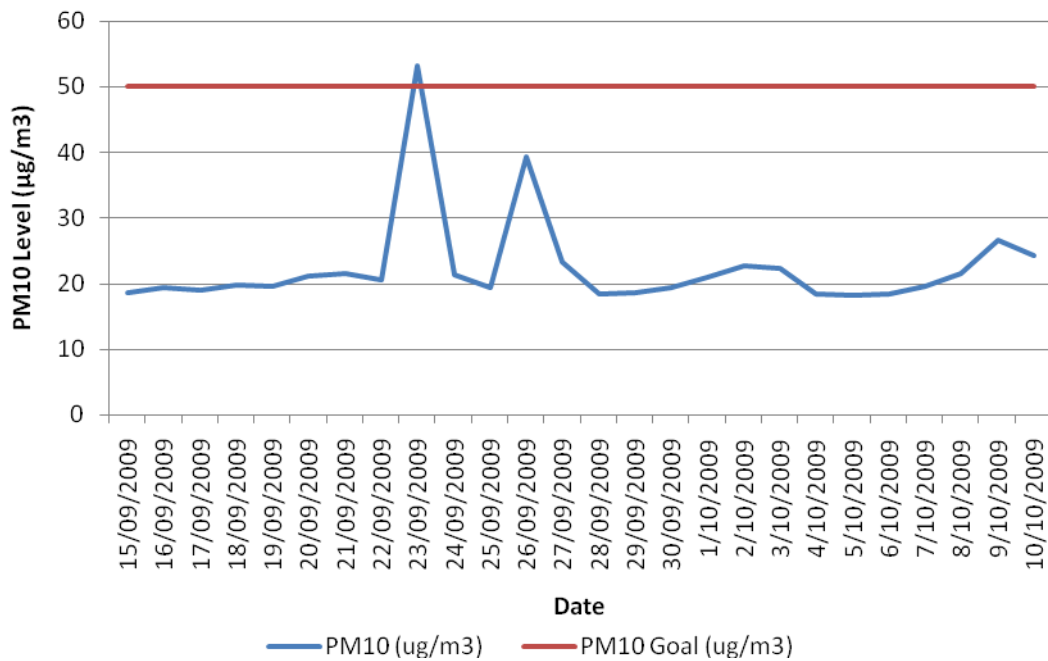
### PM10 Daily Results - Woolloowin School

Monitoring Period	Daily PM <sub>10</sub> (µg/m <sup>3</sup> /day)	CoG PM <sub>10</sub> Goal (µg/m <sup>3</sup> /day)	Comments
Tue 15/09/2009	18.5	50	
Wed 16/09/2009	19.4	50	
Thu 17/09/2009	18.9	50	
Fri 18/09/2009	19.8	50	
Sat 19/09/2009	19.5	50	
Sun 20/09/2009	21.1	50	
Mon 21/09/2009	21.6	50	
Tue 22/09/2009	20.5	50	
Wed 23/09/2009	53.2	50	Exceedance (Dust Storm)– NCR Raised
Thu 24/09/2009	21.4	50	
Fri 25/09/2009	19.4	50	
Sat 26/09/2009	39.4	50	
Sun 27/09/2009	23.2	50	
Mon 28/09/2009	18.4	50	
Tue 29/09/2009	18.5	50	
Wed 30/09/2009	19.4	50	
Thu 1/10/2009	21	50	
Fri 2/10/2009	22.7	50	
Sat 3/10/2009	22.3	50	
Sun 4/10/2009	18.3	50	
Mon 5/10/2009	18.2	50	
Tue 6/10/2009	18.3	50	
Wed 7/10/2009	19.6	50	
Thu 8/10/2009	21.6	50	
Fri 9/10/2009	26.6	50	
Sat 10/10/2009	24.3	50
