Airport Link / Northern Busway Project

Monthly Environmental Monitoring Report

May 2010

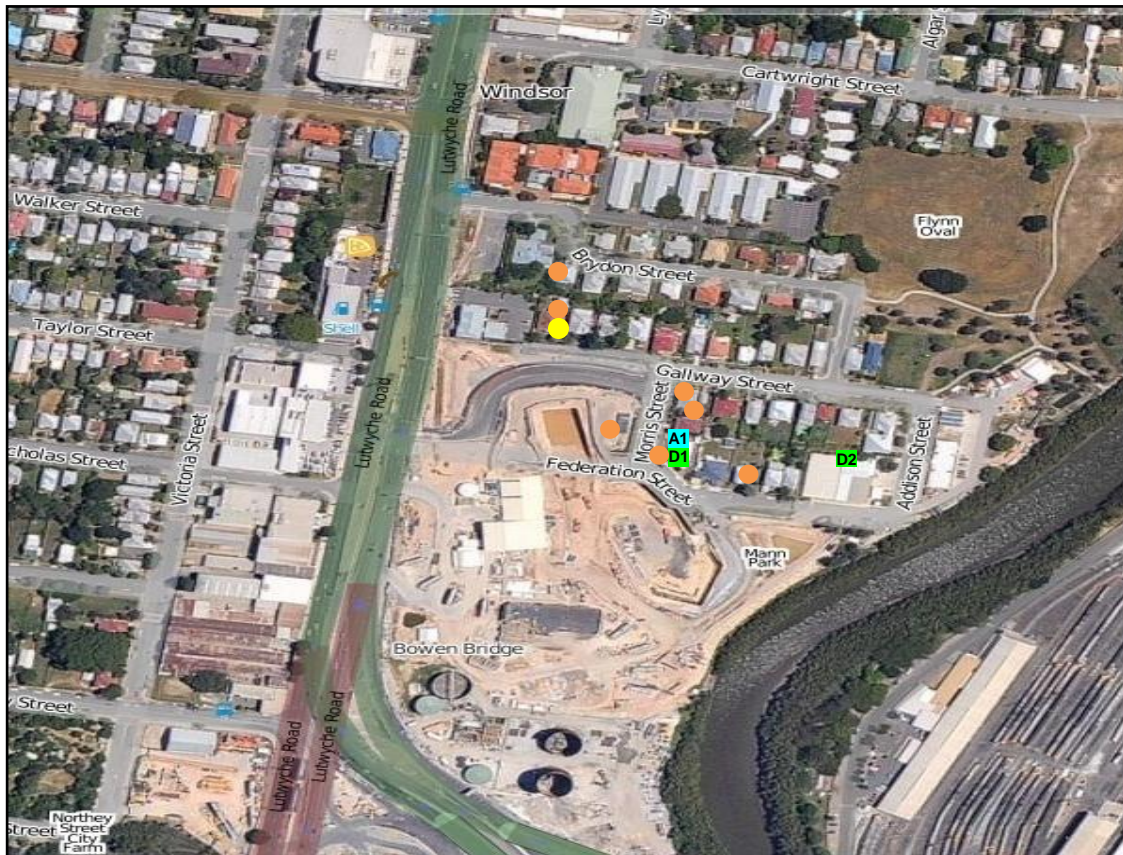
Figure 2.1 – Bowen Hills Monitoring Locations

Several monitoring locations exist within the project area as described in Figures 1-5. Note that the aerial photograph overlays used in Figures 1-5 do not accurately portray the extent of the project's progress to April 2010, though do serve a useful purpose in relating the monitoring locations to existing structures and infrastructure.

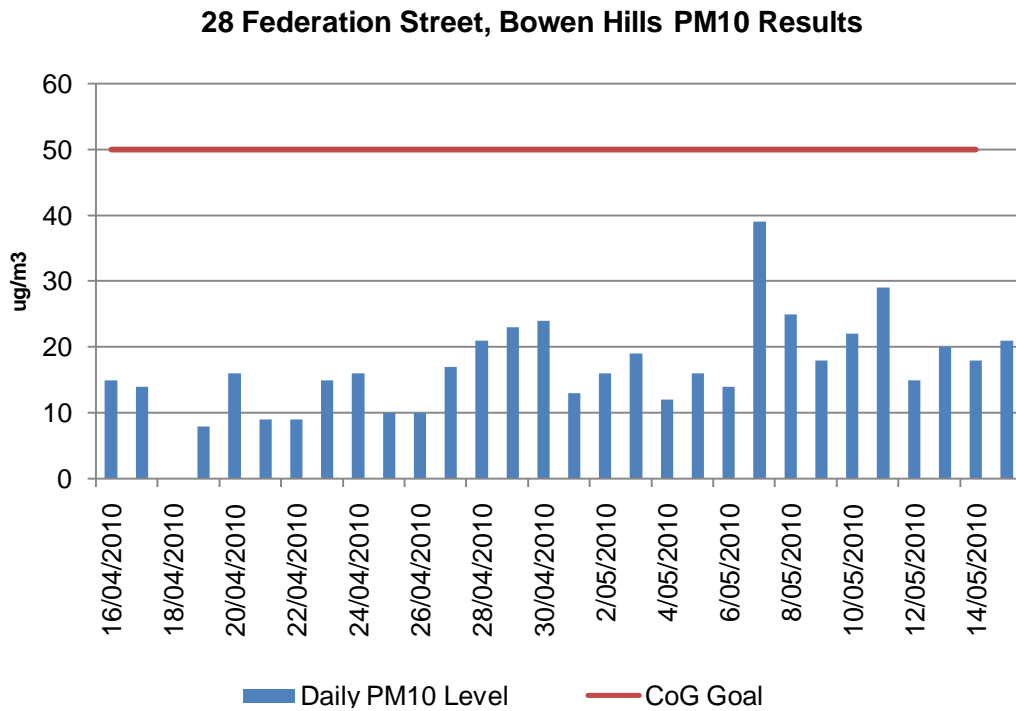
Figure 4.2.1 28 Federation St, Bowen Hills PM10 Results (for monitor location see figure 2.1 – A1)

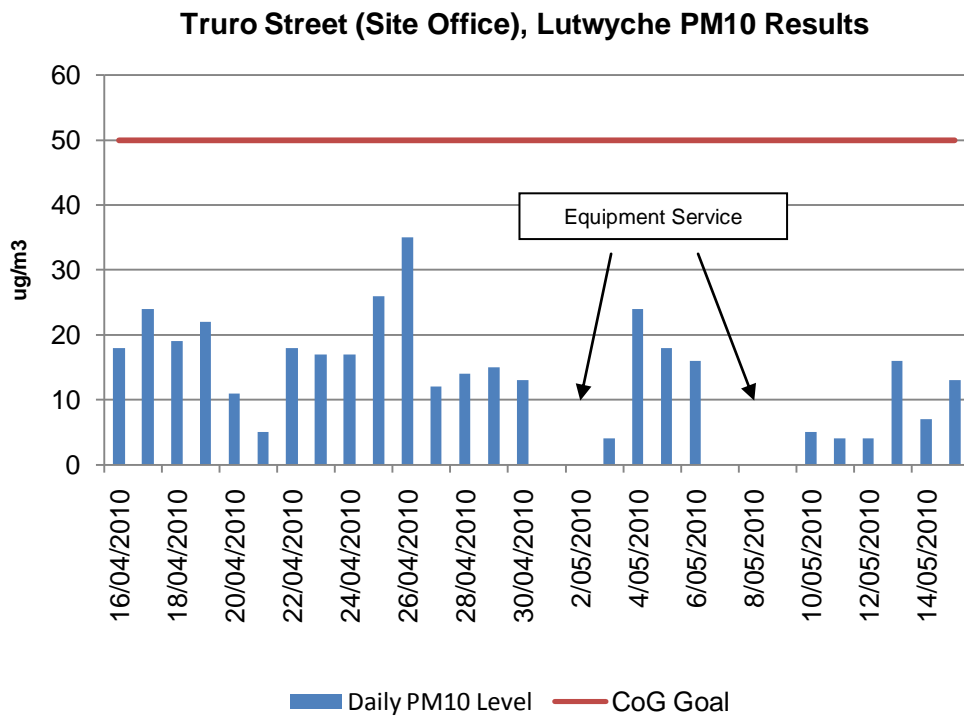
Figure 4.2.2 Truro St Site Office, Lutwyche PM10 Results (for monitor location see figure 2.2 – A1)

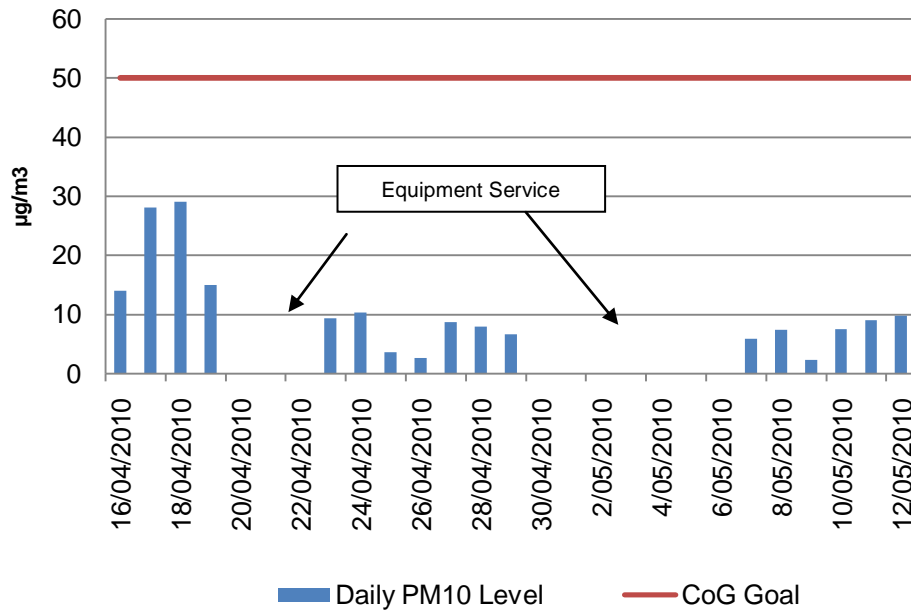
Figure 4.2.3 Northern Busway Site Office, Lutwyche PM10 Results (for monitor location see figure 2.3 – A1)

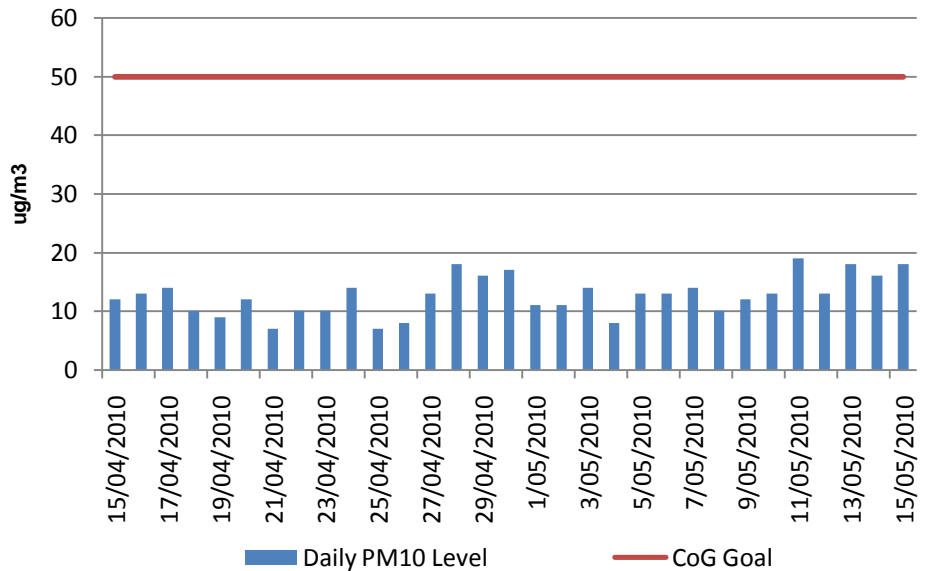
Figure 4.2.4 Wooloowin State School, Lutwyche PM10 Results (for monitor location see figure 2.4 – A3)

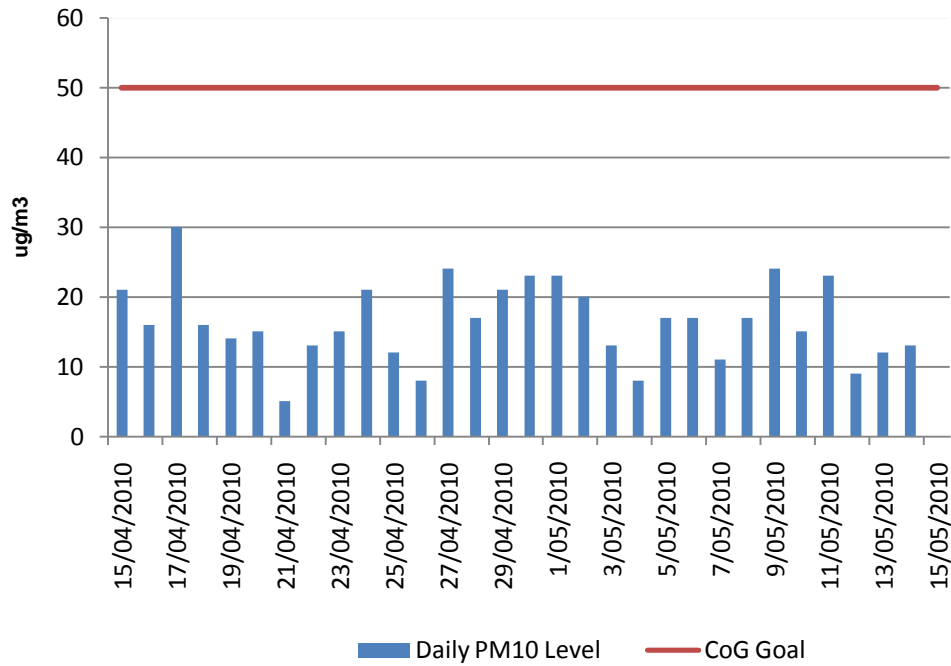
Figure 4.2.5 Perry Street, Lutwyche PM10 Results (for monitor location see figure 2.4 – A4)

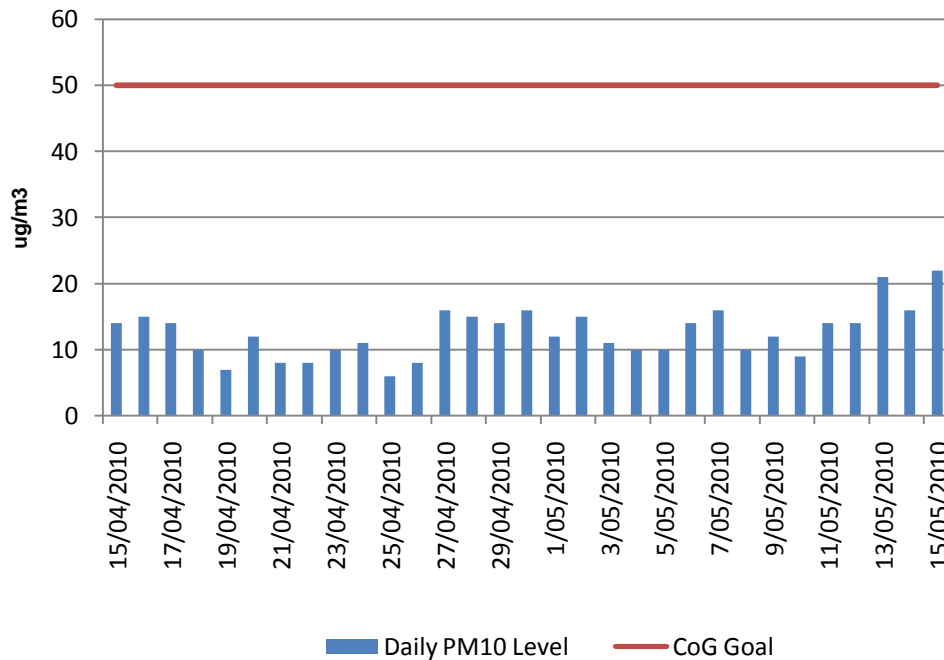
Figure 4.2.6 Kedron State High School (Adj), Kedron PM10 Results (for monitor location see figure 2.4 – A2)

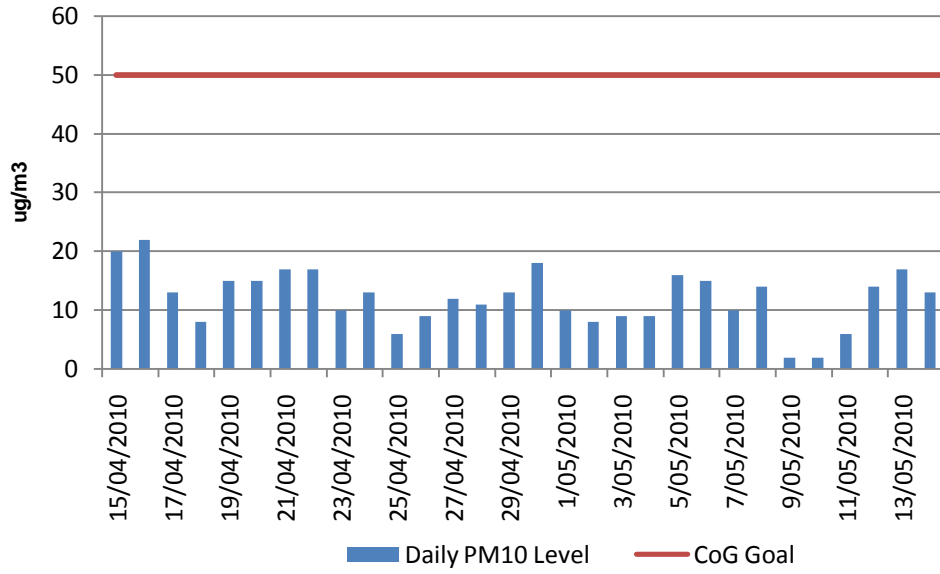
Figure 4.2.7 Erskine Avenue, Kedron PM10 Results (for monitor location see figure 2.4 – A1)

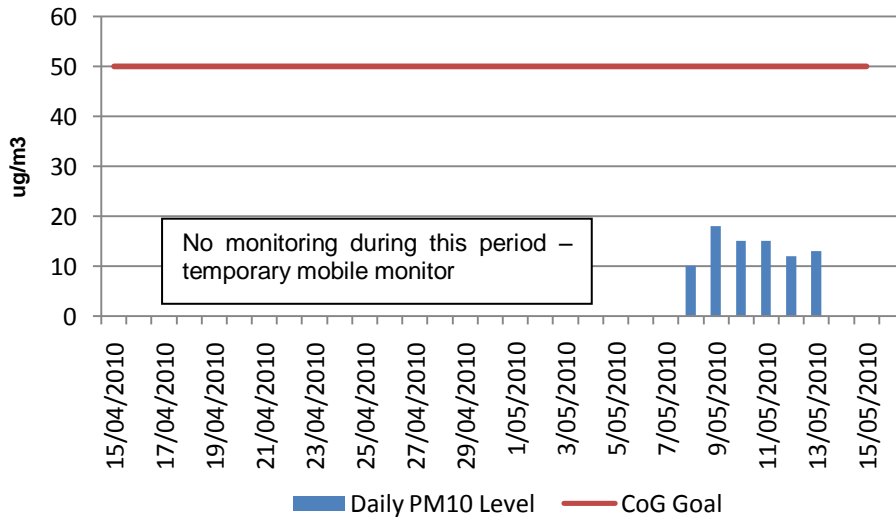
Figure 4.2.8 18 Jack St, Gordon Park, PM10 Results (for monitor location see figure 2.4 – A5)

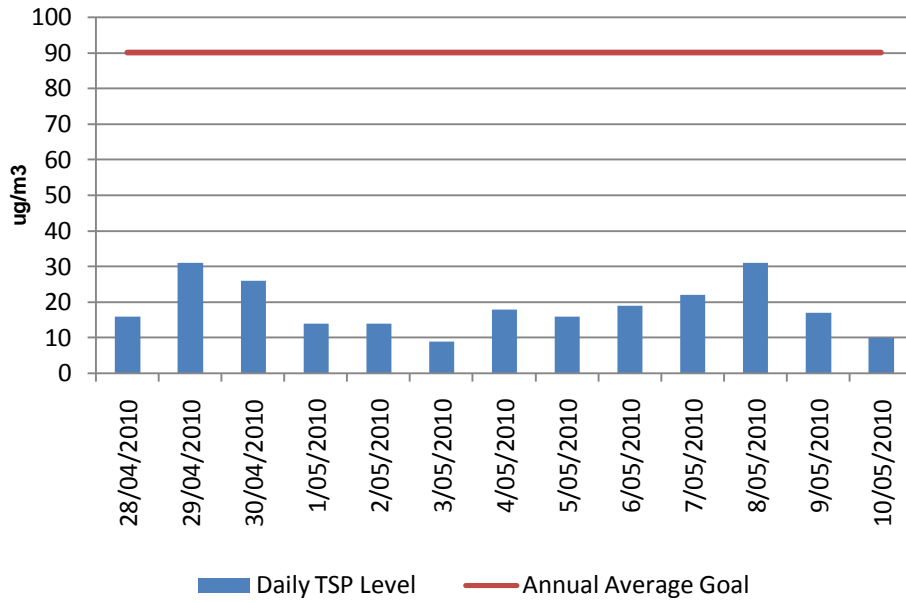
Figure 4.2.9 73 Park Rd, Woolloowin PM10 Results (for monitor location see figure 2.5 - A1)

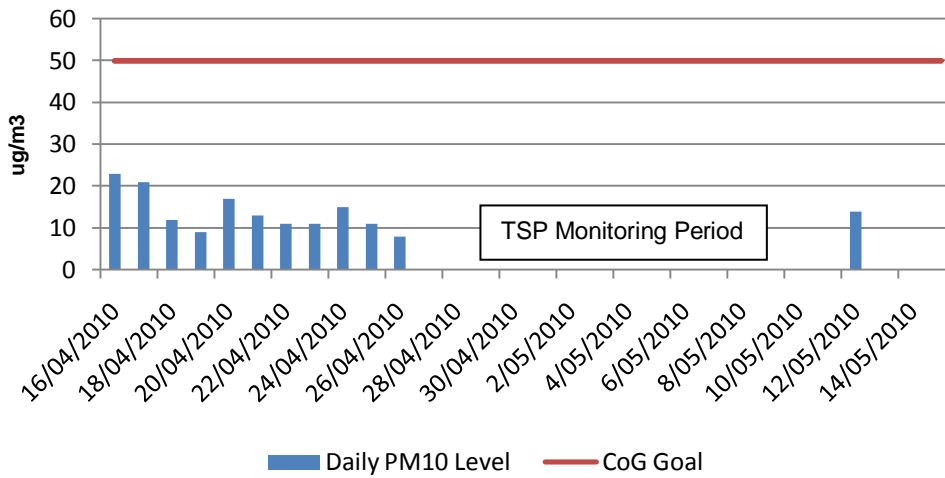
Figure 4.2.10 73 Park Rd, Woolloowin PM10 Results (for monitor location see figure 2.5 - A1)

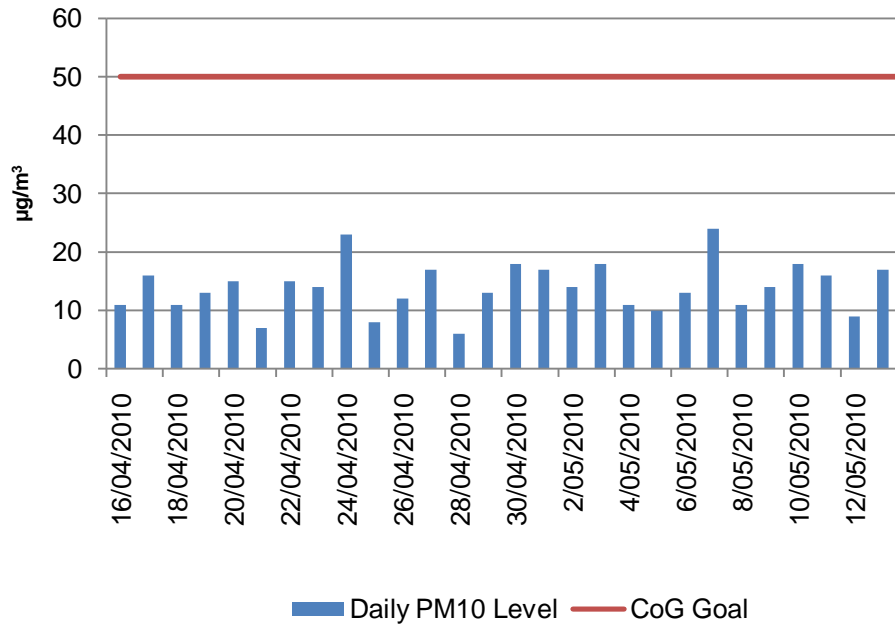
Figure 4.2.11 56 Kalinga Street, Toombul PM10 Results (for monitor location see figure 2.6 – A1)

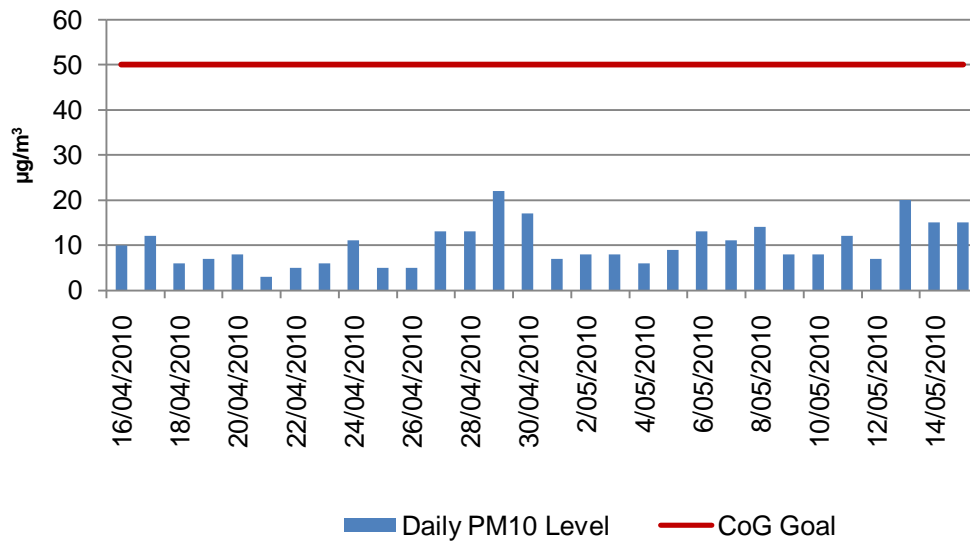
Figure 4.2.12 5 Mabel Street, Toombul PM10 Results (for monitor location see figure 2.6- A2)

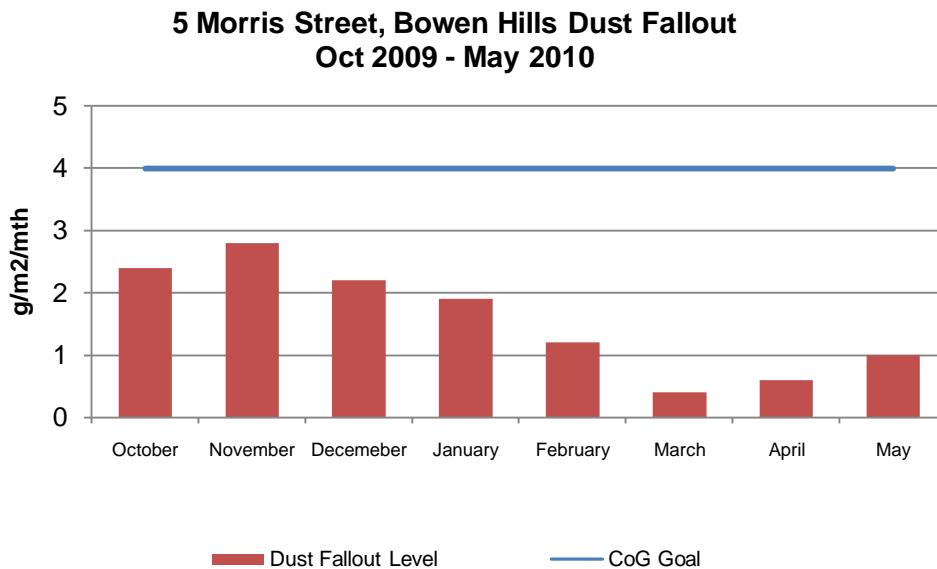
Dust deposition monitoring is undertaken on a monthly basis using a bottle and funnel placed 2m ± 0.2m above ground level in accordance with Australian Standard AS 3580.10.1: 2003. It should be noted that in most locations the placement of the deposition gauges does not meet the standard due to location and security issues. Note: due to lab processing times and field placement some results are not available at time of report writing thus will be included in next months report.

Figure 4.3.1 5 Morris St, Bowen Hills Dust Deposition Results (for monitor location refer to figure 2.1 – D1)

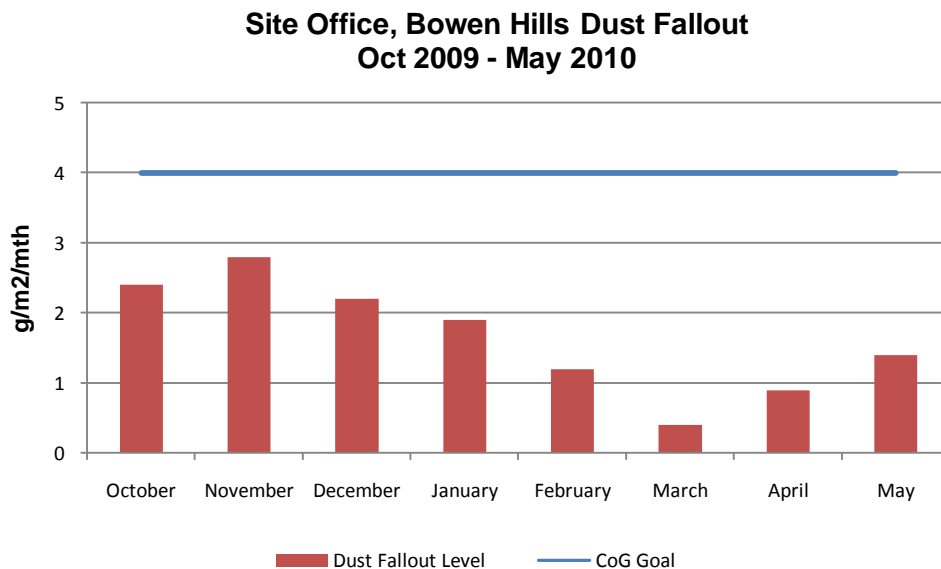
Figure 4.3.2 Site Office, Bowen Hills Dust Deposition Results (for monitor location refer to figure 2.1- D2)

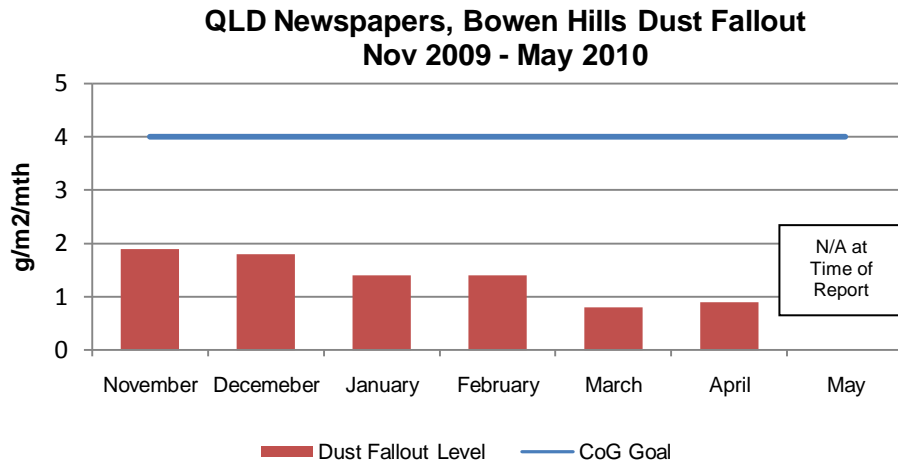
Figure 4.3.3 QNP, Bowen Hills Dust Deposition Results (monitor location 41 Campbell St, Bowen Hills)

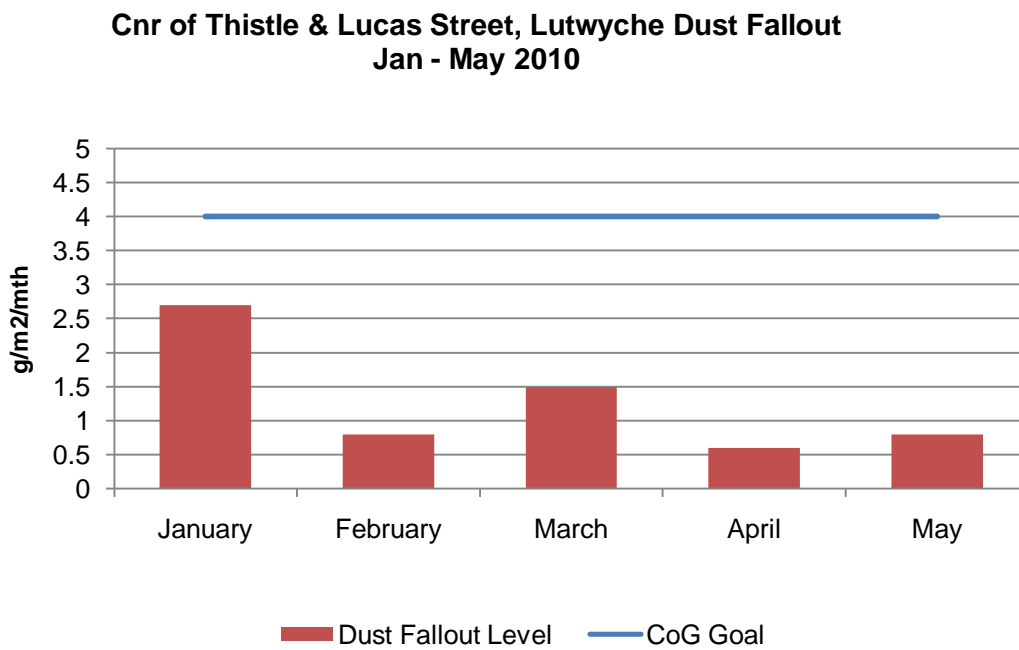
Figure 4.3.4 Cnr of Thistle & Lucas Street, Lutwyche Dust Fallout Results (location refer to figure 2.3 – D2)

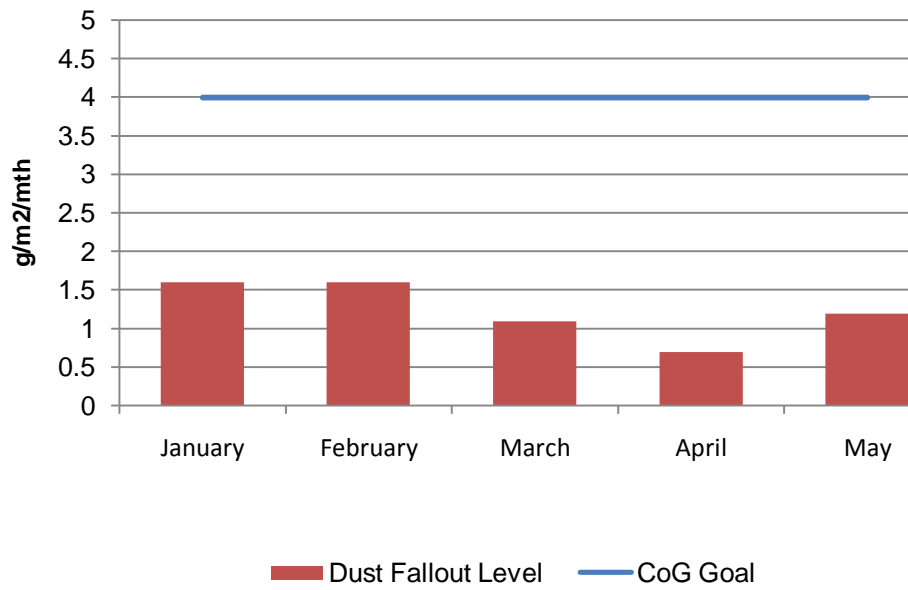
Figure 4.3.5 Kedron Brook Reserve, Northern Busway Dust Fallout Results (location refer to figure 2.3 – D1)

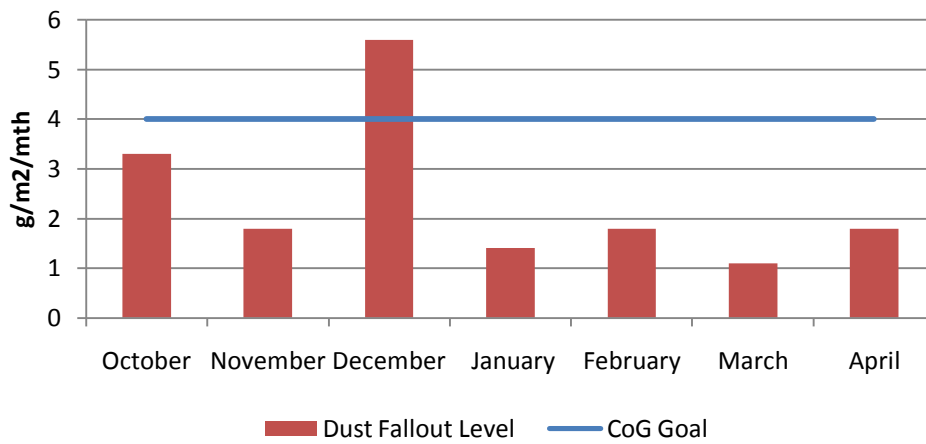
Figure 4.3.6 Erskine Avenue, Kedron Dust Fallout Results (location refer to figure 2.4 – D1)

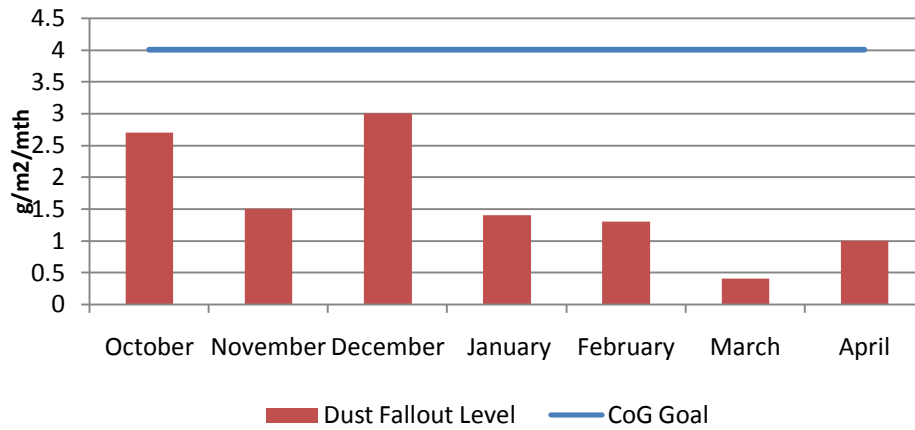
Figure 4.3.7 Adj Kedron SHS, Kedron Dust Fallout Results (location refer to figure 2.4 – D2)

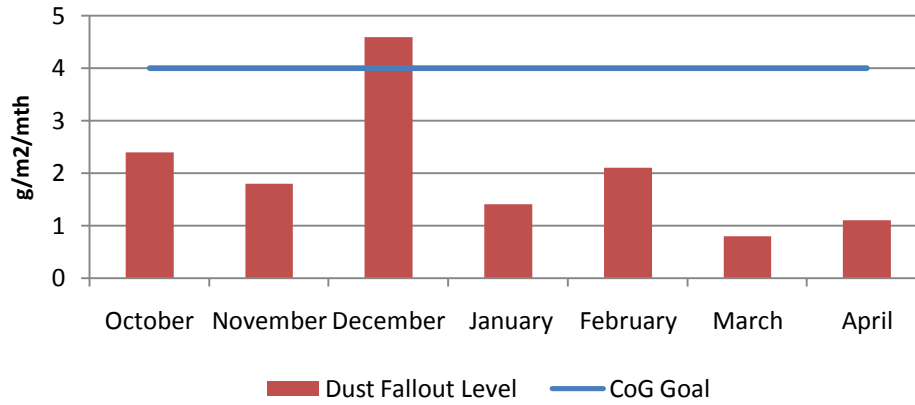
Figure 4.3.8 Wooloowin SS, Kedron Dust Fallout Results (location refer to figure 2.4 – D3)

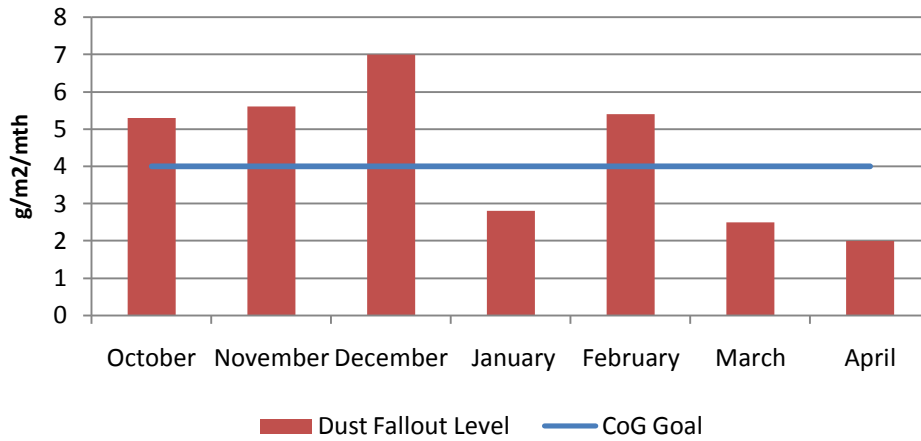
Figure 4.3.9 Perry St, Lutwyche Dust Fallout Results (location refer to figure 2.4 – D4)

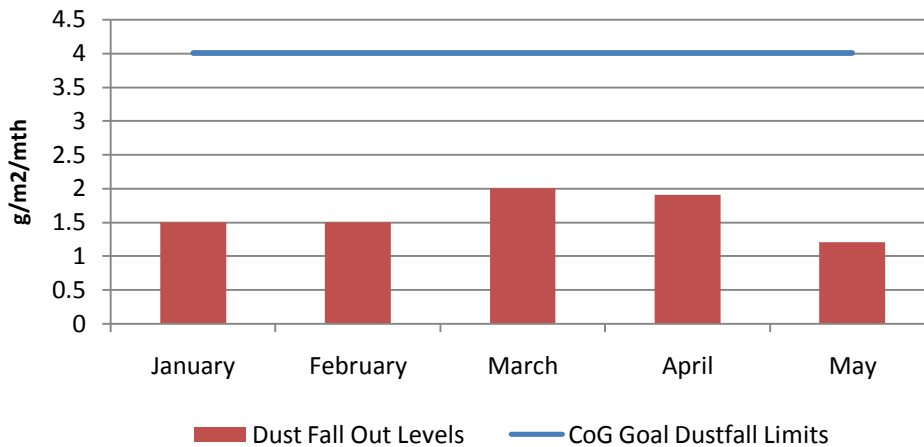
Figure 4.3.10 68 Park Road, Wooloowin Dust Fallout Results (location refer to figure 2.5 – D1)

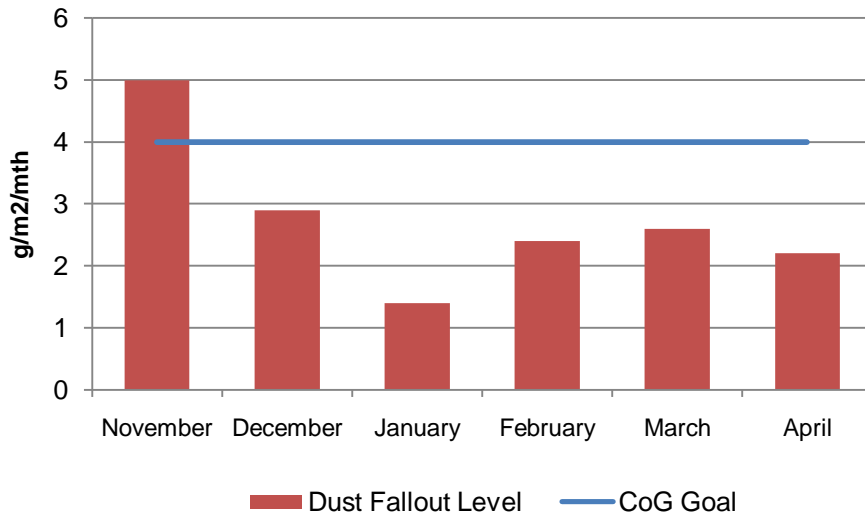
Figure 4.3.11 56 Kalinga Street Toombul, Dust Fallout Results (location refer to figure 2.6 – D1)

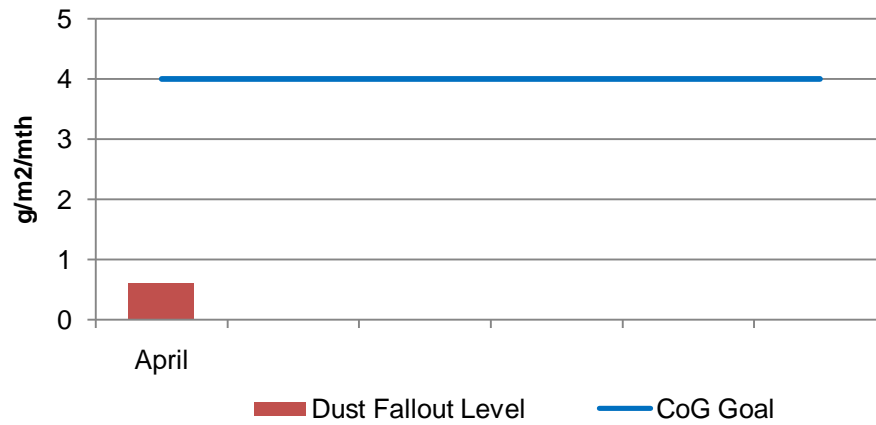
Figure 4.3.12 Mabel Street, Clayfield Dust Fallout Results (location refer to figure 2.6 – D2)

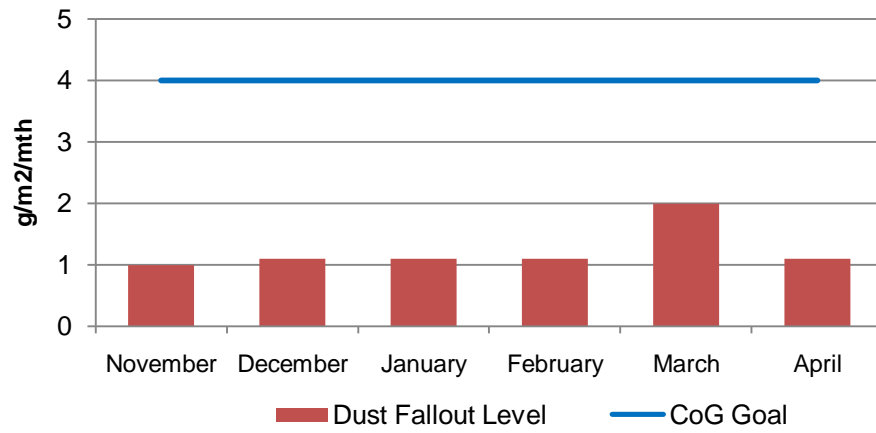
Figure 4.3.13 Bage Street Toombul, Dust Fallout Results (location refer to fig 2.6 – D3)
