Airport Link / Northern Busway Project

Monthly Environmental Monitoring Report

June 2011

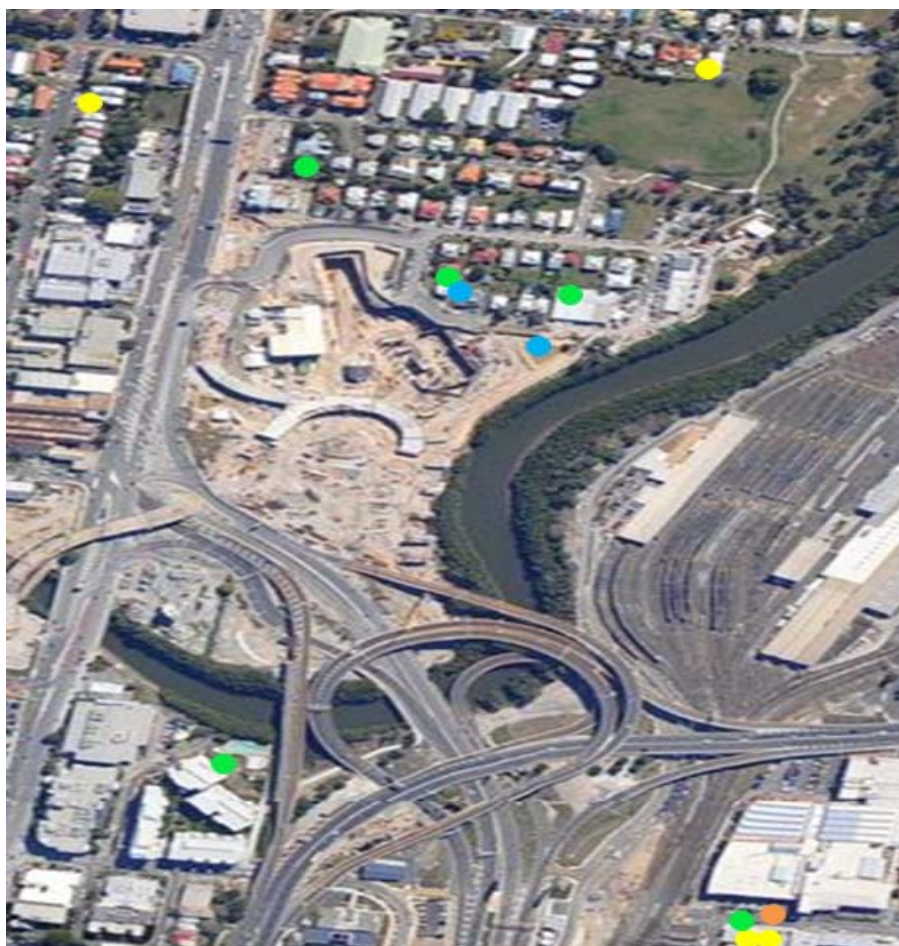
Figure 2.1 – Bowen Hills Monitoring Locations

- Noise (during construction)
- Vibration
- Air (TSP/PM₁₀)
- Air (Dust Deposition)

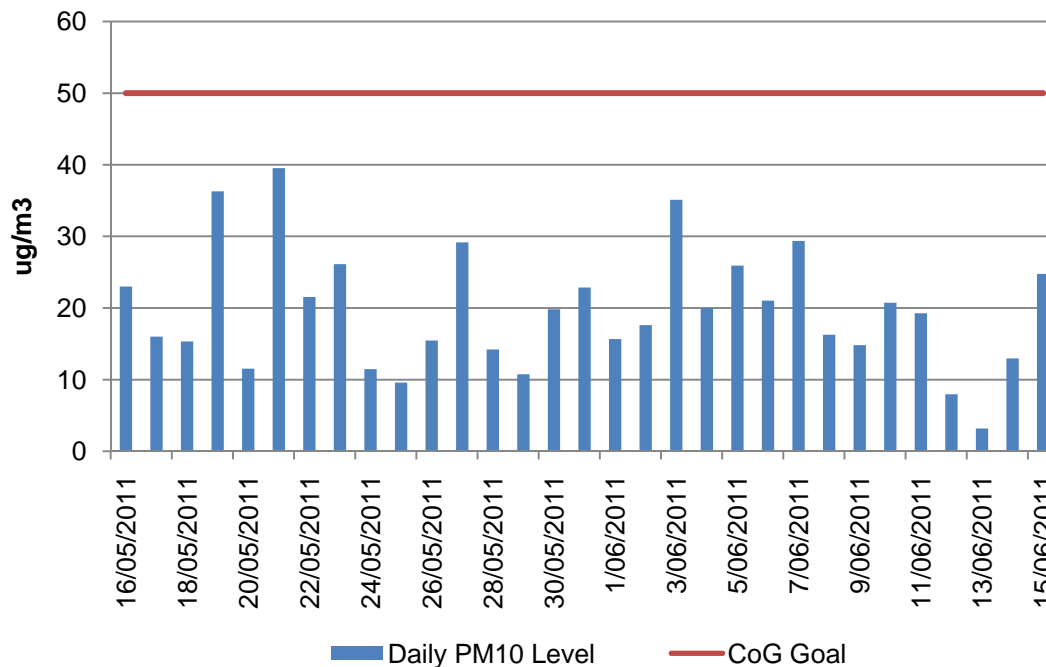
Figure 4.2.1: 5 Morris Street, Bowen Hills PM10 Results (for monitor location see figure 2.1)

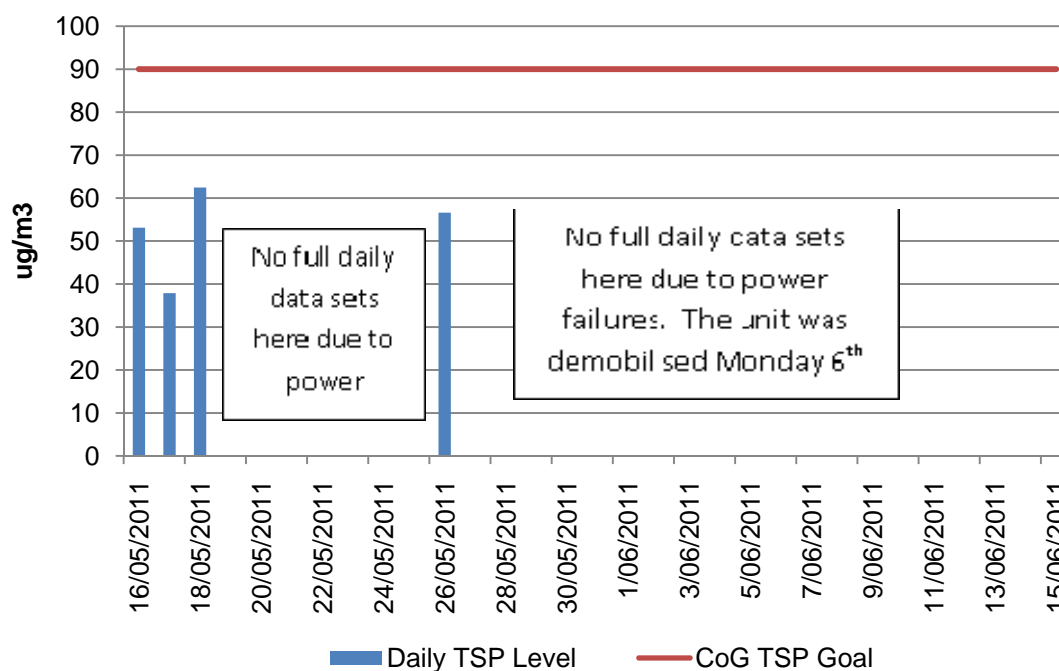
Figure 4.2.2 Federation Street Gate 4, Windsor TSP Results (for monitor location see figure 2.1)

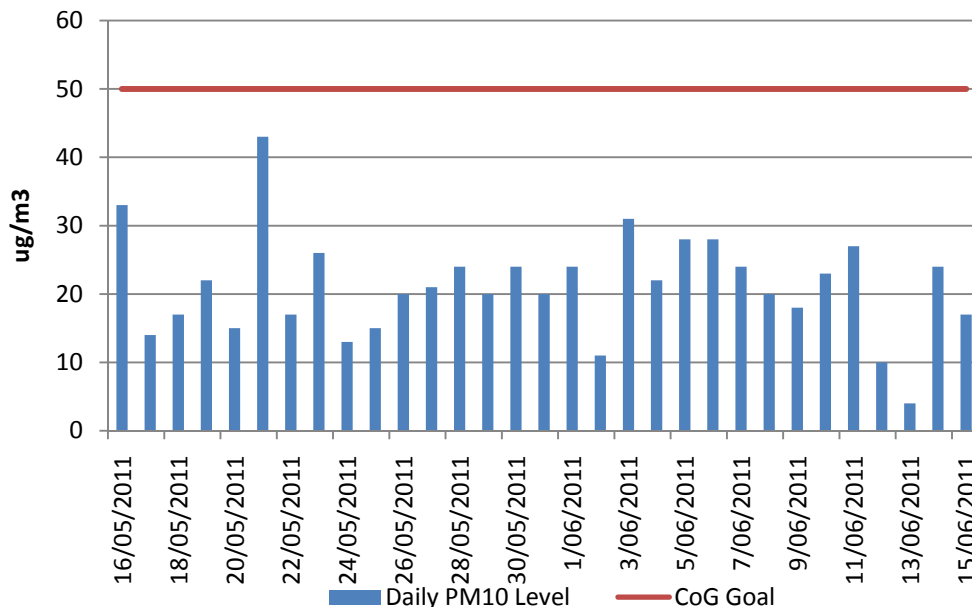
Figure 4.2.3: Erskine Avenue, Kedron PM10 Results (for monitor location see figure 2.4 – A1)

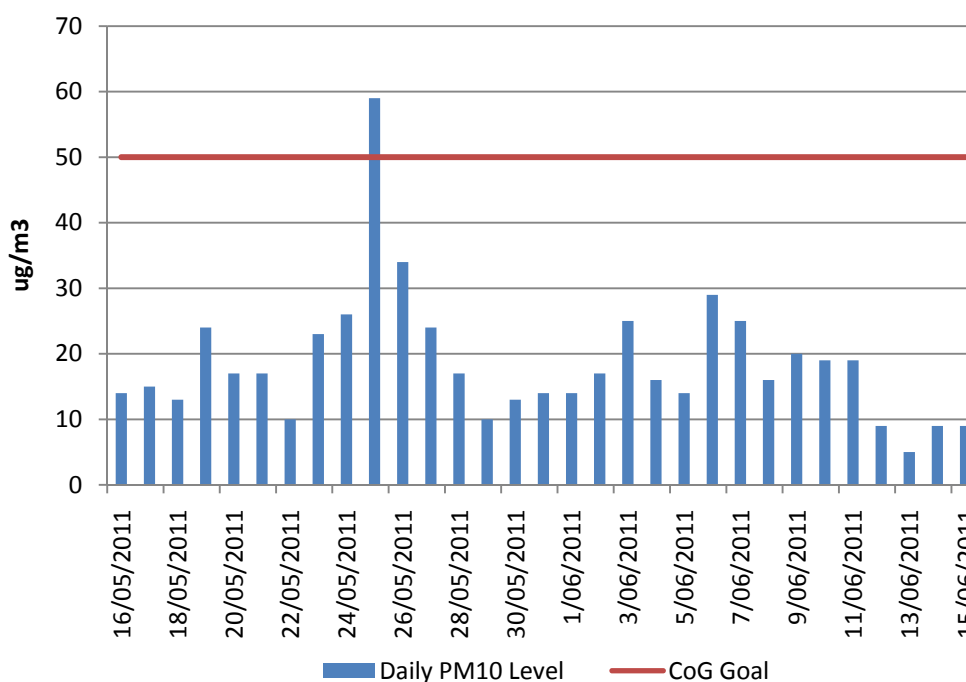
Figure 4.2.4: Kedron State High School (Adj), Kedron PM10 Results (for monitor location see figure 2.4 – A2)

On one occasion this month the daily average recorded by the EBAM for PM10 at the Kedron State High school was above the CoG goal. This goal is adopted from the Environmental Protection (*Air Policy 2008*). This policy states that the limit of 50ug/m³ should not be exceeded more than 5 times per year. An onsite investigation was completed to determine the cause of the exceedance and mitigations reviewed and implemented to prevent recurrence.

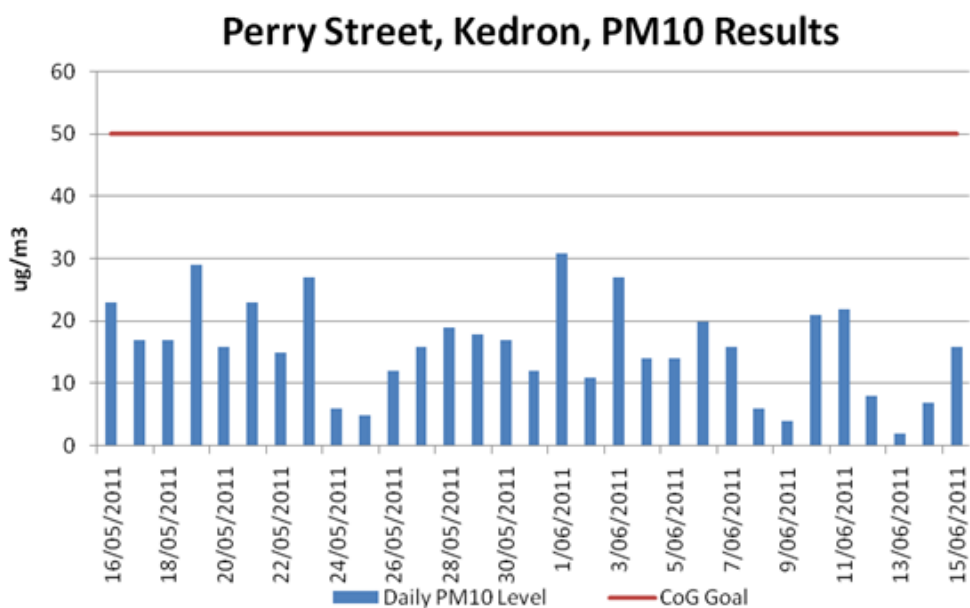
Figure 4.2.5: Perry Street, Kedron PM10 Results (for monitor location see figure 2.4 – A2)

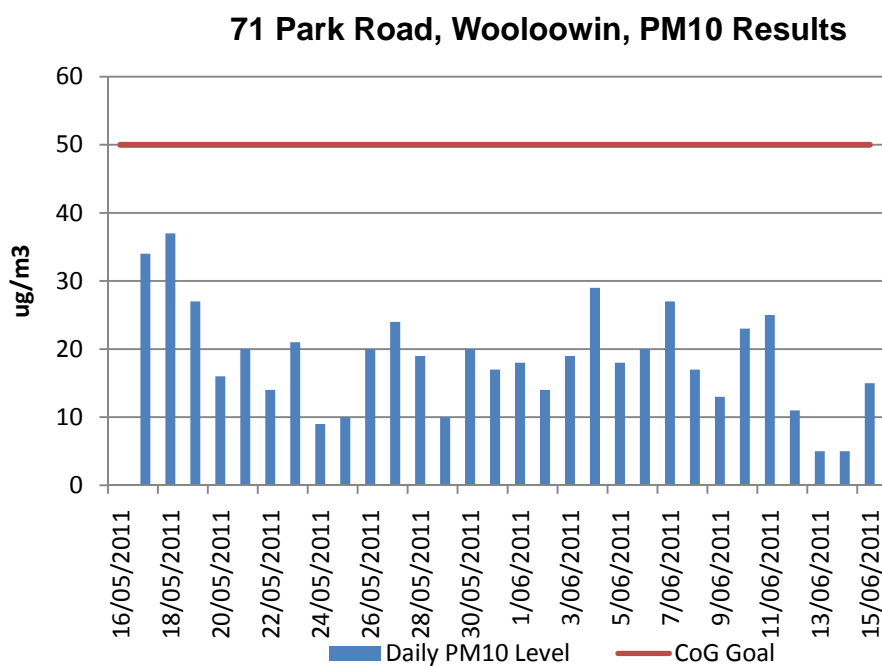
Figure 4.2.6: 71 Park Road, Woolloowin PM10 Results (for monitor location see figure 2.1 – A1)

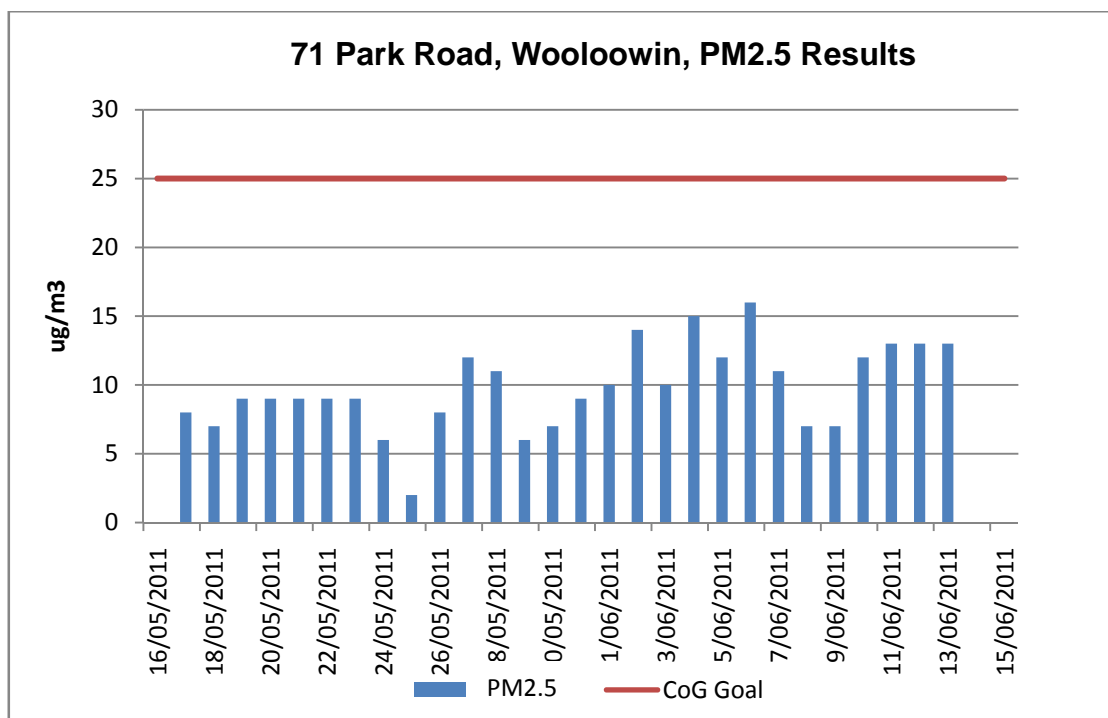
Figure 4.2.7: 71 Park Road, Woolloowin PM2.5 Results (for monitor location see figure 2.1 – A1)

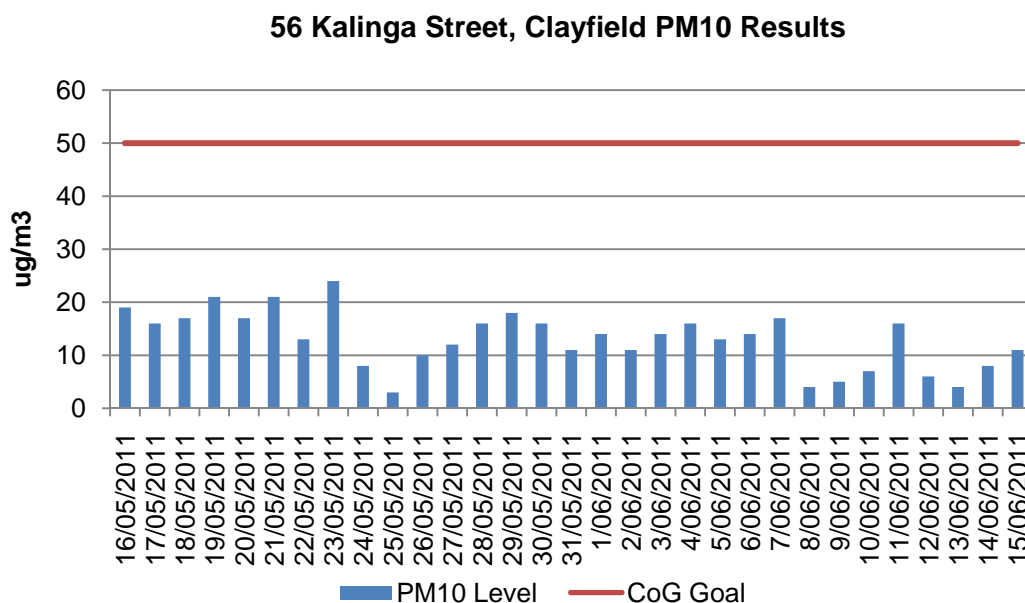
Figure 4.2.8: 56 Kalinga Street, Toombul PM10 Results (for monitor location see Figure 2.6 – A1)

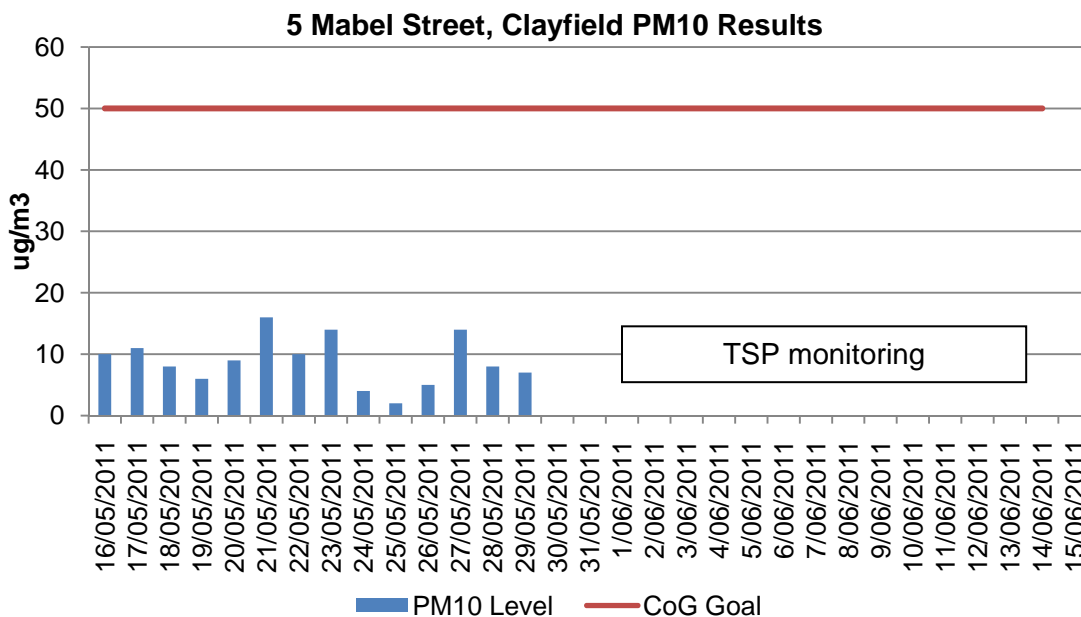
Figure 4.2.9: 5 Mabel Street, Clayfield PM10 Results (for monitor location see Figure 2.6- A2)

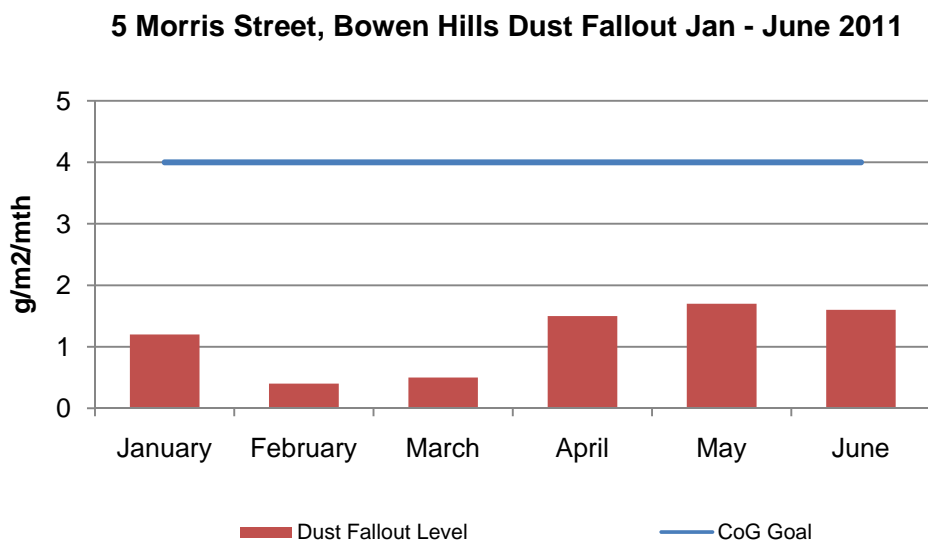
Figure 4.3.1: 5 Morris St Bowen Hills Dust Deposition Results (for monitor location refer to figure 2.1)

Dust deposition monitoring is undertaken on a monthly basis using a bottle and funnel placed 2m ± 0.2m above ground level in accordance with Australian Standard AS 3580.10.1:2003. It should be noted that in all locations the placement of the deposition gauges does not strictly meet the standard due to location and security restrictions. Efforts to comply with location standards have been made however as much as possible.

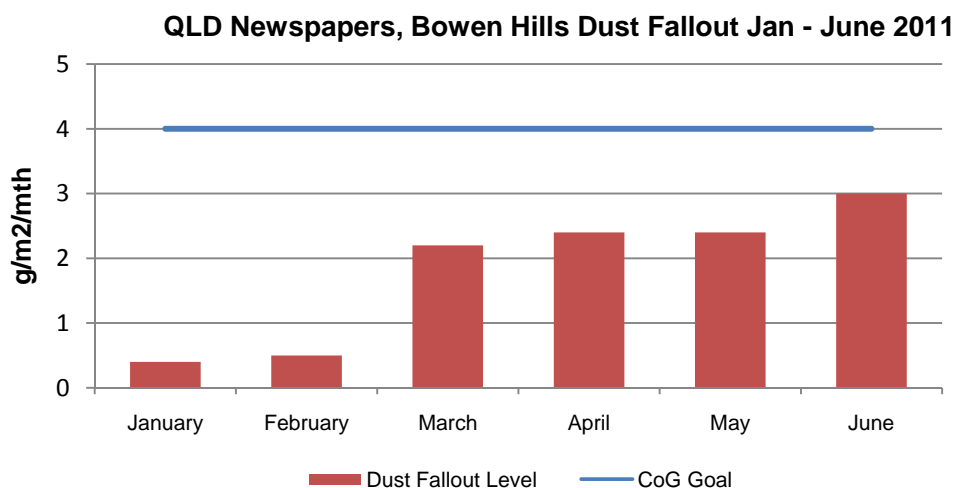
Figure 4.3.2: Queensland Newspapers, Bowen Hills Dust Deposition Results (for monitor location refer to figure 2.1)

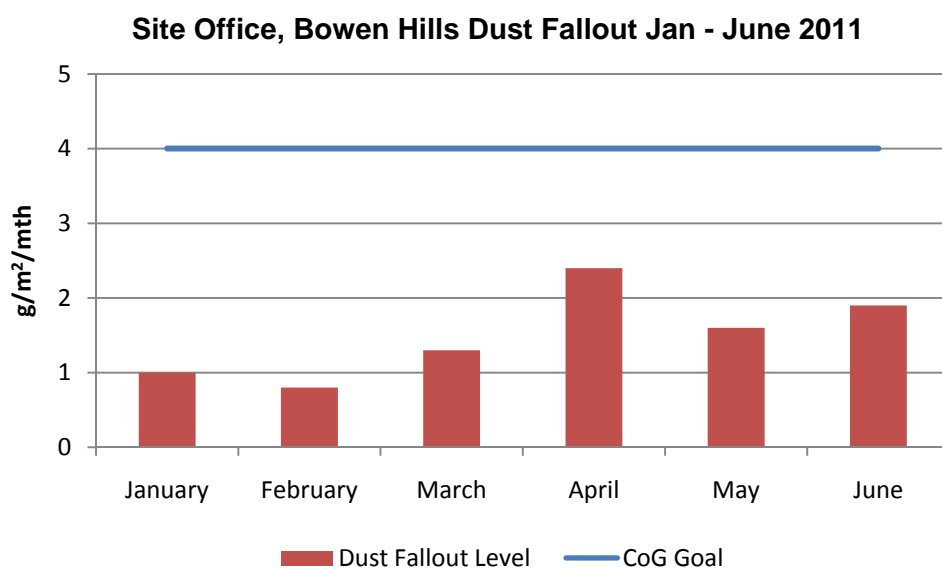
Figure 4.3.3: Site Office, Bowen Hills Dust Deposition Results (for monitor location refer to figure 2.1)

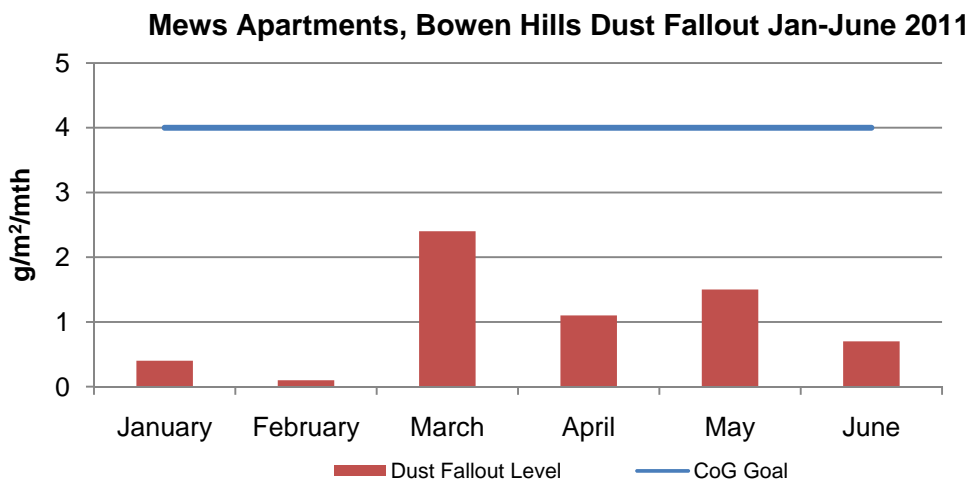
Figure 4.3.4: Mews Apartments, Bowen Hills Dust Deposition Results (for monitor location refer to figure 2.1)

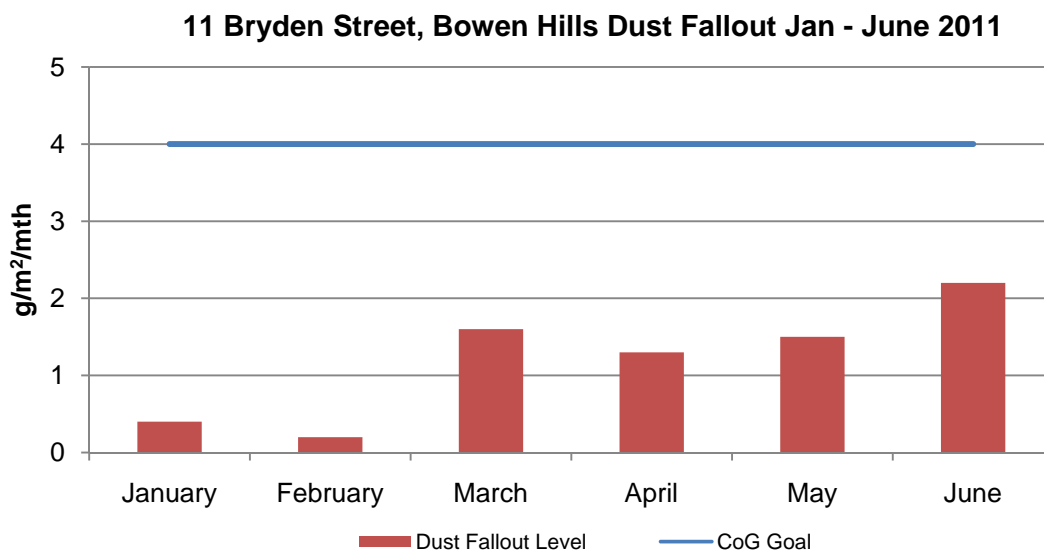
Figure 4.3.5: 11 Bryden Street, Bowen Hills Dust Deposition Results (for monitor location refer to figure 2.1)

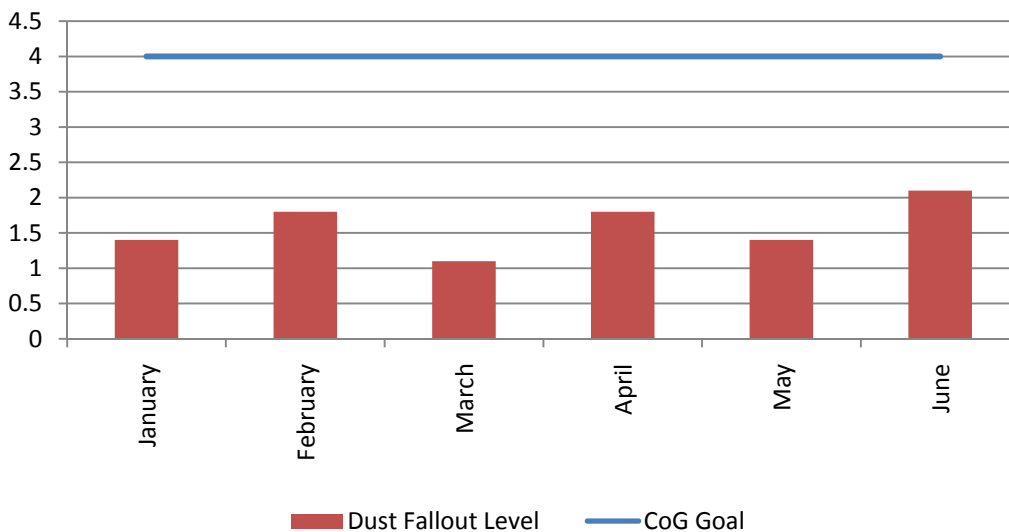
Figure 4.3.6: Erskine Avenue, Kedron Dust Fallout January – June 2011 (for monitor location see figure 2.4 – A1)

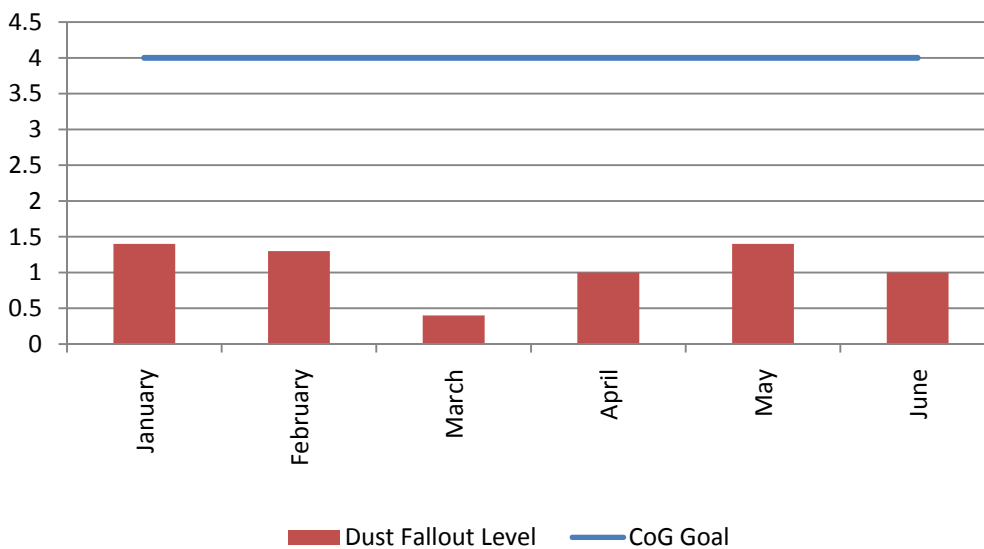
Figure 4.3.7: Kedron State High School, Dust Fallout January – June 2011 (for monitor location see figure 2.4 A2)

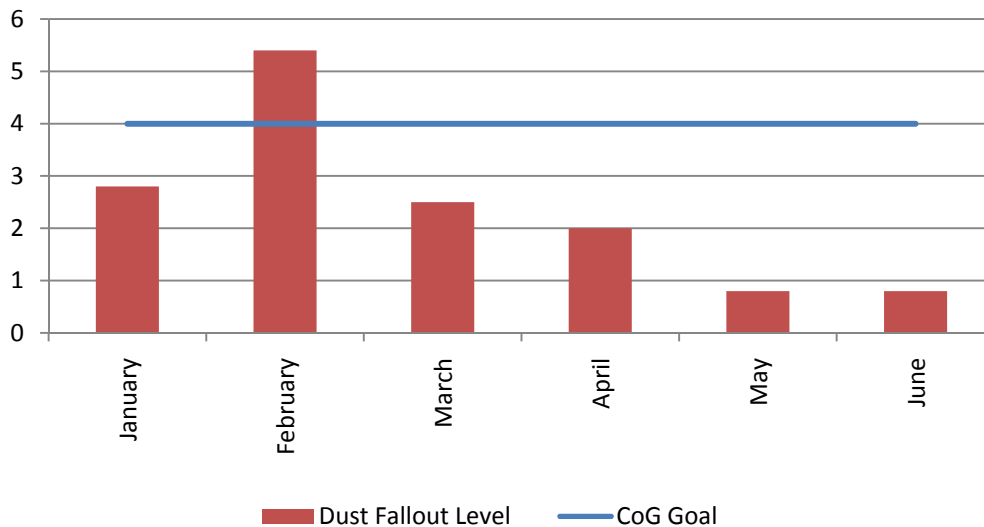
Figure 4.3.8: Perry Street, Lutwyche Dust Fallout January – June 2011 (for monitor location see figure 2.4 – A3)

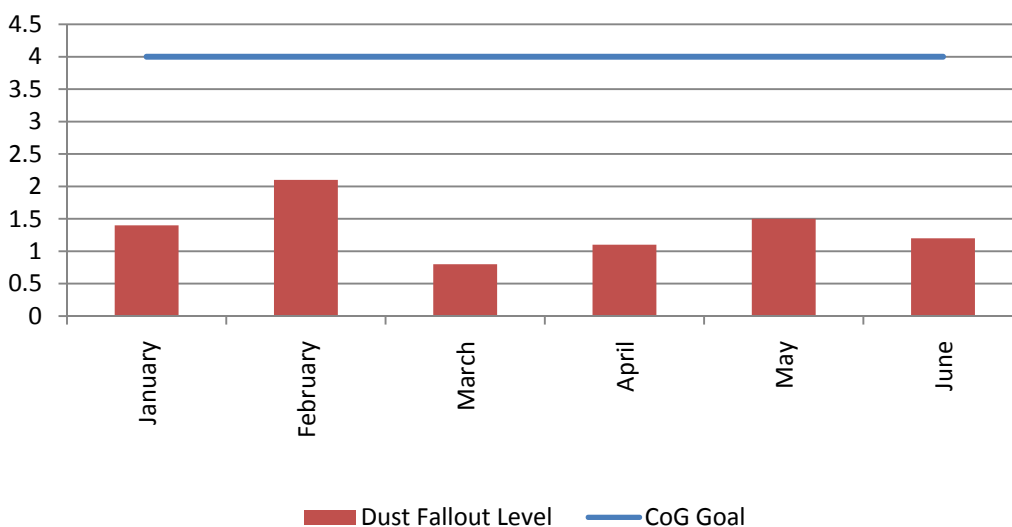
Figure 4.3.9: Woolloowin State School, Dust Fallout January - June 2011 (for monitor location see figure 2.4 – A4)

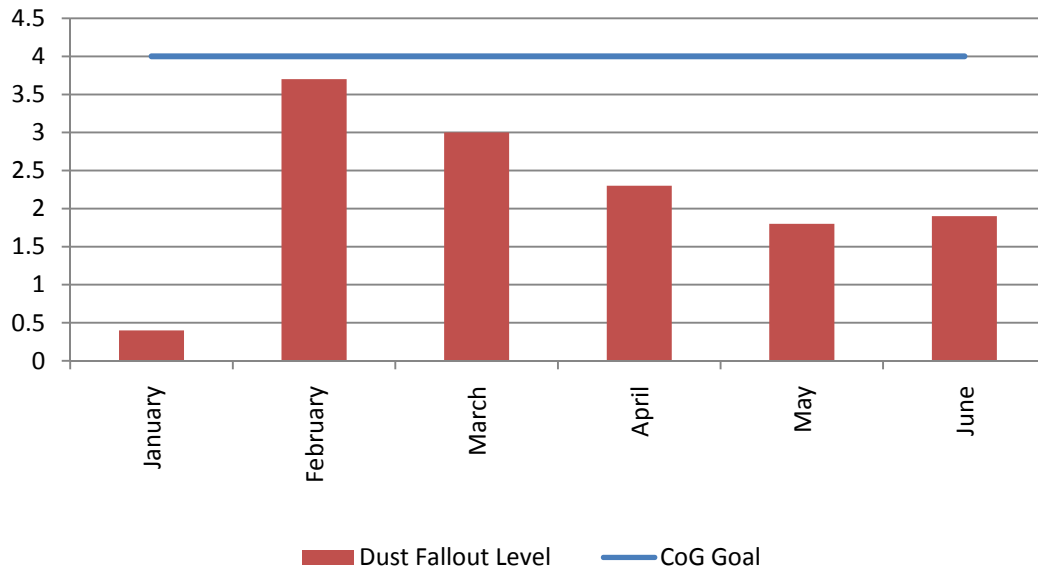
Figure 4.3.10: 228 Gympie Road, Kedron Dust Fallout January – June 2011 (for monitor location see figure 2.4)

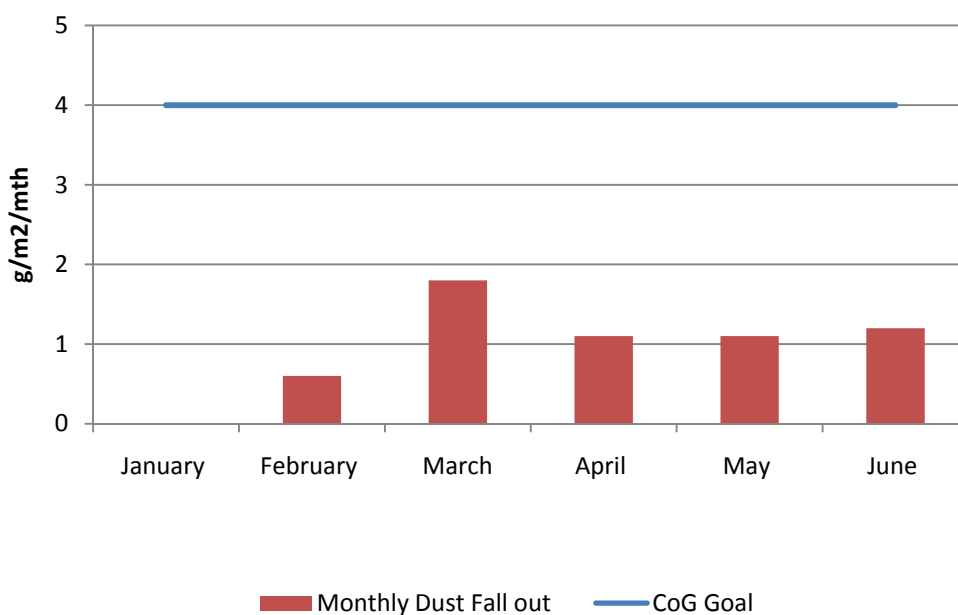
Figure 4.3.11: 68 Park Road, Woolloowin Dust Deposition Results (for monitor location refer to figure 2.1)

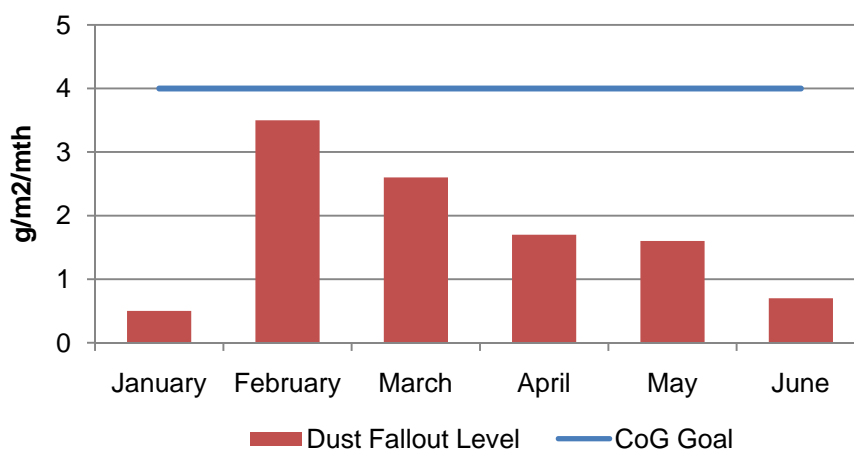
Figure 4.3.12: 56 Kalinga Street Toombul, Dust Fallout (location refer to figure 2.6 – D1)

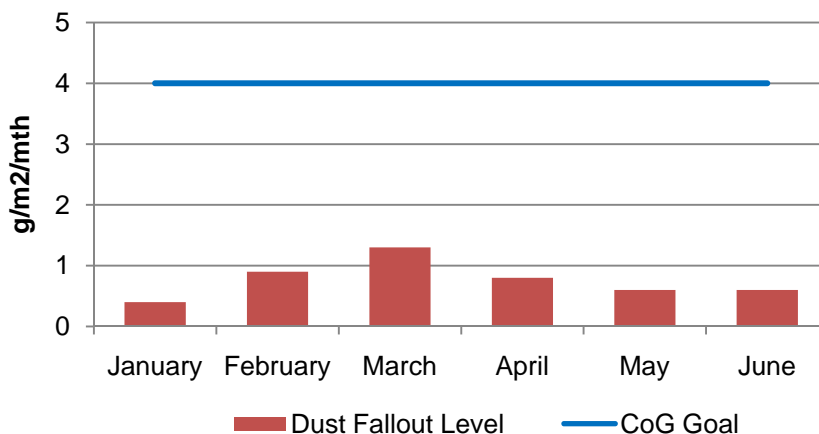
Figure 4.3.13: Mabel Street Toombul, Dust Fallout (location refer to figure 2.6 – D2)

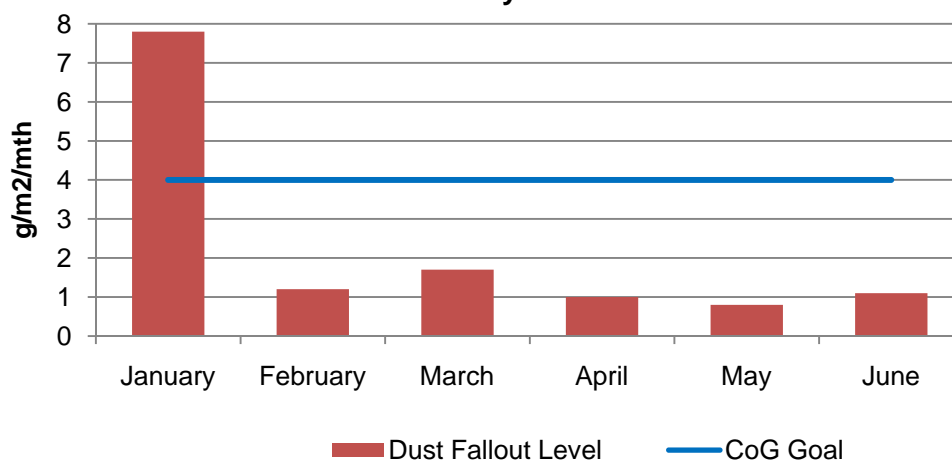
Figure 4.3.14: Bage Street Toombul, Dust Fallout (location refer to figure 2.6 – D3)
