Airport Link / Northern Busway Project

Monthly Environmental Monitoring Report

November 2011

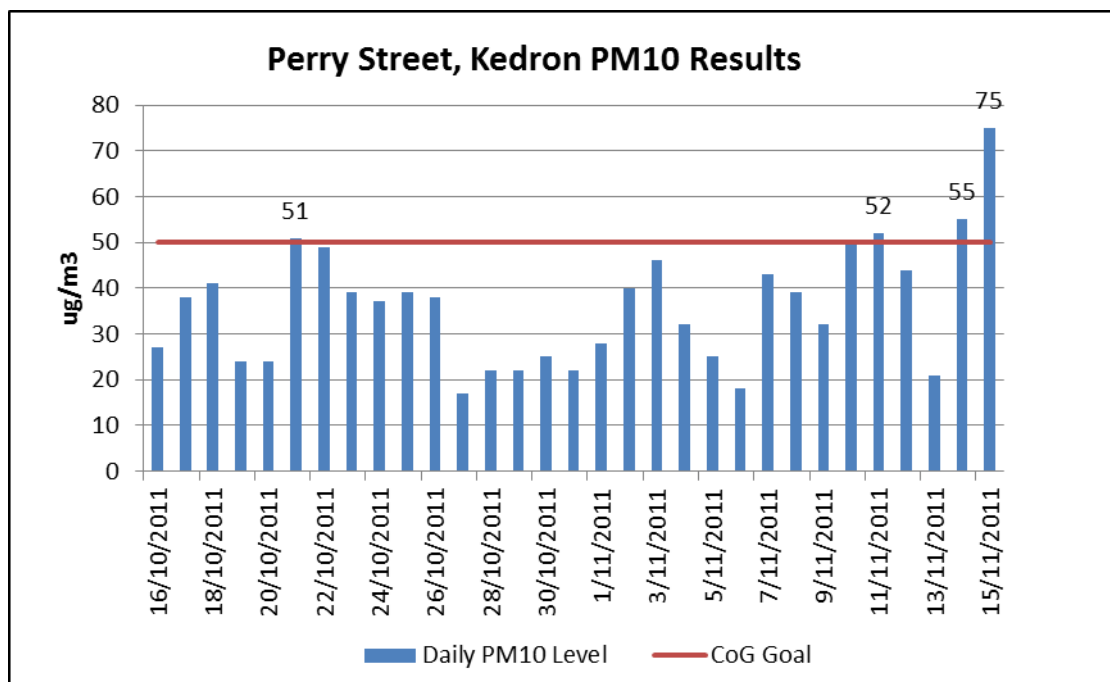
Figure 4.2.6: Perry Street, Lutwyche PM10 Results (for monitor location see figure 2.4 – A3)

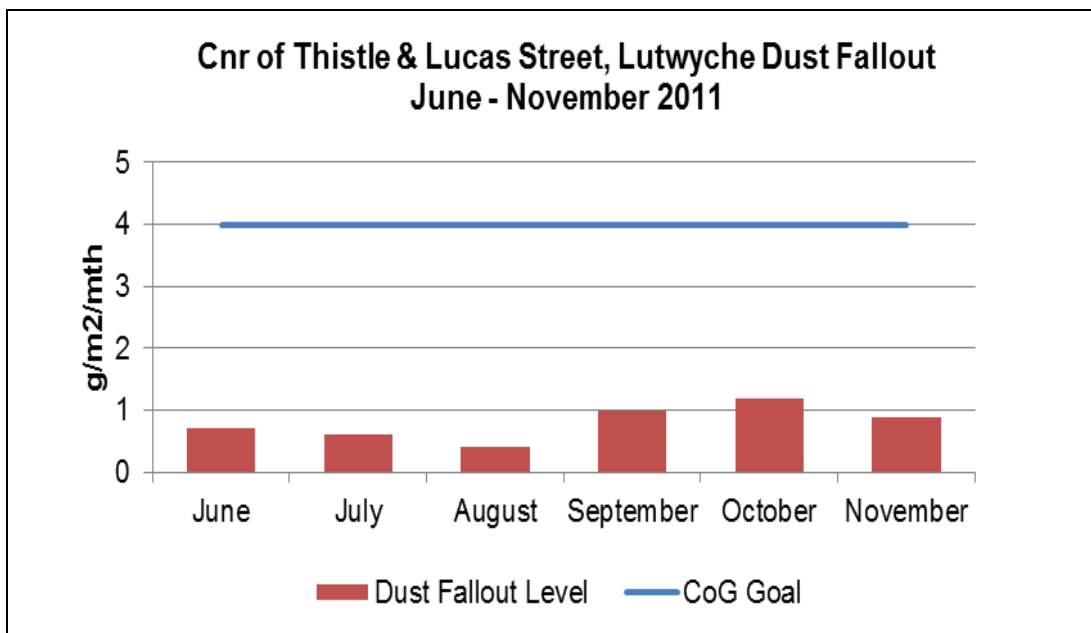
Figure 4.3.6: Cnr of Thistle & Lucas Street, Lutwyche Dust Fallout Results (location refer to figure 2.3 – D2)
