Airport Link / Northern Busway Project

Monthly Environmental Monitoring Report

July 2011

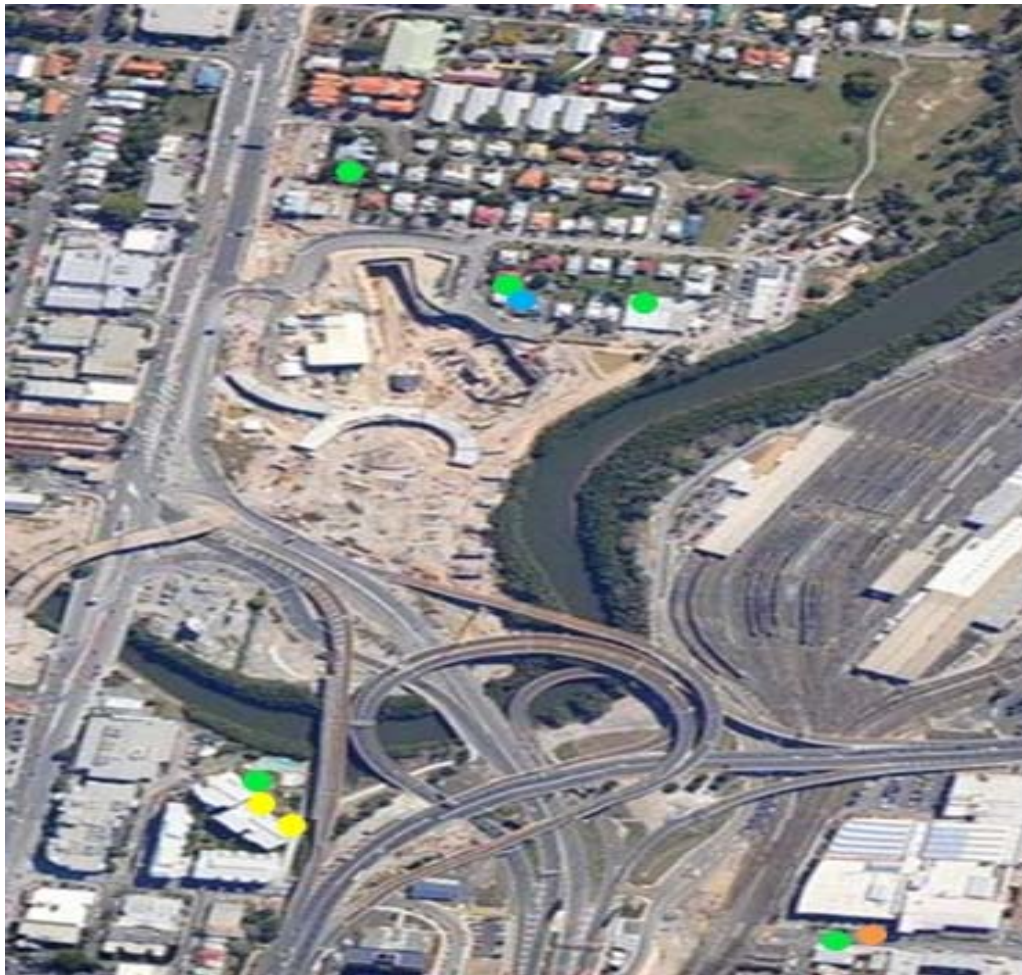
Figure 2.1 - Bowen Hills Monitoring Locations

Legend

| ● Noise (during construction) | ● Air (TSP/PM ₁₀) |
| ● Vibration | ● Air (Dust Deposition) |

Note: locations are indicative only

Several monitoring locations exist within the project area as described in Figures 1-5. Note that the aerial photograph overlays used in Figures 1-5 do not accurately portray the extent of the project's progress to mid-July 2011, though do serve a useful purpose in relating the monitoring locations to existing structures and infrastructure.

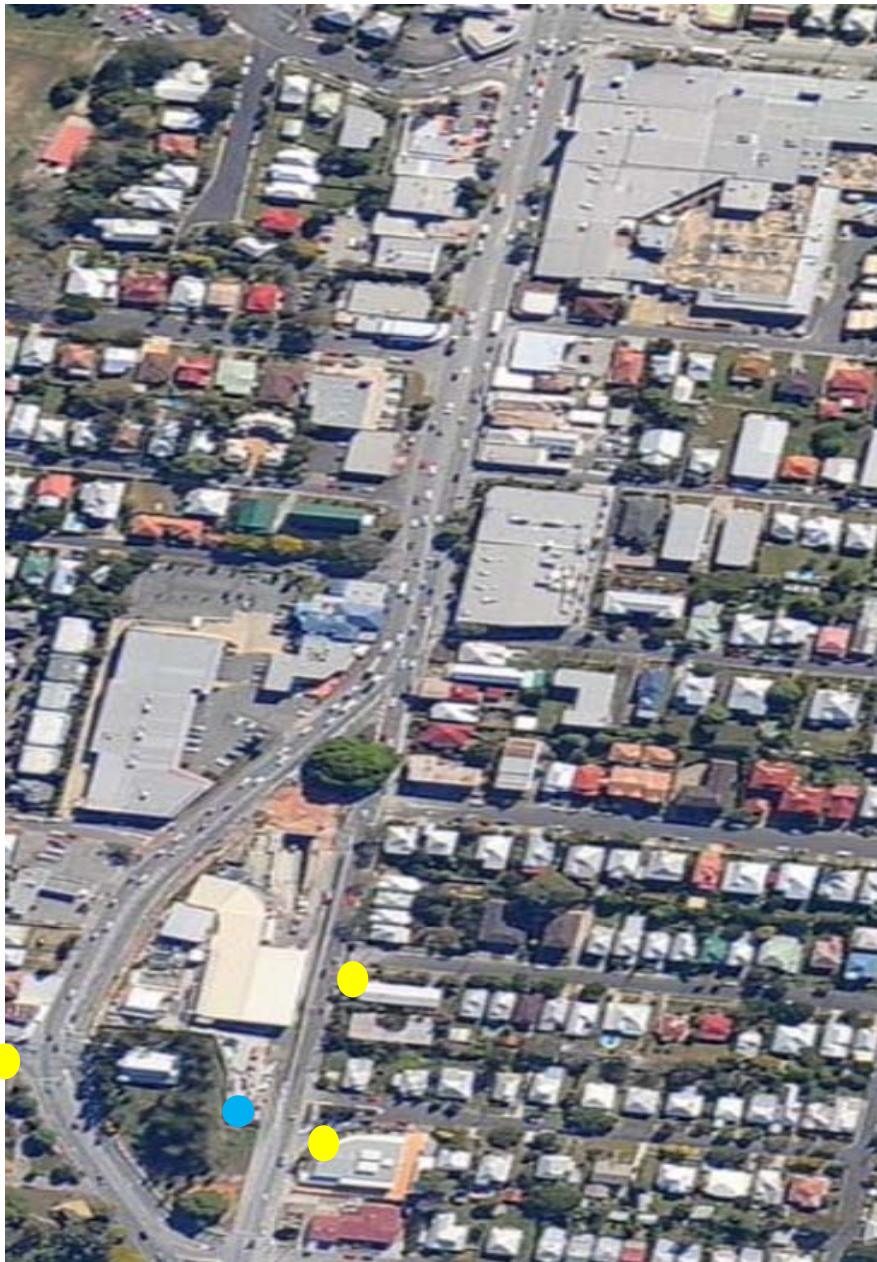
Figure 2.2 - Truro Street Mid-Tunnel Monitoring Locations

- Noise (during construction)
- Vibration

- Air (PM₁₀)
- Air (Dust Deposition)

Note: locations are indicative only

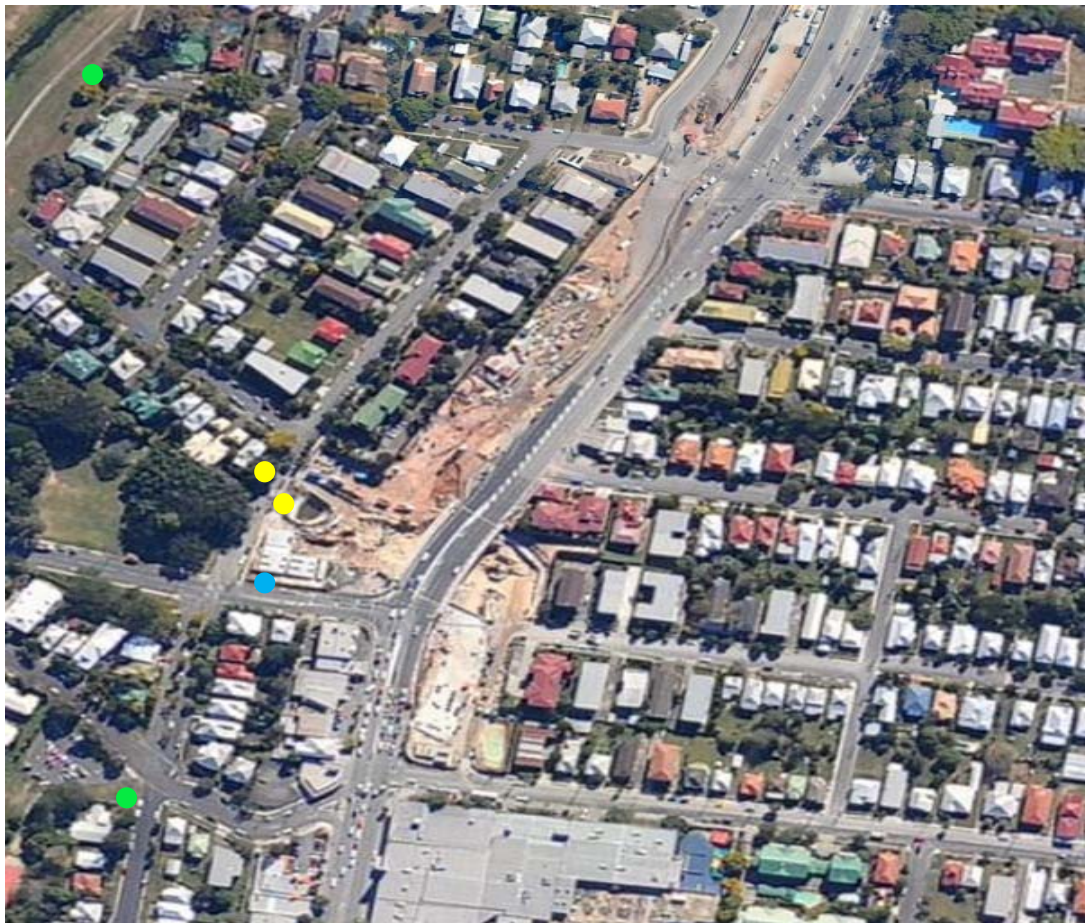
Figure 2.3 - Northern Busway Monitoring Locations

- Noise (during construction)
- Vibration
- Air (PM₁₀)
- Air (Dust Deposition)

Note: locations are indicative only

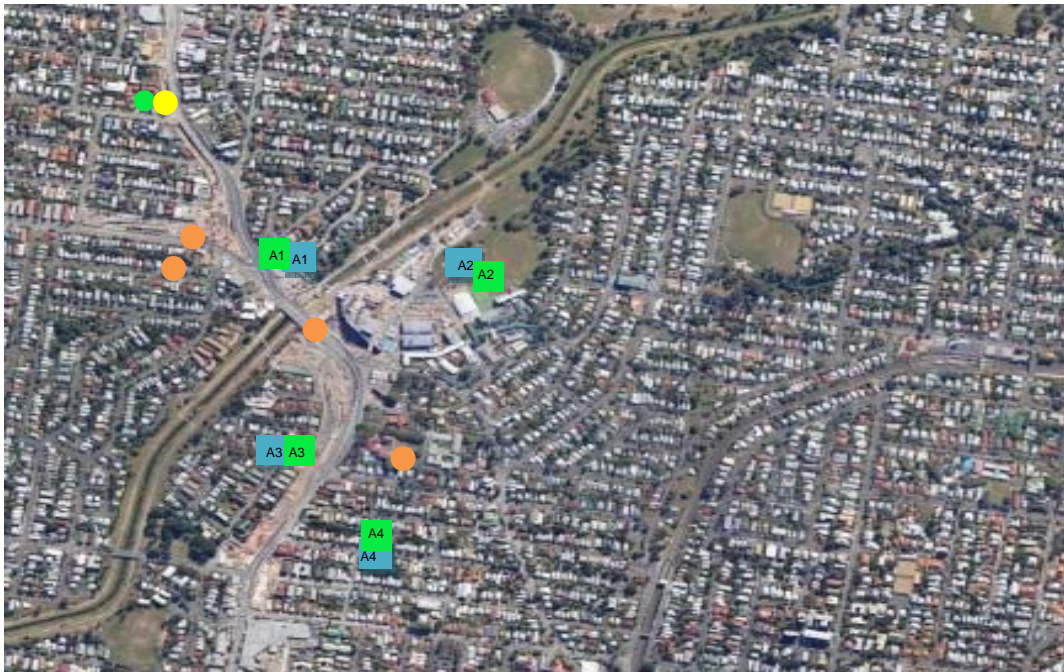
Figure 2.4 - Kedron Monitoring Locations

- Noise (during construction)
- Vibration
- Air (PM₁₀)
- Air (Dust Deposition)

Note: locations are indicative only

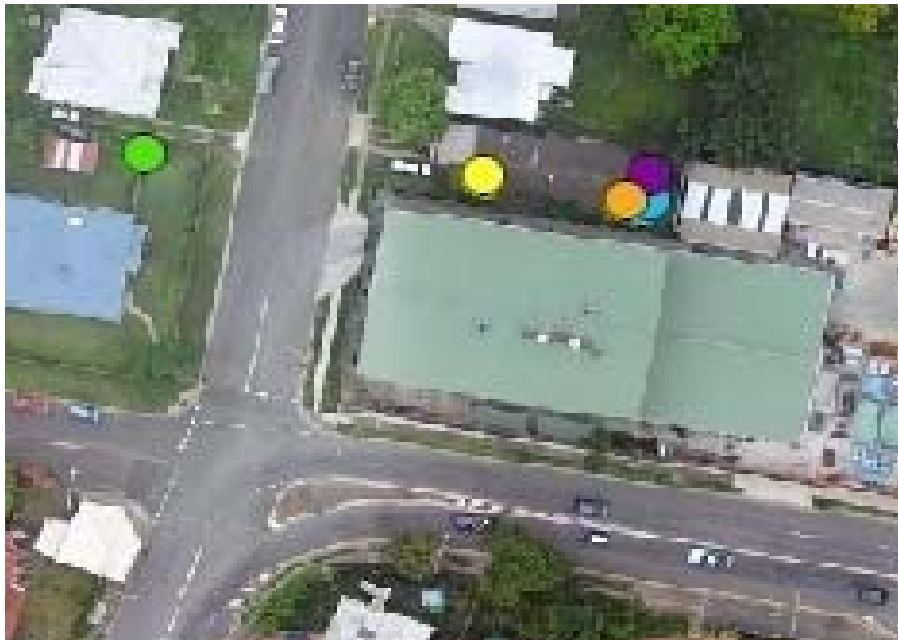
Figure 2.5 - Wooloowin Monitoring Locations

- Noise (during construction)
- Vibration
- Air (CO and NO₂)
- Air (PM₁₀/TSP)
- Air (Dust Deposition)

Note: locations are indicative only

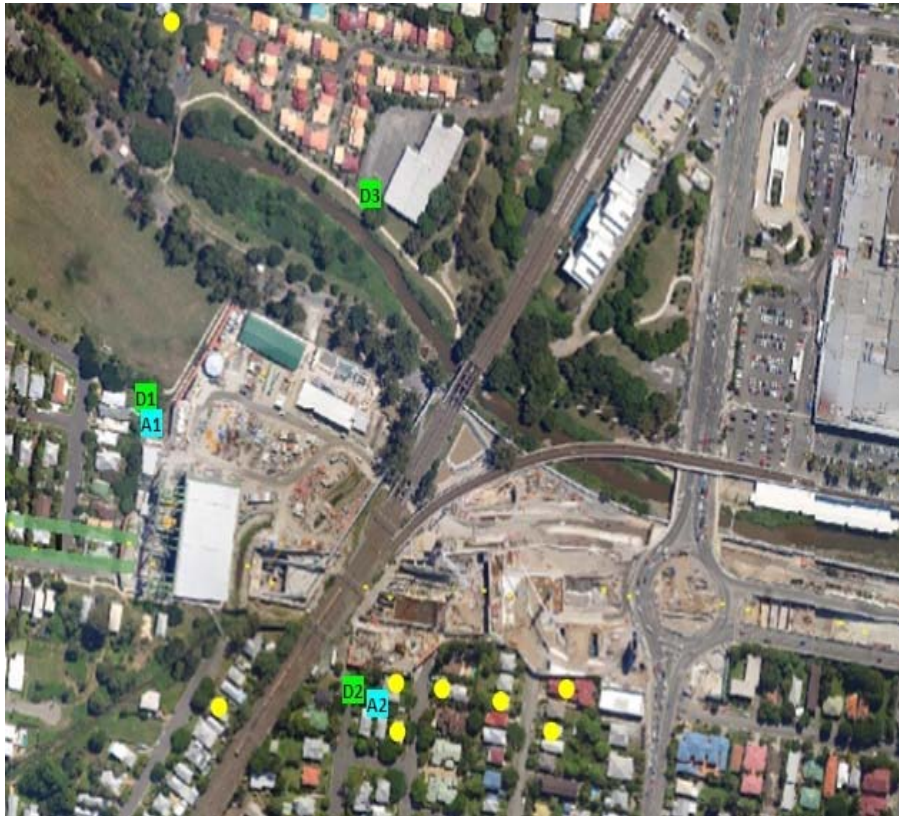
Figure 2.6 - Toombul Monitoring Locations

- Noise (during construction)
- Air (Dust Deposition)
- Air (PM₁₀)

Note: locations are indicative only.

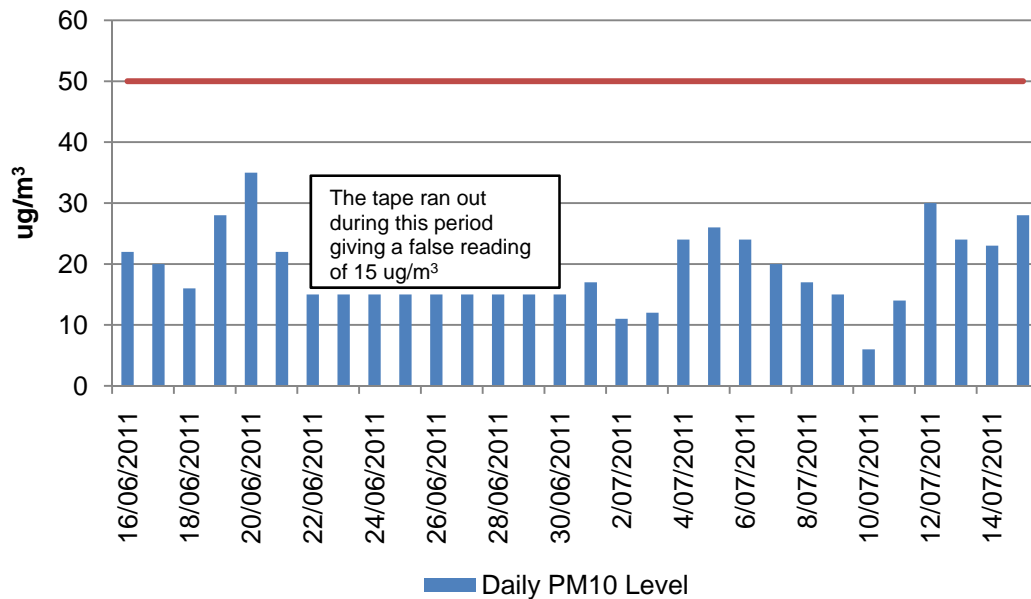
Figure 4.2.1
5 Morris Street, Bowen Hills PM10 Results

(for monitor location see figure 2.1)

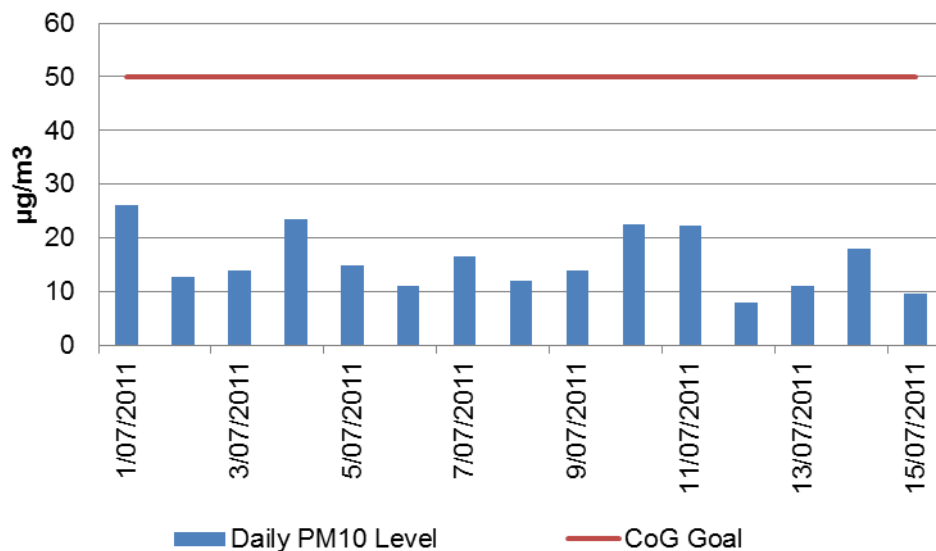
Figure 4.2.2
Northern Busway Site Office, Lutwyche PM10 Results

(for location see figure 2.3 – A1)

The two weeks prior to the above graph (from 16th June to 30th June 2011) were not available due to equipment failure. The Dust trak unit has been sent to the manufacturer for repair and re-calibration.

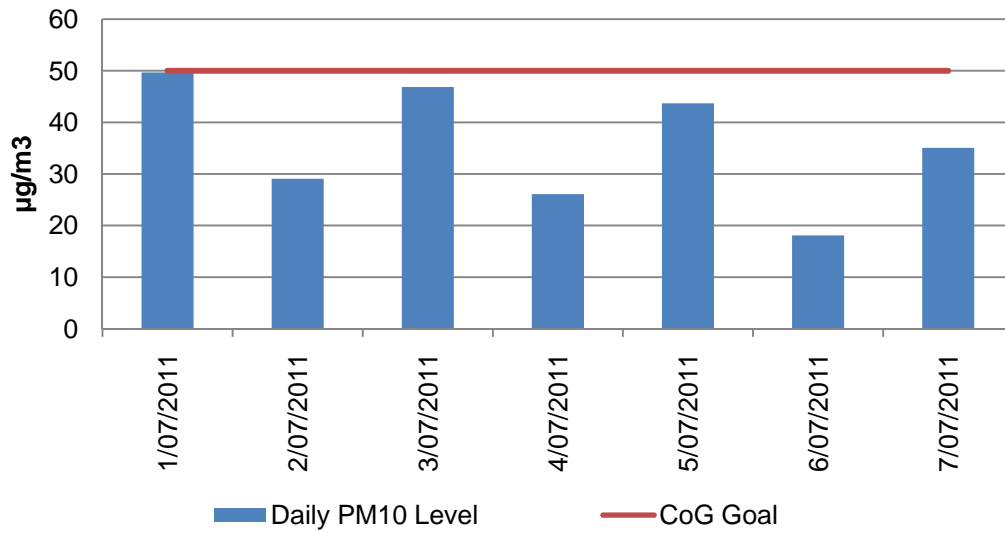
**Figure 4.2.3
Truro Street Site Office, PM10 Results**

(for location see figure 2.2 – A1)

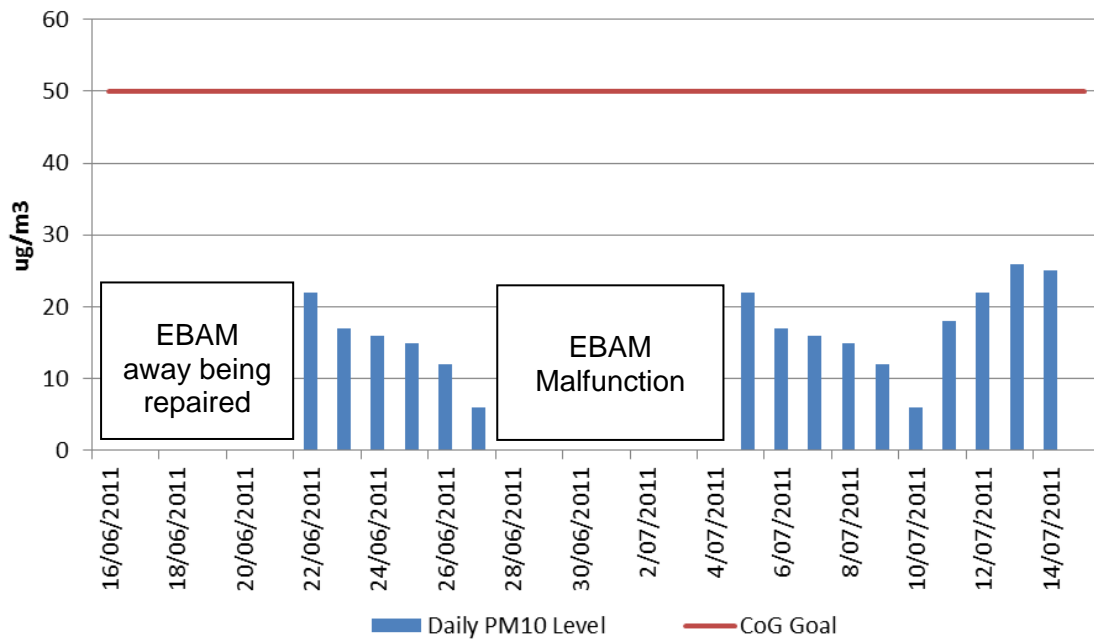
**Figure 4.2.4
Erskine Avenue, Kedron, PM10 Results**

(for monitor location see figure 2.4 – A1)

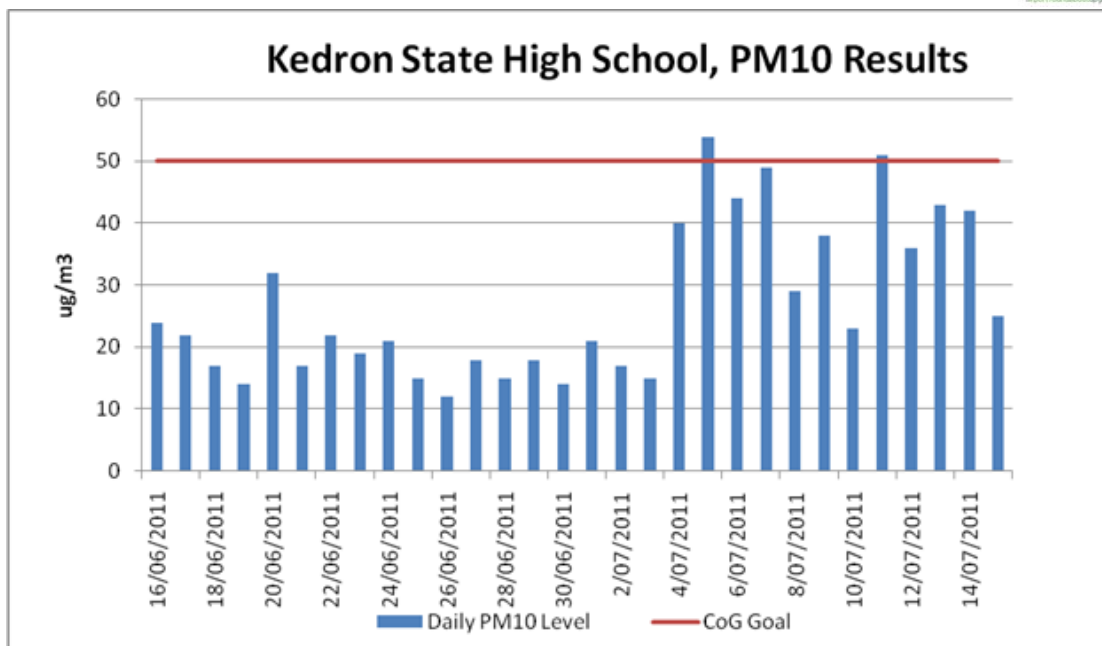
(for monitor location see figure 2.4 – A2)

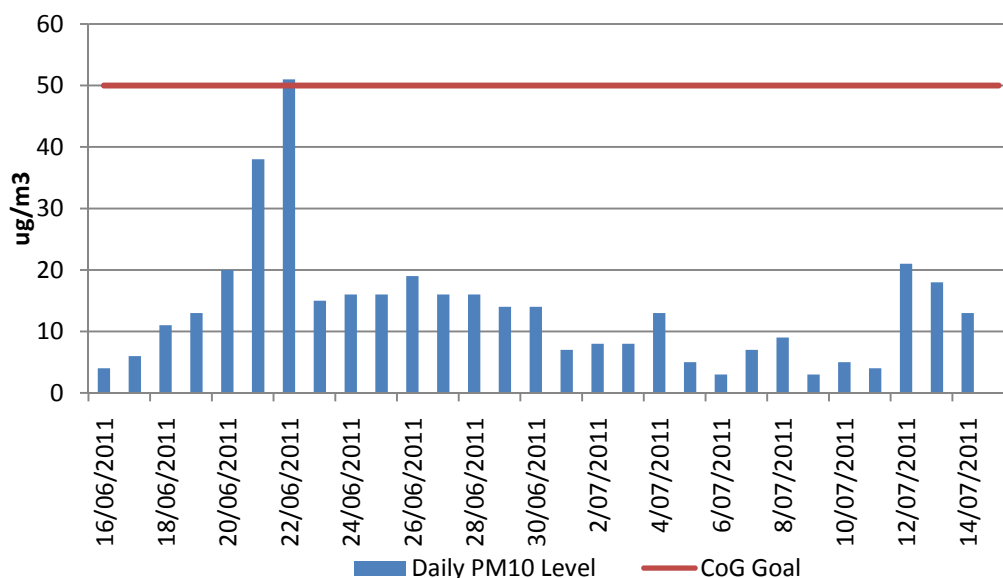
**Figure 4.2.6
Perry Street, Kedron, PM10 Results**

(for monitor location see figure 2.4 – A3)

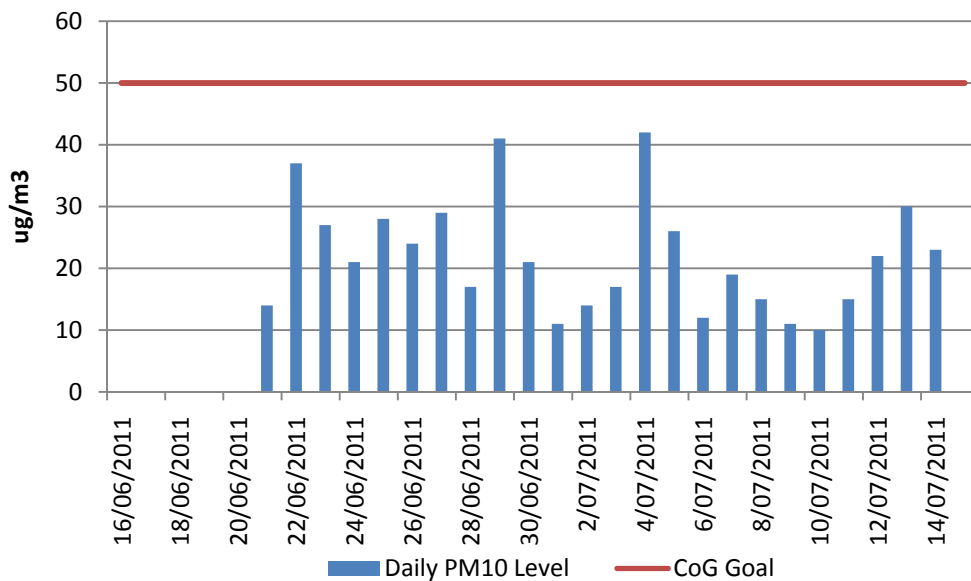
**Figure 4.2.7
Wooloowin State School, PM10 Results**

(for monitor location see figure 2.5 – A4)

The TSP monitor at Woolloowin State School has yet to be returned to site and continues to be repaired by the manufacturers.

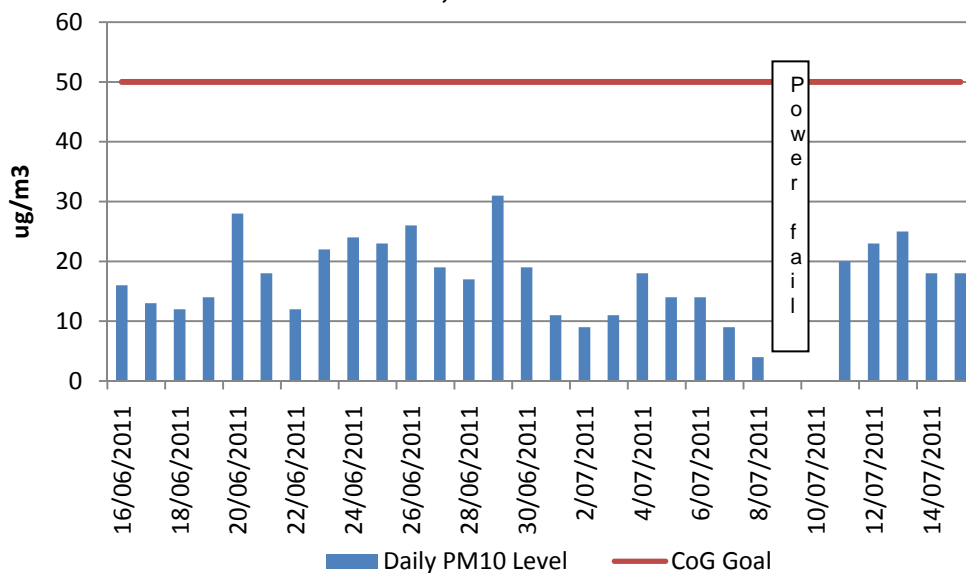
**Figure 4.2.8
71 Park Road, Wooloowin PM10 Results**

(for monitor location see figure 2.5 – A1)

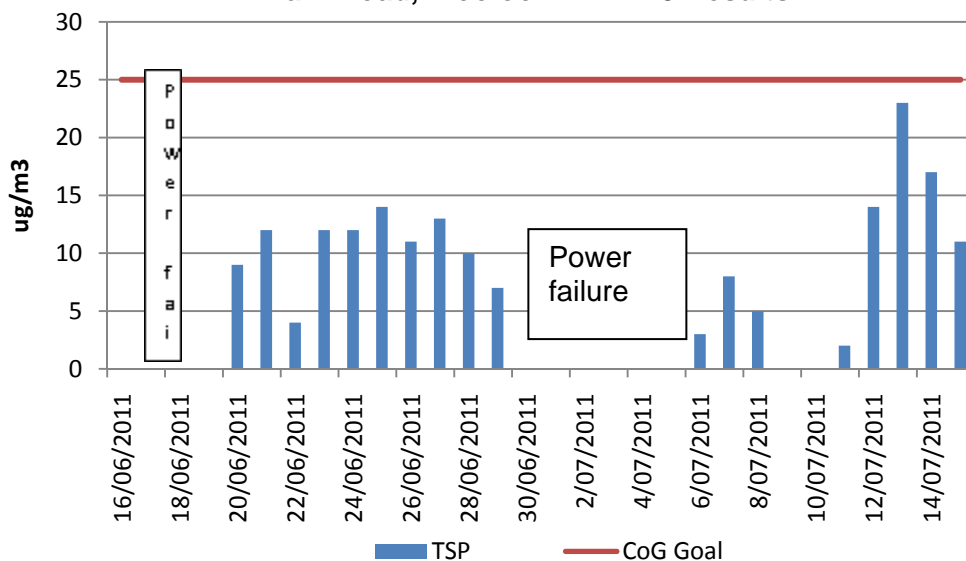
Figure 4.2.9
71 Park Road, Woollooin PM2.5 Results

(for monitor location see figure 2.5 – A1)

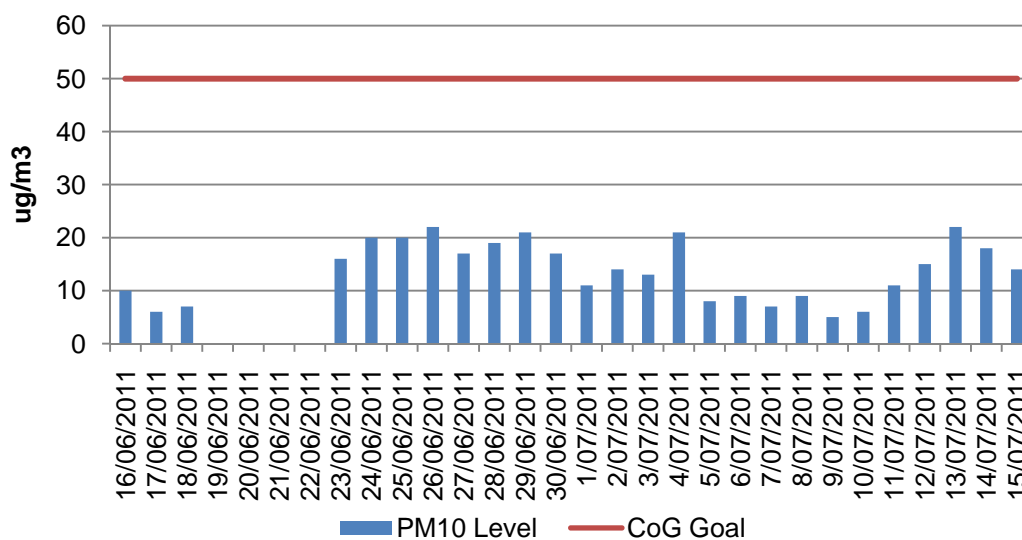
Figure 4.2.10
56 Kalinga Street, Clayfield PM10 Results

(for monitor location see Figure 2.6 – A1)

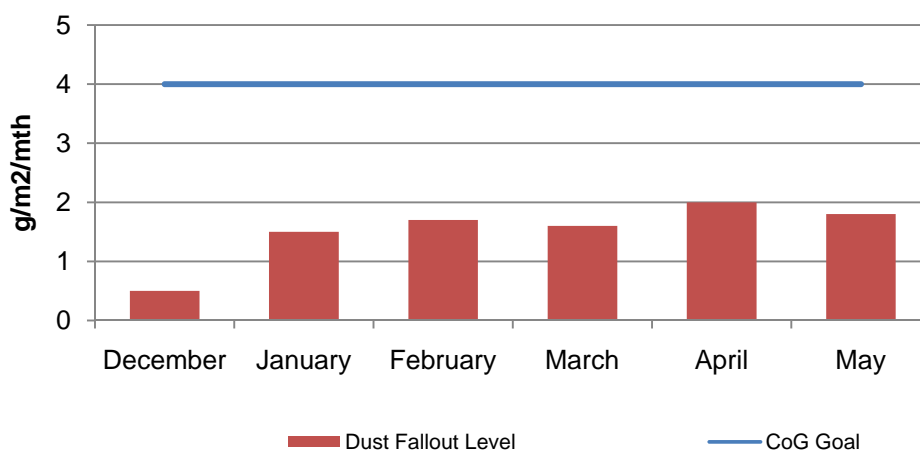
Figure 4.3.1
5 Morris Street, Bowen Hills Dust Fallout February - July 2011

(for monitor location refer to figure 2.1)

Dust deposition monitoring is undertaken on a monthly basis using a bottle and funnel placed 2m ± 0.2m above ground level in accordance with Australian Standard AS 3580.10.1: 2003. It should be noted that in many locations the placement of the deposition gauges does not strictly meet the location criteria in the above mentioned standard due to access and security difficulties, though best endeavours to comply with the criteria are undertaken. Morris Street dust result for June/July monitoring period were unavailable at the time of reporting. Dust results will be reported in Aug 2011 report.

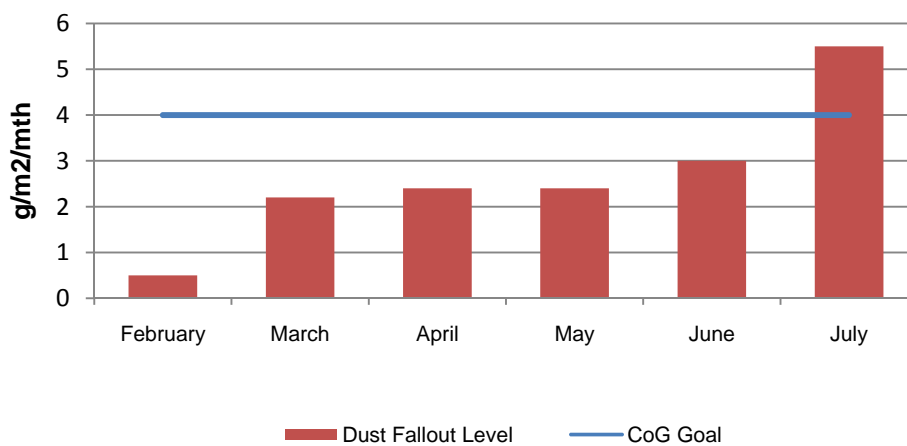
Figure 4.3.2
QLD Newspapers, Bowen Hills Dust Fallout February- July 2011

(for monitor location refer to figure 2.1)

On one occasion this month the depositional dust levels at the Queensland Newspaper complex exceeded the CoG Goal of 4g/m²/month. A CoG NCR has been raised and an investigation is nearing completion to determine the root cause of this result and effective means to prevent recurrence.

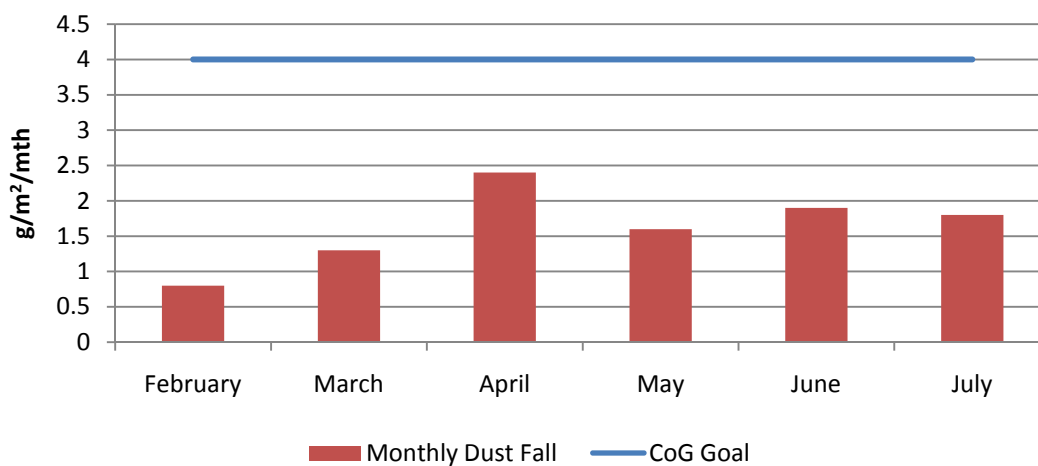
Figure 4.3.3
Site Office, Bowen Hills Dust Fallout February - July 2011

(for monitor location refer to figure 2.1)

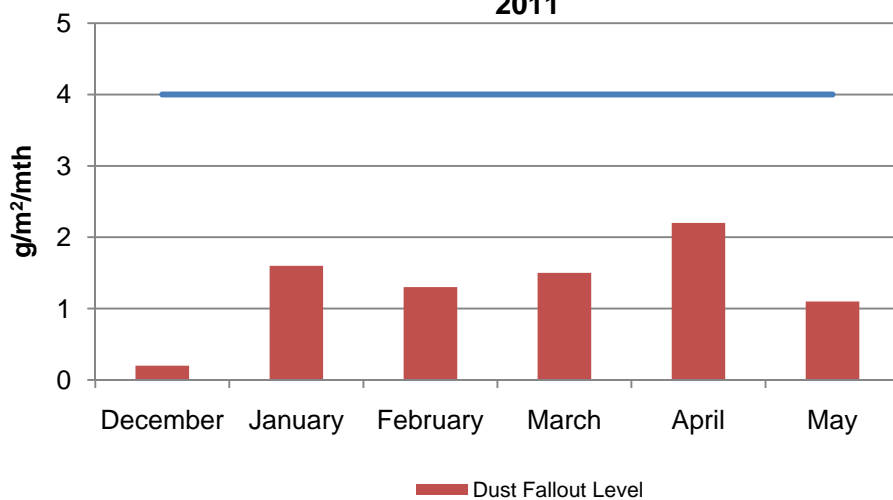
**Figure 4.3.4:
11 Bryden Street, Bowen Hills Dust Fallout February - July
2011**

(for monitor location refer to figure 2.1)

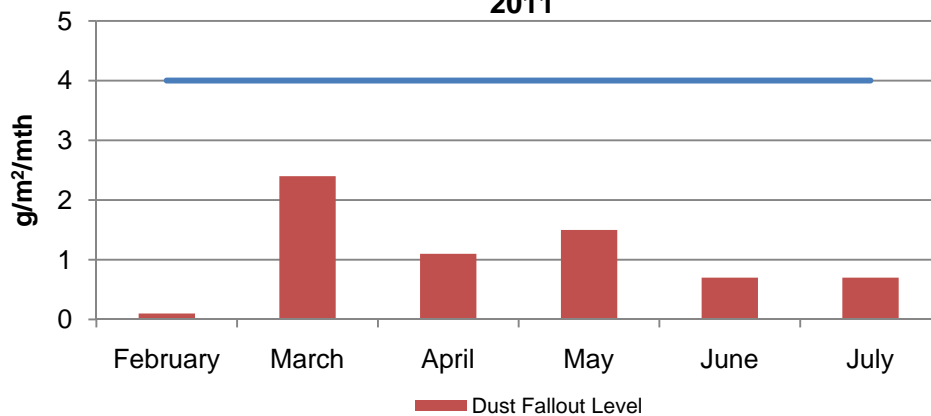
**Figure 4.3.5
Mews Apartments, Bowen Hills Dust Fallout February - July
2011**

(for monitor location refer to figure 2.1)

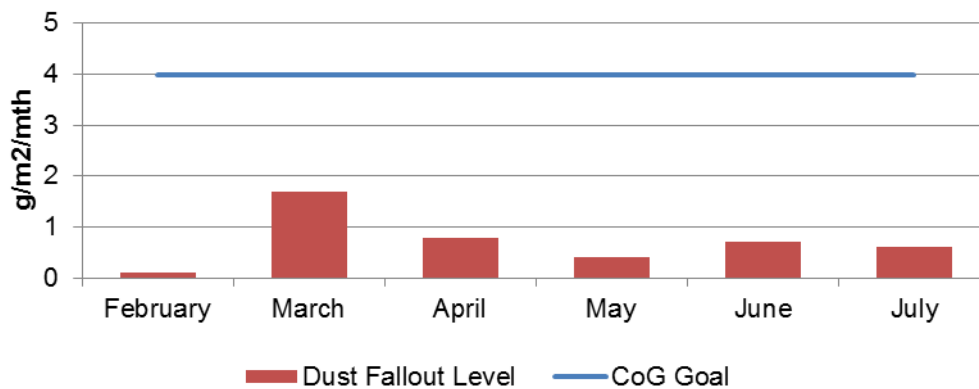
Figure 4.3.6
Cnr of Thistle & Lucas Street, Lutwyche Dust Fallout
February - July 2011

(for locations refer to figures 2-3)

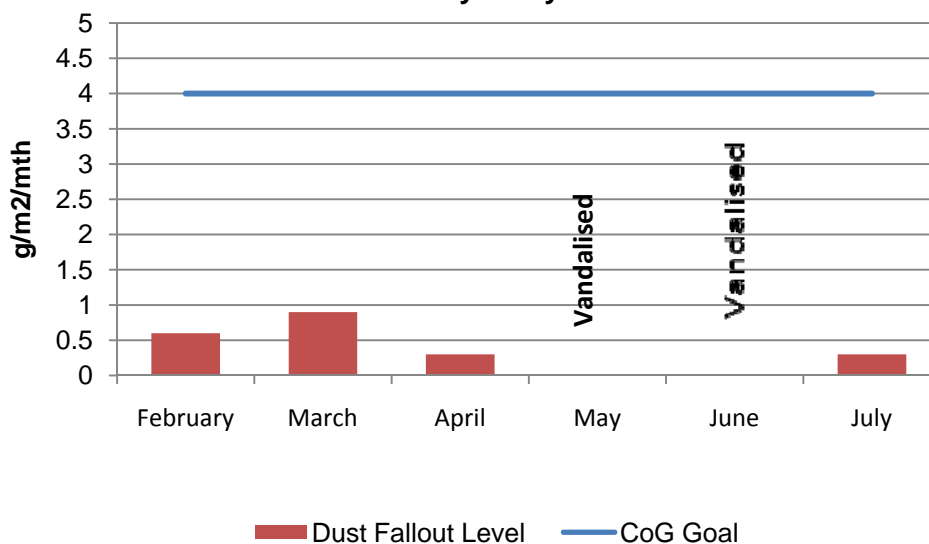
Figure 4.3.7
Kedron Brook Reserve, Northern Busway Dust Fallout
February- July 2011

(location refer to figure 2.3 – D1)

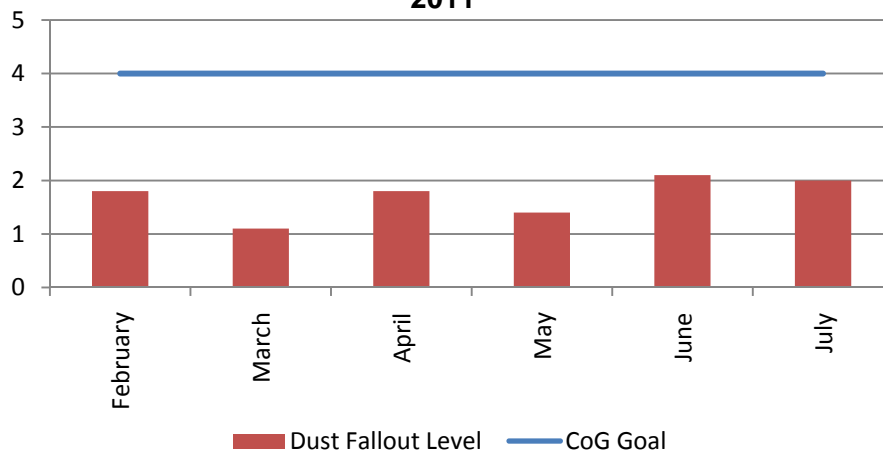
**Figure 4.3.8:
Erskine Avenue Kedron Dust Fallout, February - July
2011**

(for monitor location see figure 2.4 – A1)

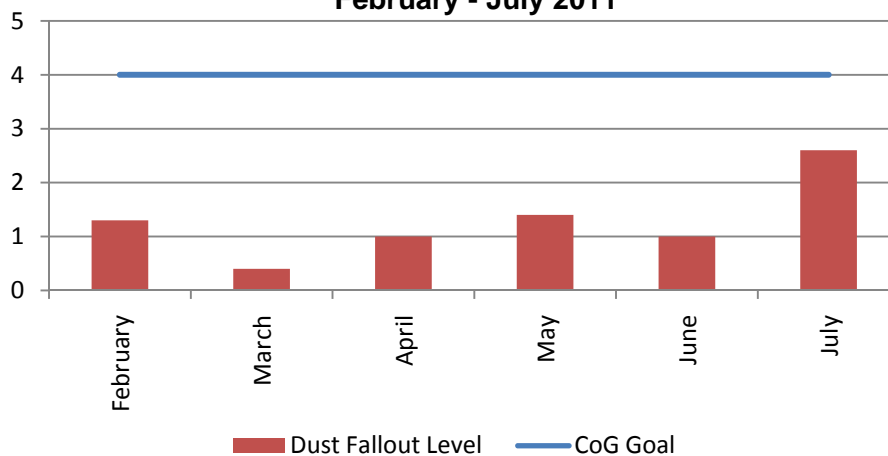
**Figure 4.3.9:
Kedron State High School, Kedron, Dust Fallout
February - July 2011**

(for monitor location see figure 2.4 – A1)

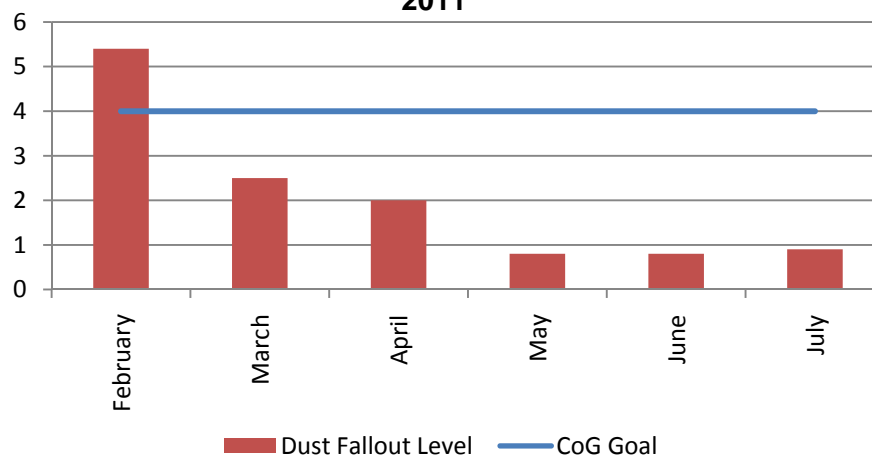
Figure 4.3.10
Perry Street Lutwyche, Dust Fallout, February - July 2011

(for monitor location see figure 2.3)

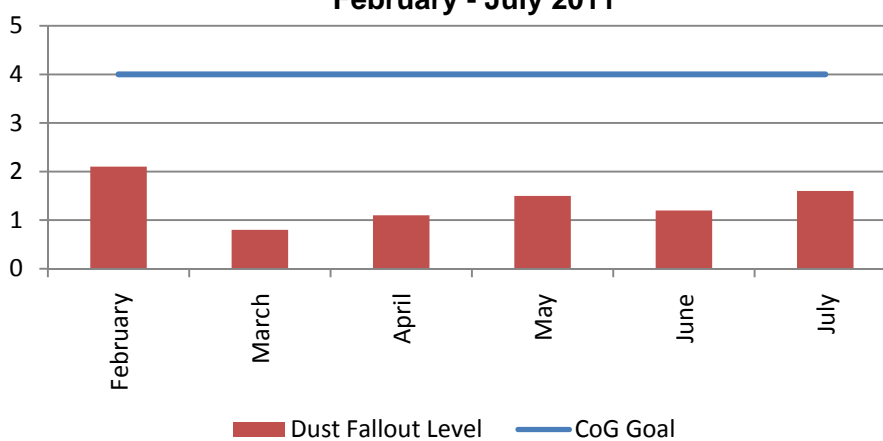
Figure 4.3.11
Woollooin State School Woollooin, Dust Fallout, February - July 2011

(for monitor location see figure 2.5)

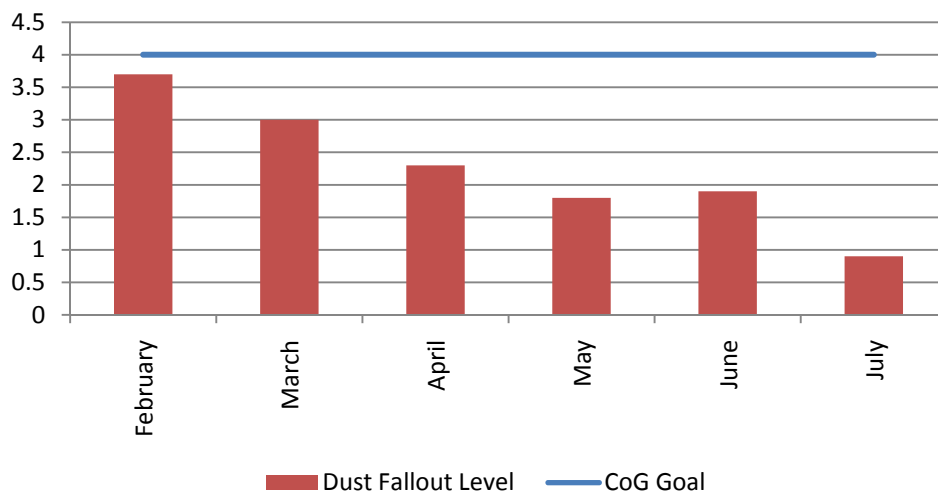
Figure 4.3.12
228 Gympie Road Kedron, Dust Fallout February - July 2011

(for monitor location see figure 2.4)

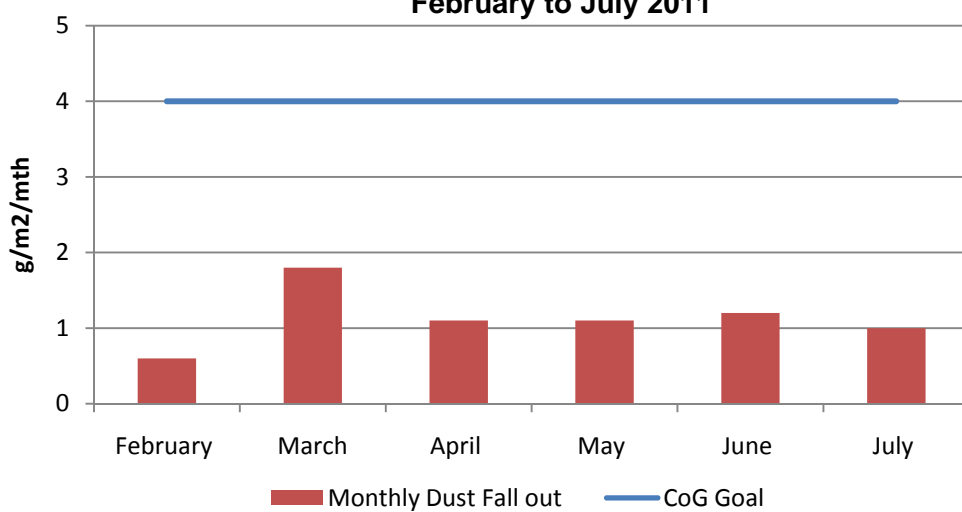
Figure 4.3.13
68 Park Road, Wooloowin Dust Fallout February to July 2011

(for monitor location refer to figure 2.5)

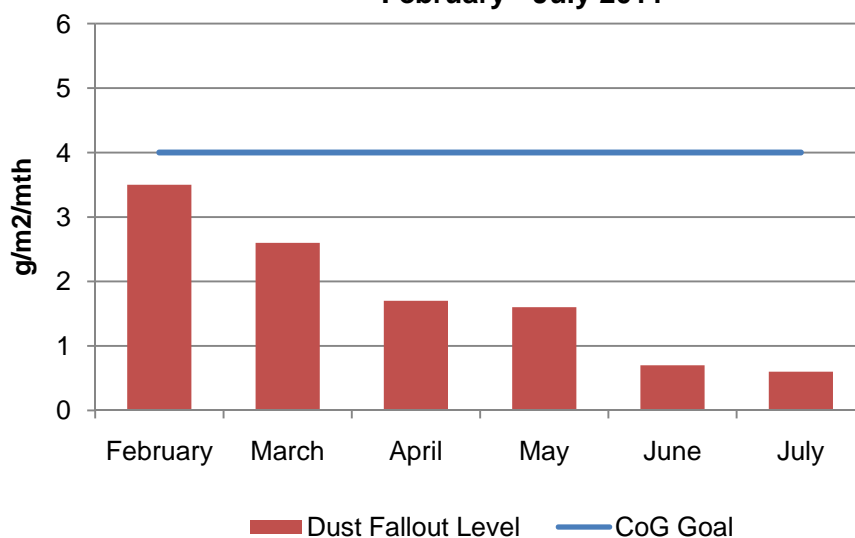
Figure 4.3.14
Kalinga Street, Toombul Dust Fallout
February - July 2011

(location refer to figure 2.6 – D1)

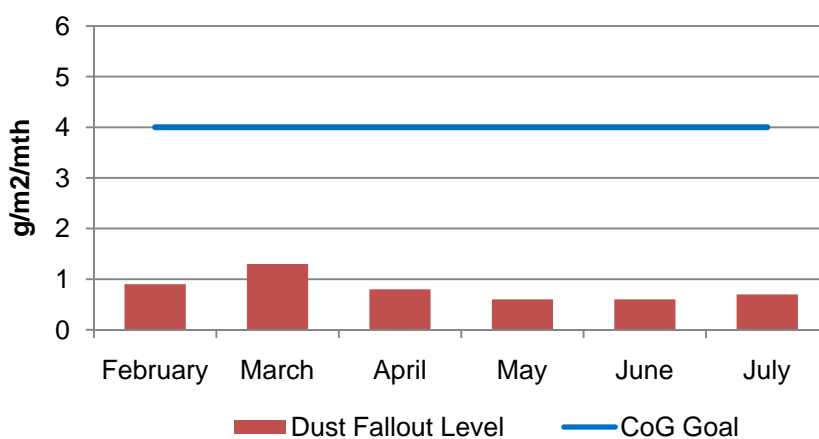
Figure 4.3.15
Mabel Street, Toombul Dust Fallout February - July 2011

(location refer to figure 2.6 – D2)

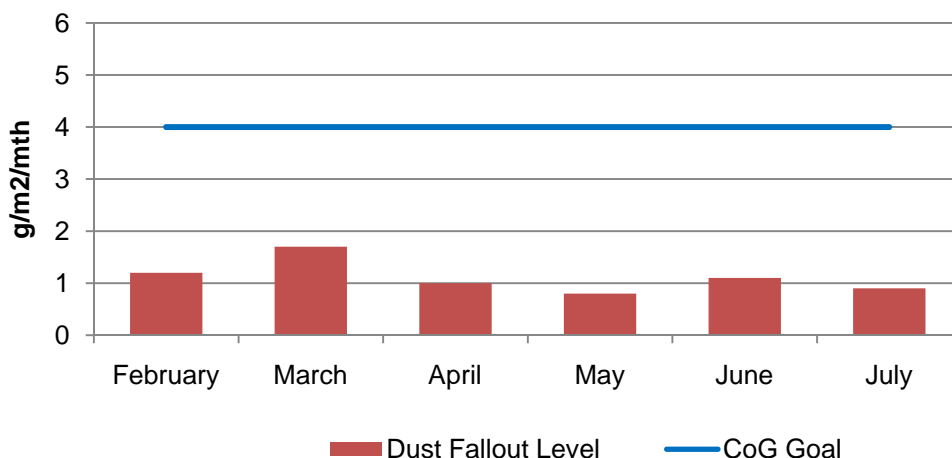
Figure 4.3.16
Bage Street, Toombul Dust Fallout February - July 2011

(location refer to figure 2.6 – D3)
