# Airport Link / Northern Busway Project

## Monthly Environmental Monitoring Report

October 2011

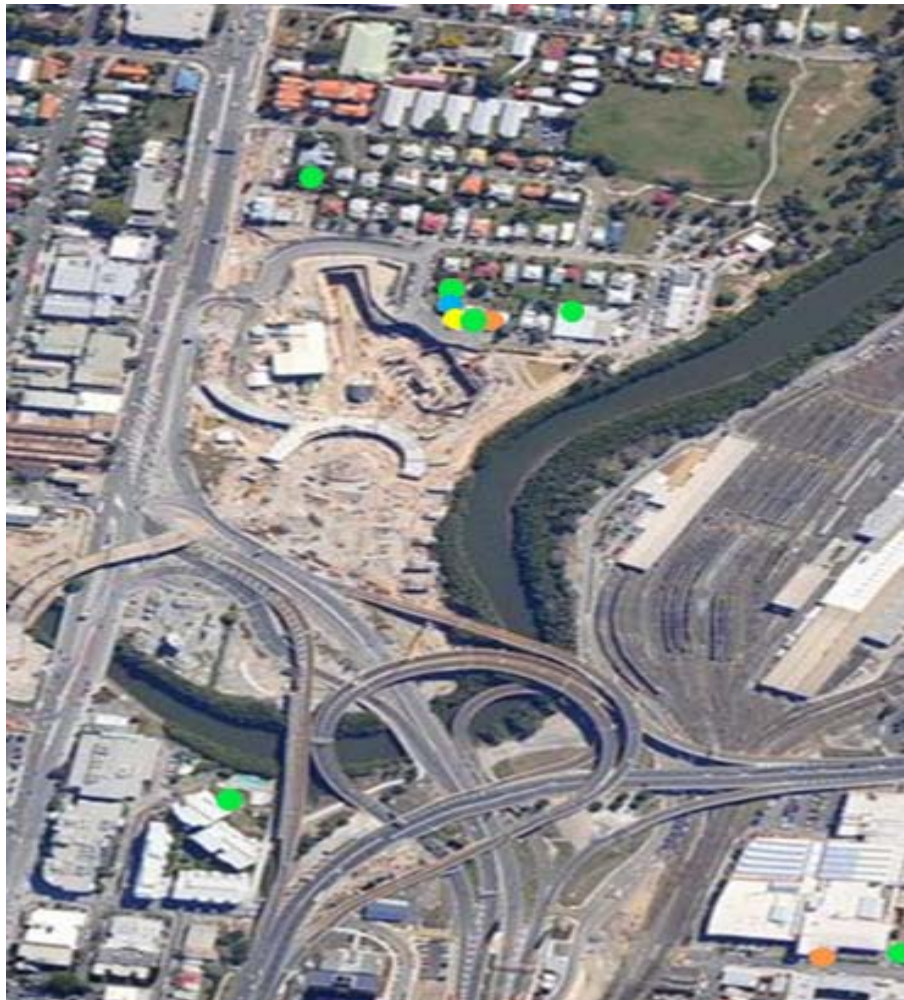
### 2.1 - Bowen Hills Precinct Monitoring Locations

Several monitoring locations exist within the project area as described in Figures 1-5. Note that the aerial photograph overlays used in Figures 1-5 do not accurately portray the extent of the project's progress to October 2011, though do serve a useful purpose in relating the monitoring locations to existing structures and infrastructure.

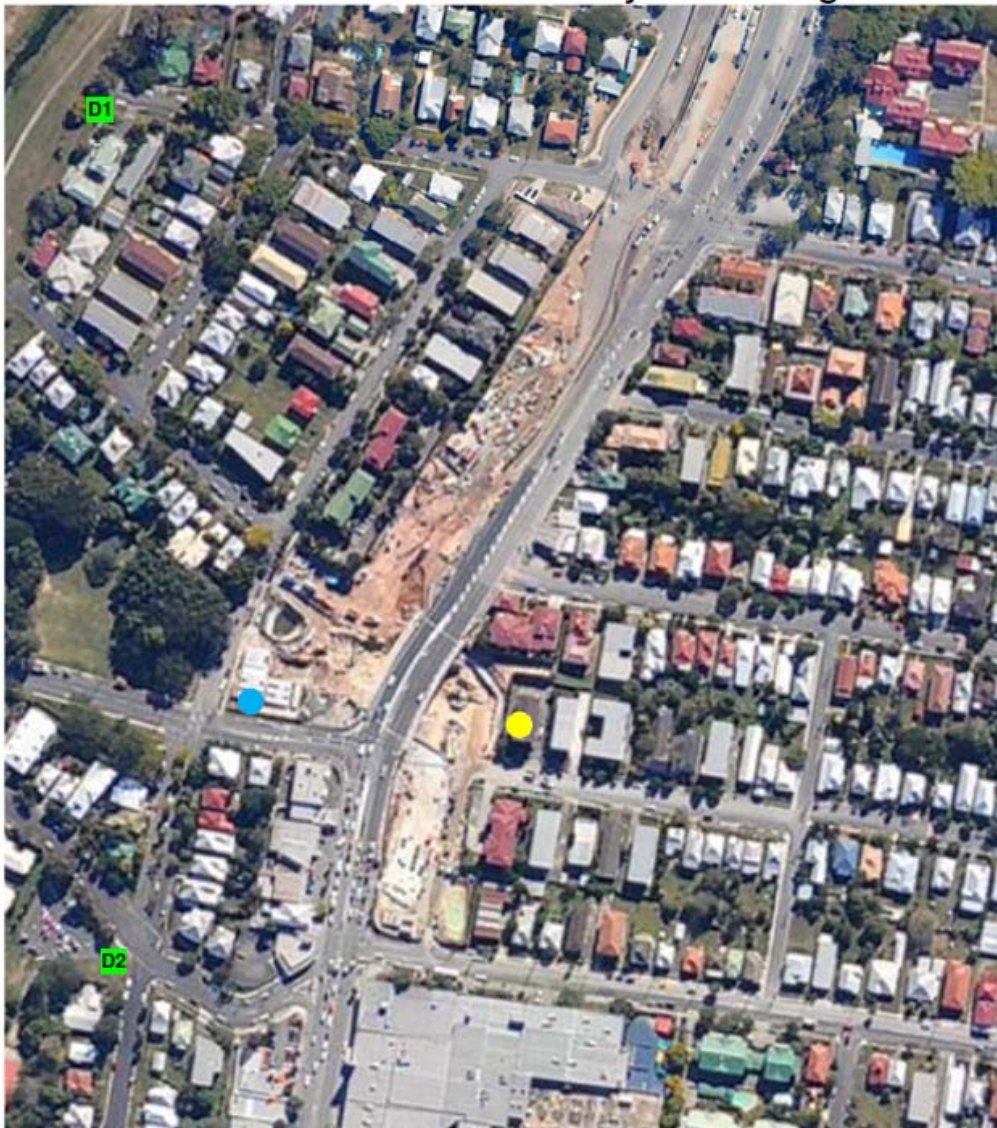
**Figure 2.3 - Northern Busway Monitoring Locations**

**Figure 2.3 – Nthn Busway Monitoring Locations**

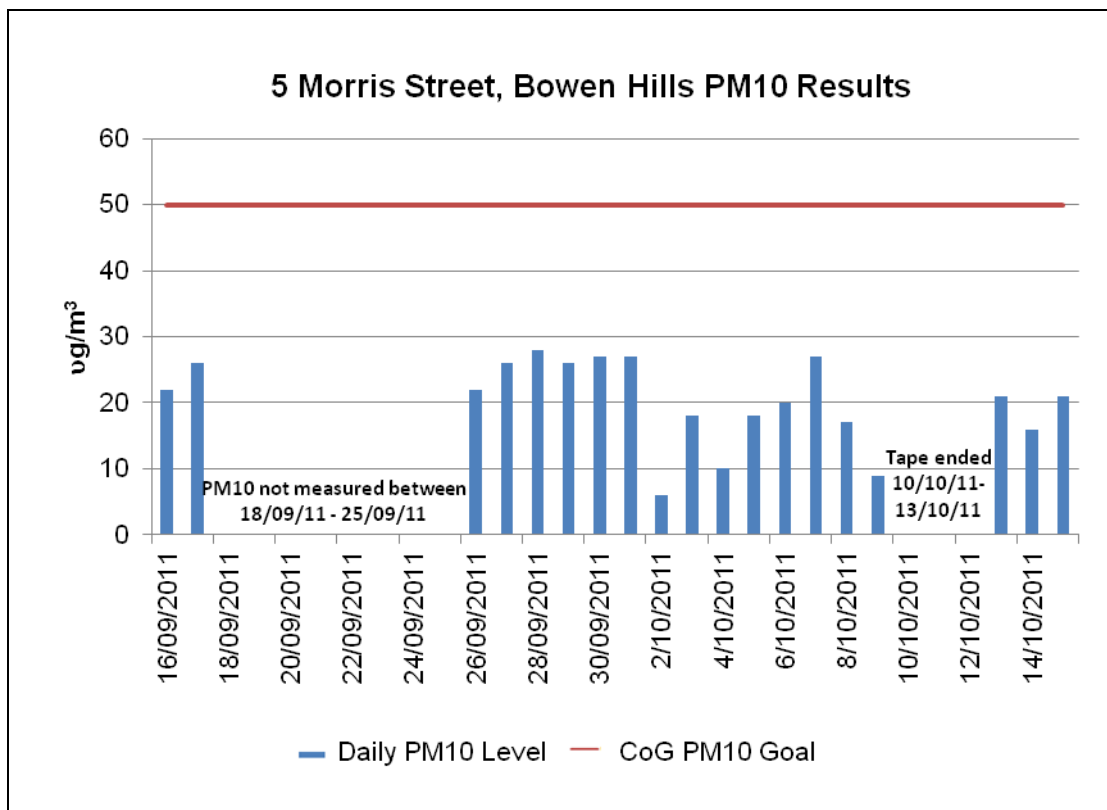
Figure 4.2.1: 5 Morris Street, Windsor PM10 Results (for monitor location see figure 2.1)  
Please note that PM10 was not measured between 18/9/11 to 25/09/11 due to equipment failure.

PM10 monitoring was undertaken at various locations using an EBAM continuous sampler in accordance with Queensland Department of Environment and Resource Management's Air Sampling Manual. Results are summarised in Figure 4.2.1 below. It should be noted that the placement of the sampler unit does not strictly meet the siting standards described in AS 3580.1.1:2007 due to location and security restrictions. Efforts to comply with location standards have been made however as much as possible.

Elevated PM 10 and TSP air quality results on the dates of 17th to 20th September 2011 were recorded at some monitoring locations within the Airport link corridor. Elevated air quality results on these dates can be attributed to widespread bushfires across South-East Queensland. DERM Air Quality Monitoring revealed city-wide elevated PM10 levels. Considering this, there were no exceedances of the Coordinator Generals Air Quality Conditions caused as a consequence of TJH construction activities throughout this period.

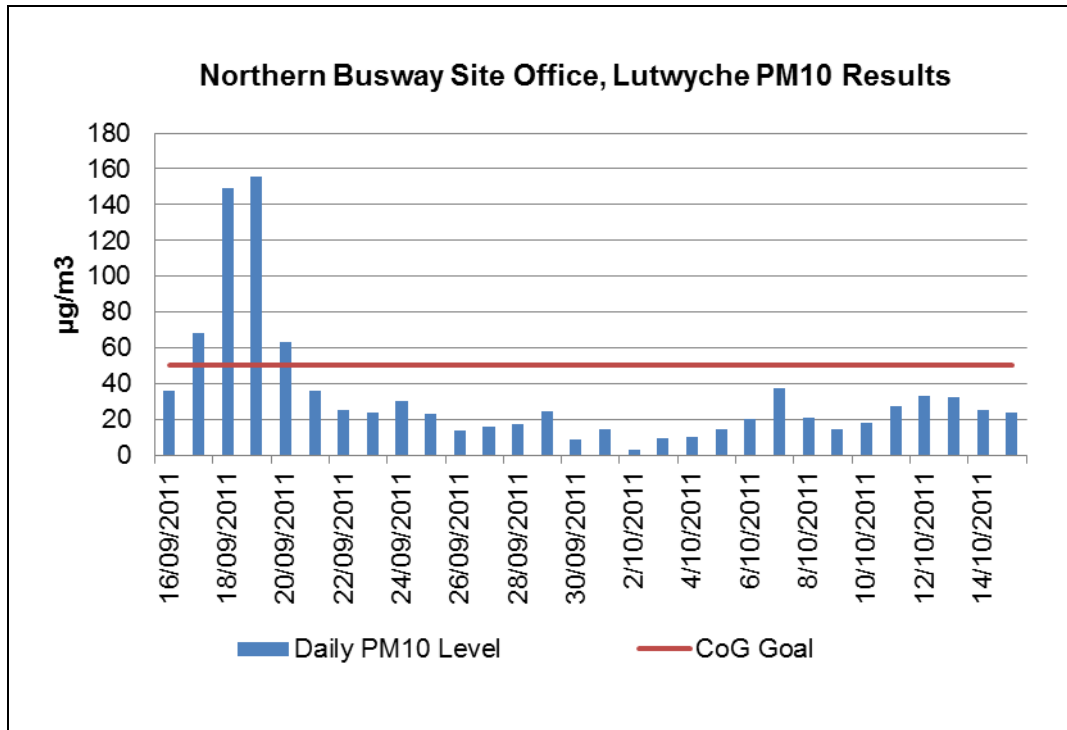
Figure 4.2.2: Northern Busway Site Office, Lutwyche PM10 Results (for location see figure 2.3 – A1)

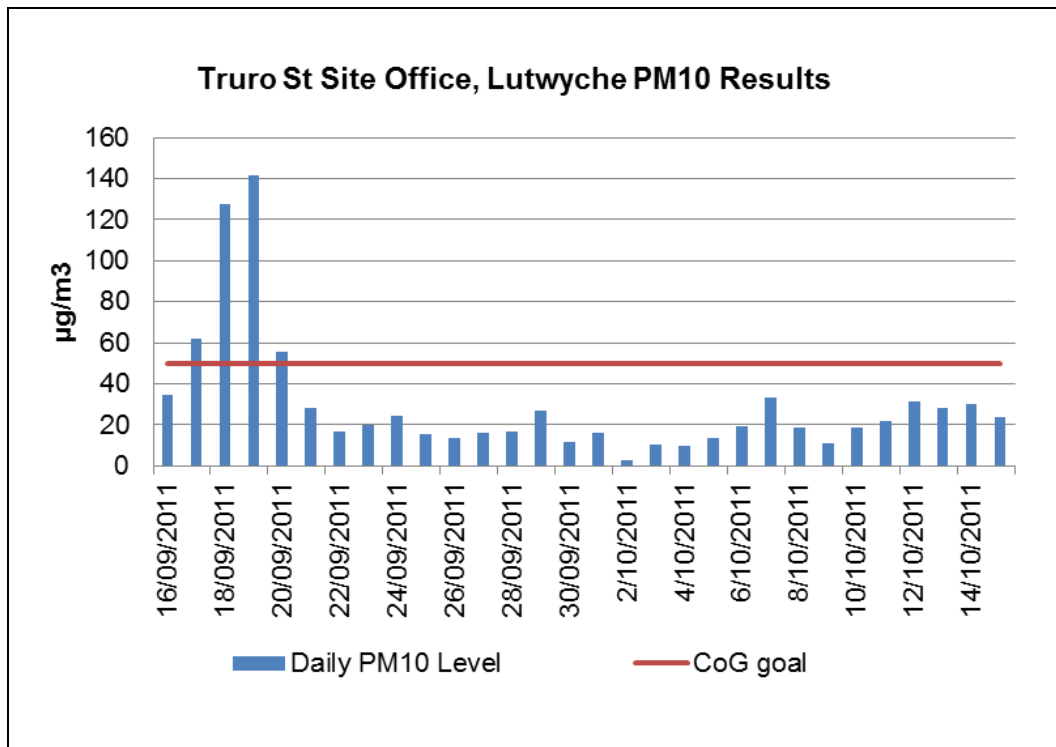
Figure 4.2.3: Truro Street Mid Tunnel Site Office, PM10 Results (for location see figure 2.2 – A1)

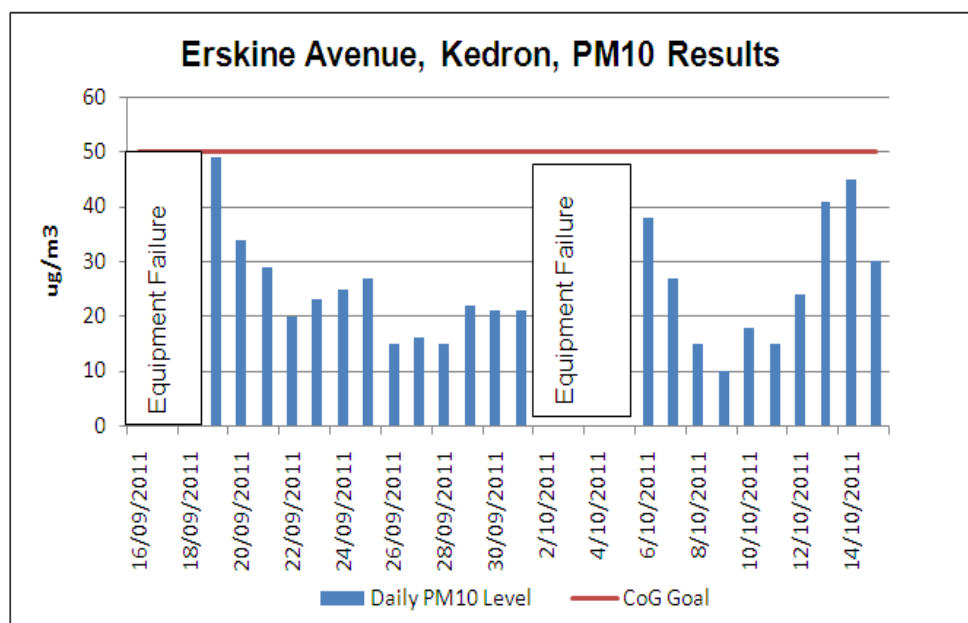
Figure 4.2.4: Erskine Avenue, Kedron PM10 Results (for monitor location see figure 2.4 – A1)

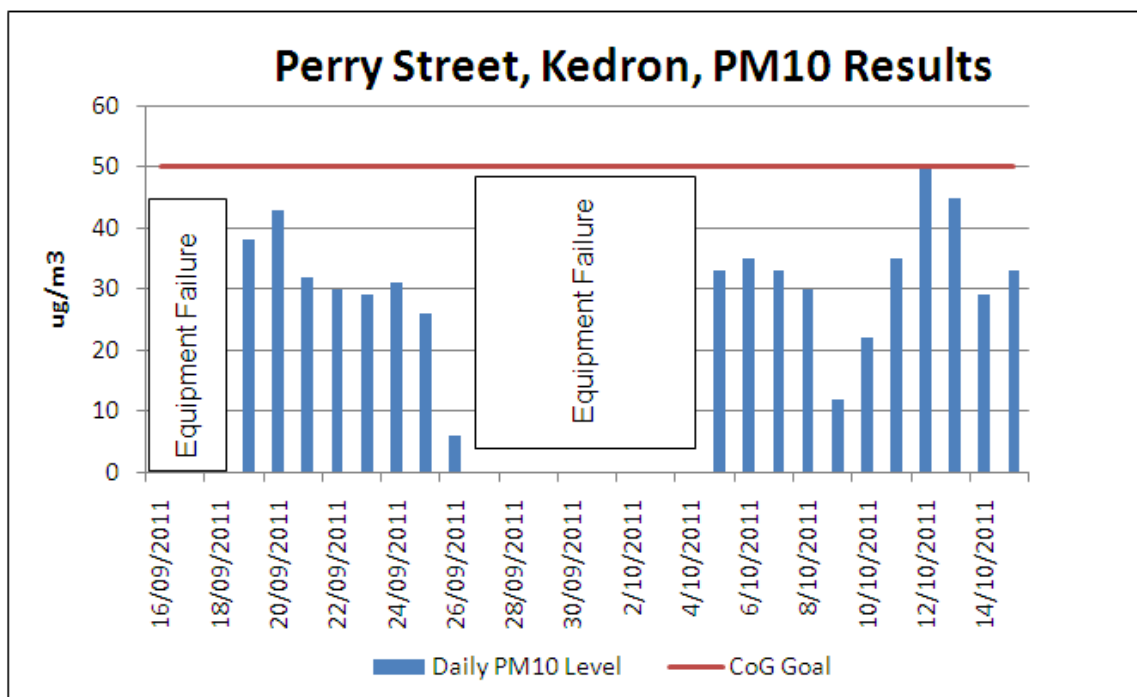
Figure 4.2.5: Perry Street, Kedron PM10 Results (for monitor location see figure 2.4 – A1)

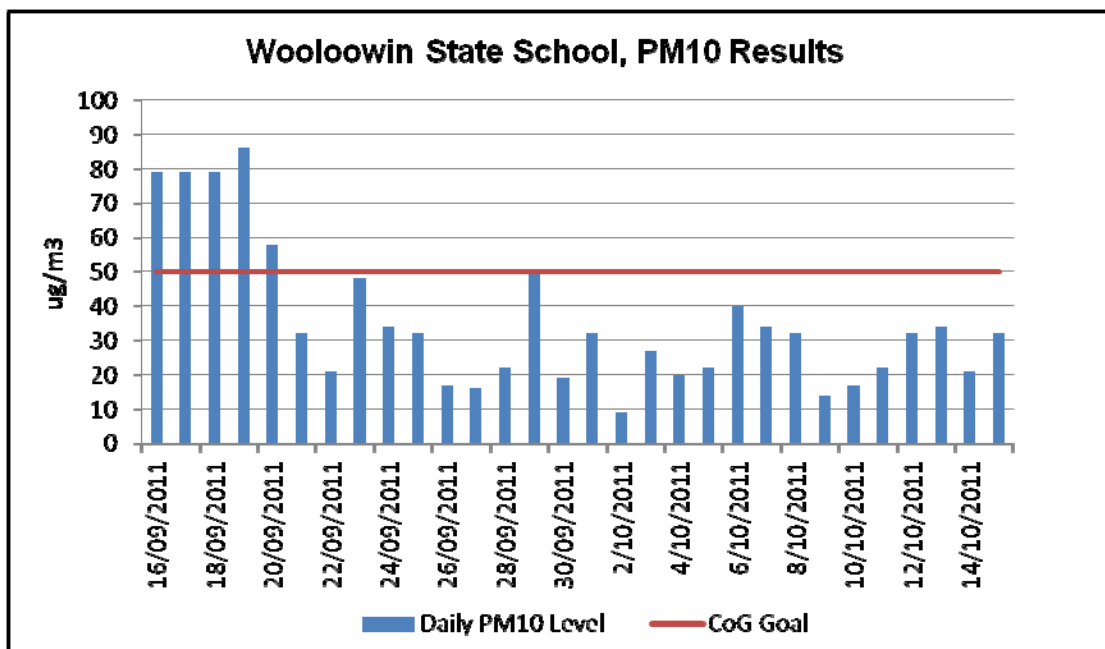
Figure 4.2.6: Wooloowin State School, Lutwyche PM10 Results (for monitor location see figure 2.4 – A4)

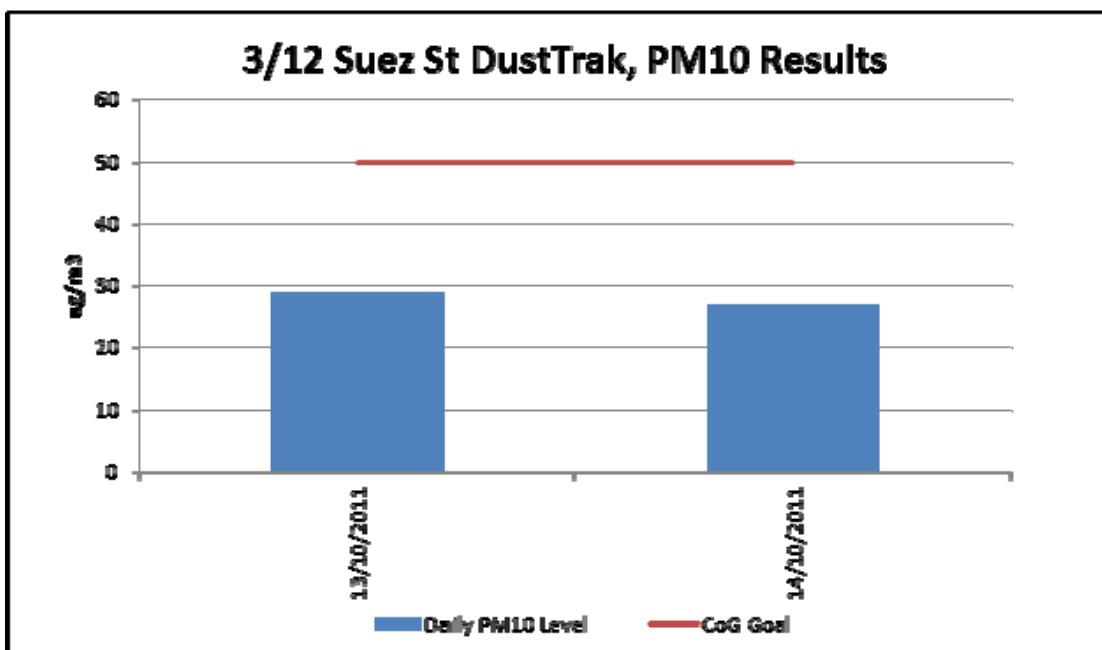
Figure 4.2.7: 3/12 Suez Street, PM10 Results (for monitor location see figure 2.4 – A4)

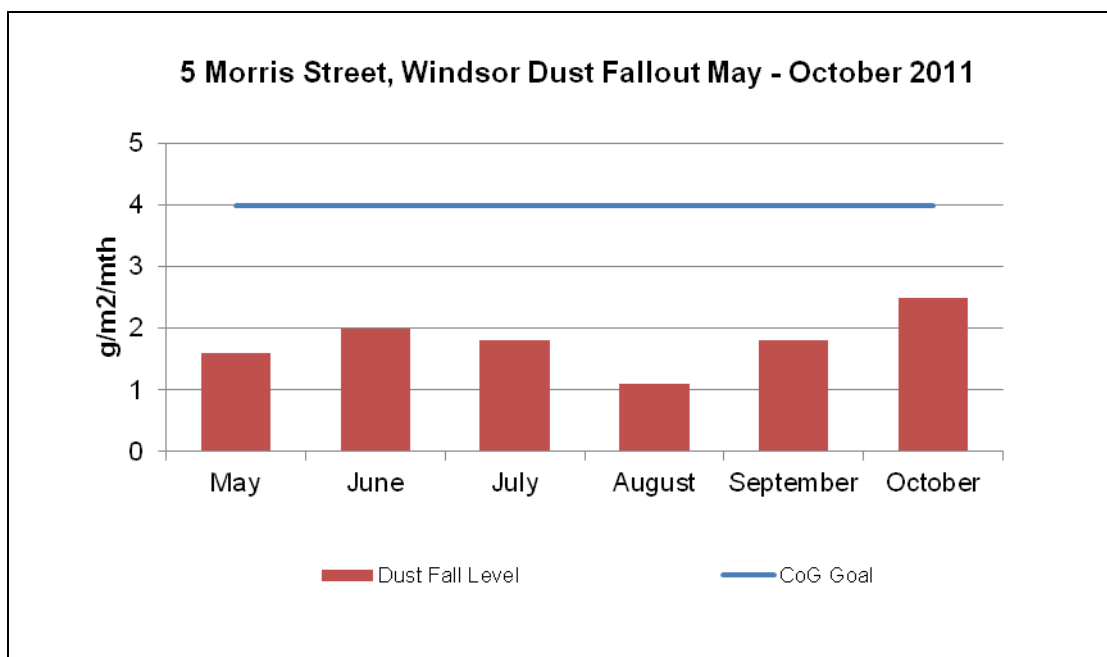
Figure 4.3.1: 5 Morris St Windsor Dust Deposition Results (for monitor location refer to figure 2.1)

Dust deposition monitoring is undertaken on a monthly basis using a bottle and funnel placed 2m ± 0.2m above ground level in accordance with Australian Standard AS 3580.10.1:2003. It should be noted that in all locations the placement of the deposition gauges does not strictly meet the standard due to location and security restrictions. Efforts to comply with location standards have been made however as much as possible.

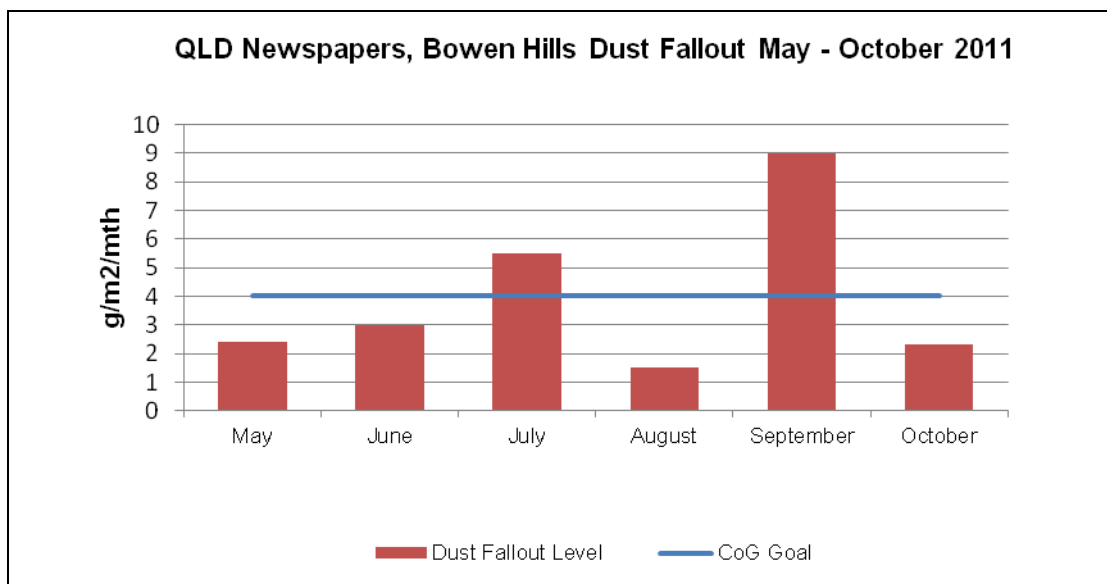
Figure 4.3.2: Queensland Newspapers, Bowen Hills Dust Deposition Results (for monitor location refer to figure 2.1)

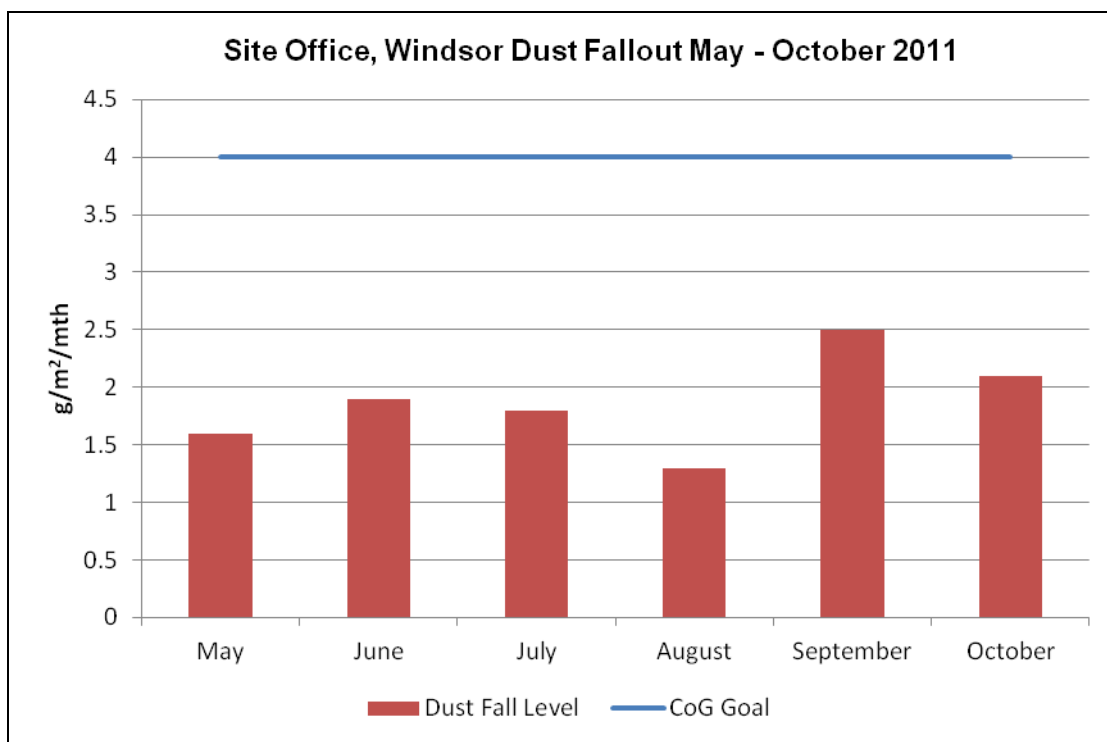
Figure 4.3.3: Site Office, Windsor Dust Deposition Results (for monitor location refer to figure 2.1)

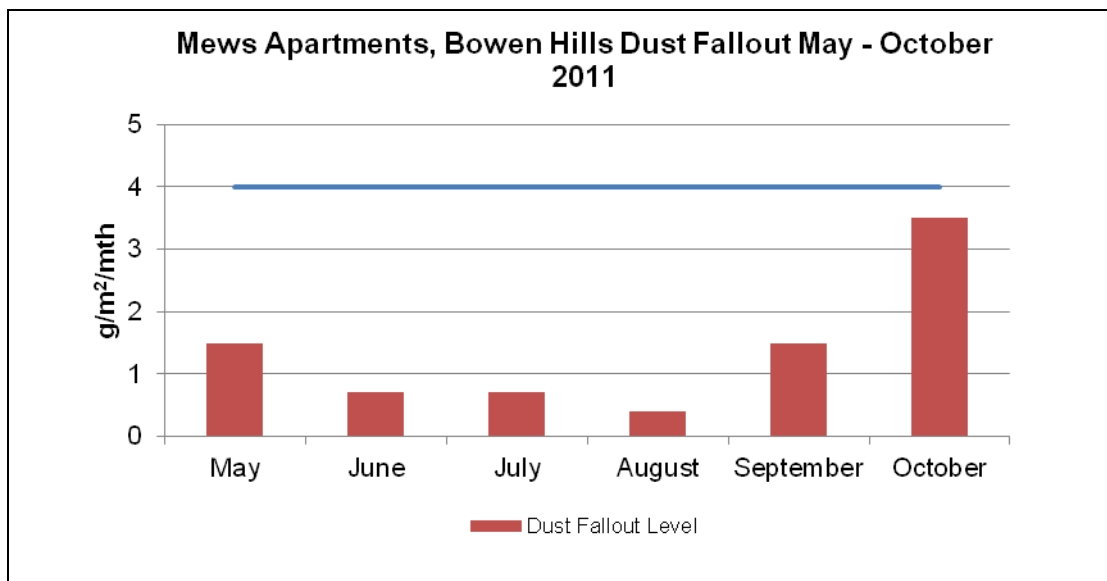
Figure 4.3.4: Mews Apartments, Bowen Hills Dust Deposition Results (for monitor location refer to figure 2.1)

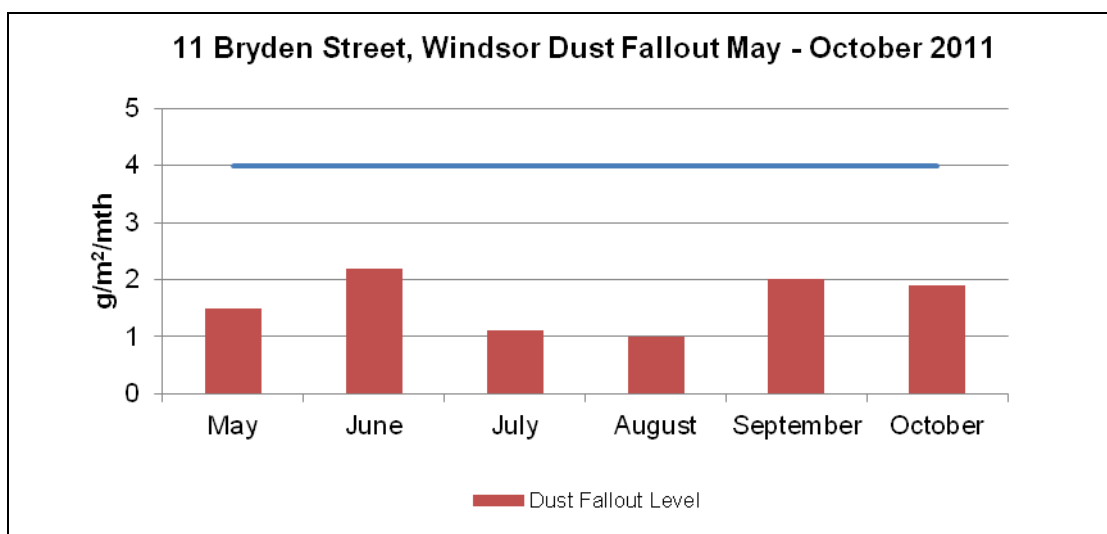
Figure 4.3.5: 11 Bryden Street, Windsor Dust Deposition Results (for monitor location refer to figure 2.1)

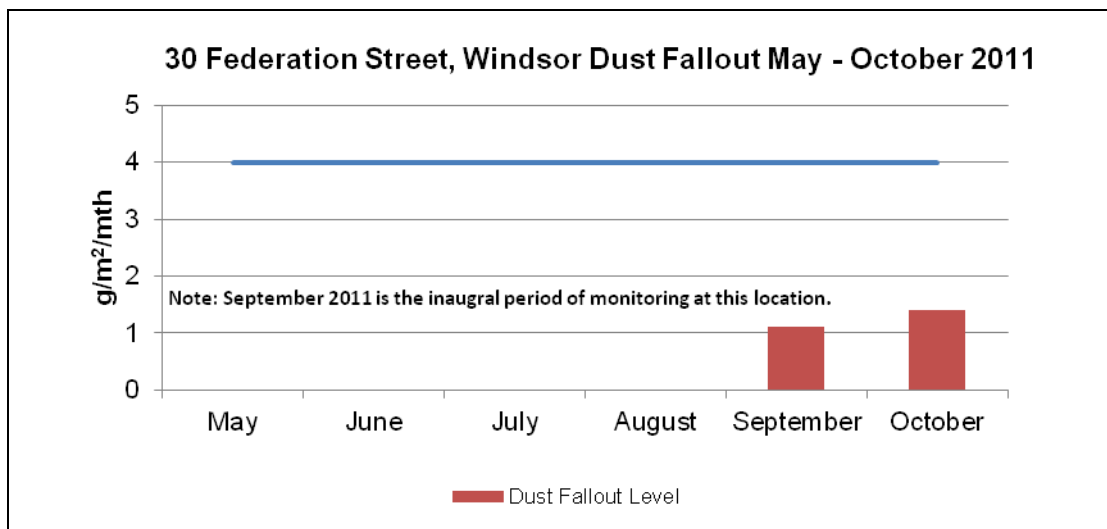
Figure 4.3.6: 30 Federation Street, Windsor Dust Deposition Results (for monitor location refer to figure 2.1)

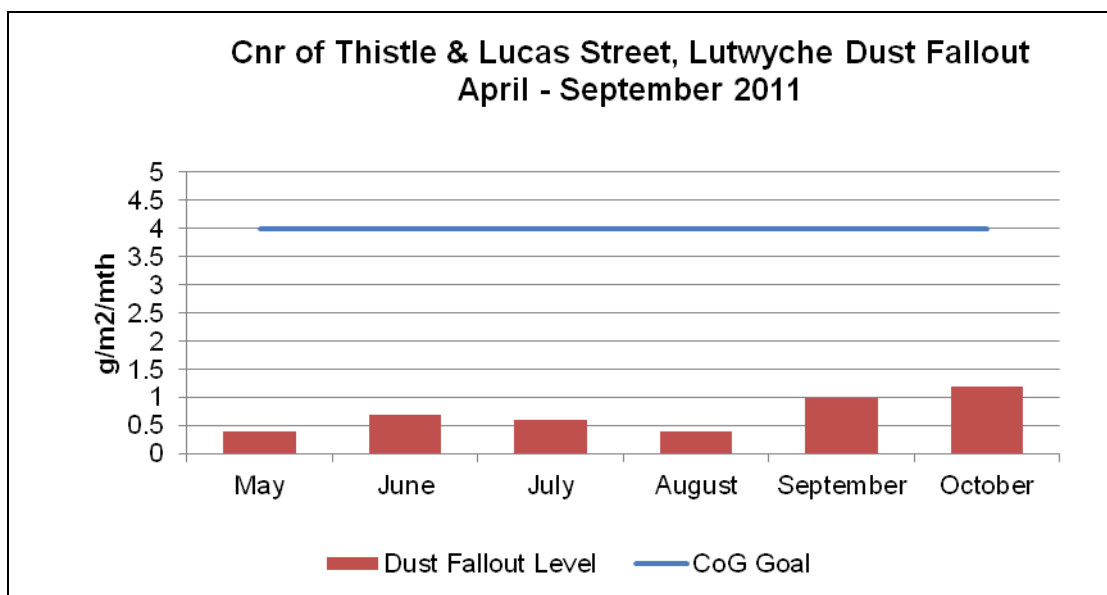
Figure 4.3.7: Cnr of Thistle & Lucas Street, Lutwyche Dust Fallout Results (location refer to figure 2.3 – D2)

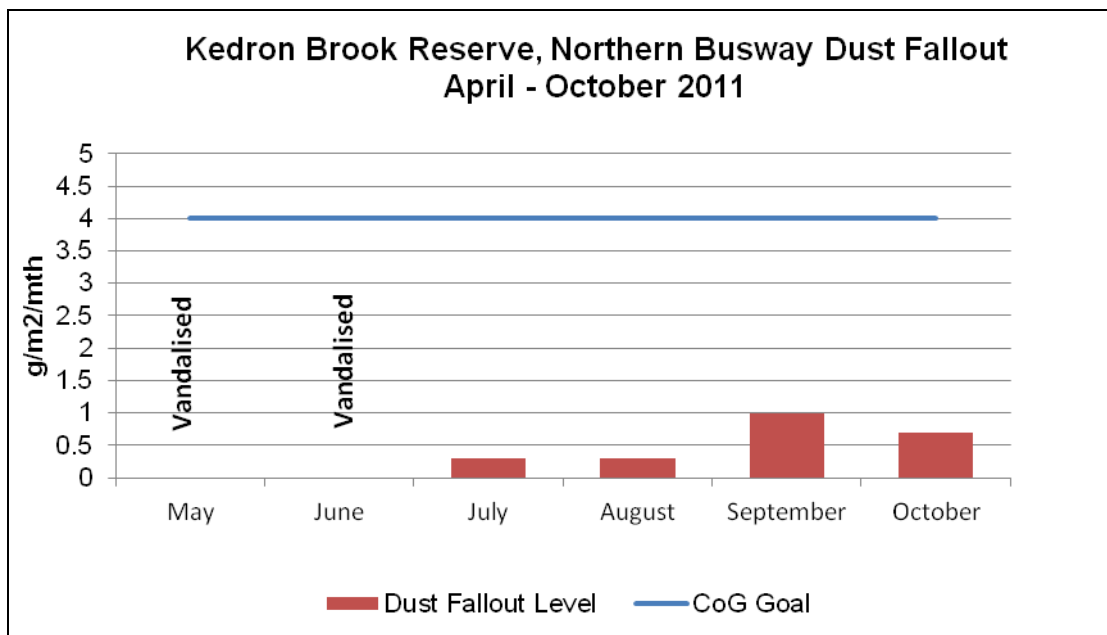
Figure 4.3.8: Kedron Brook Reserve, Northern Busway Dust Fallout Results (location refer to figure 2.3 – D1)

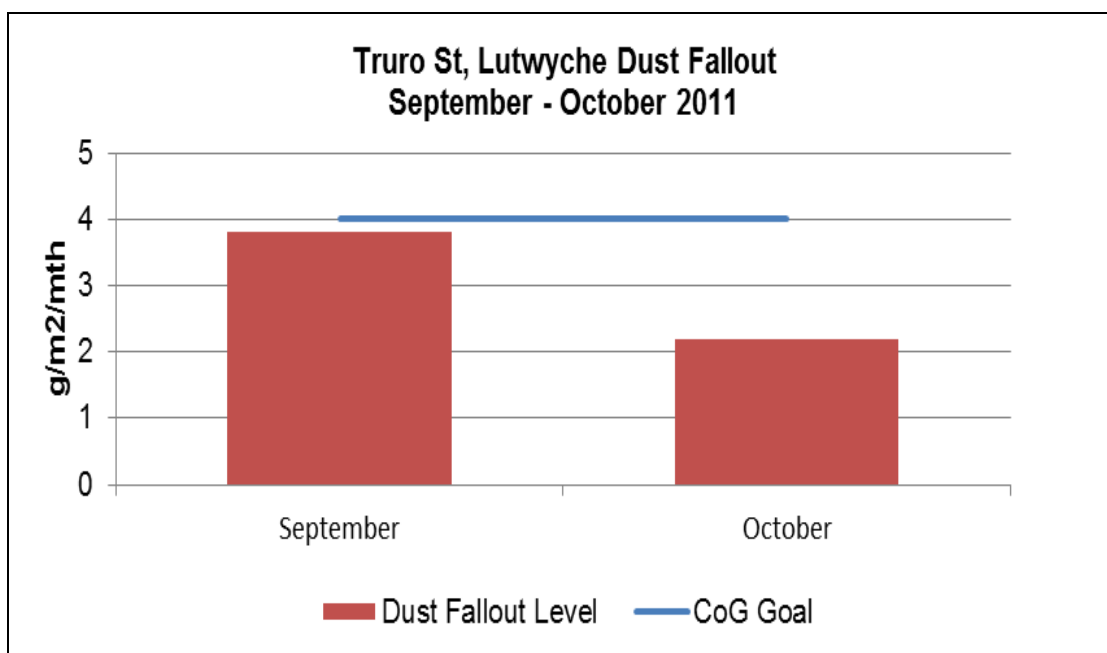
Figure 4.3.9: Truro Street, Lutwyche Fallout Results (location refer to figure 2.2)

The dust deposition result from Truro Street shown in Figure 4.3.7 is only the second time dust deposition monitoring has occurred in this location, therefore only the two results can be reported.

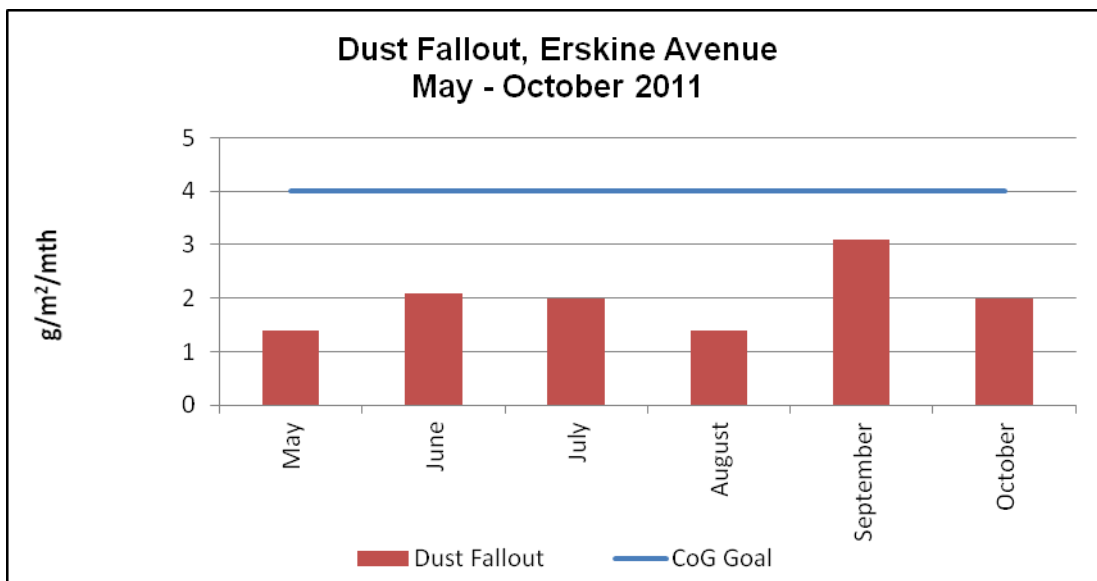
Figure 4.3.10: Erskine Avenue, Kedron Dust Fallout May – October 2011 (for monitor location see figure 2.4 – A1)

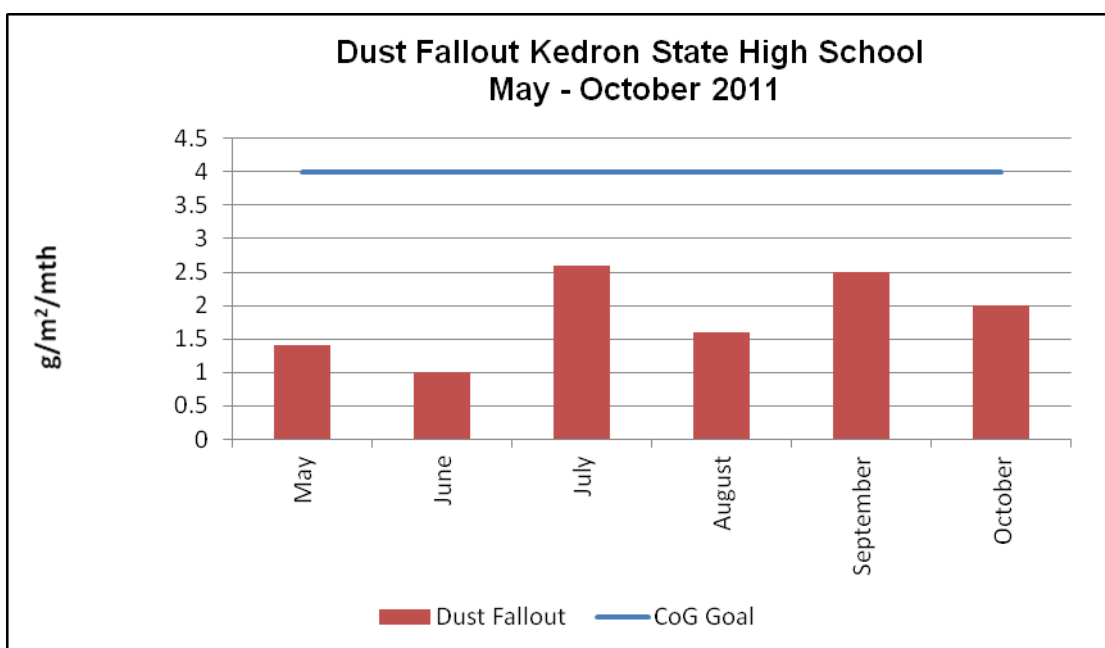
Figure 4.3.11: Kedron State High School, Dust Fallout May – October 2011 (for monitor location see figure 2.4 A2)

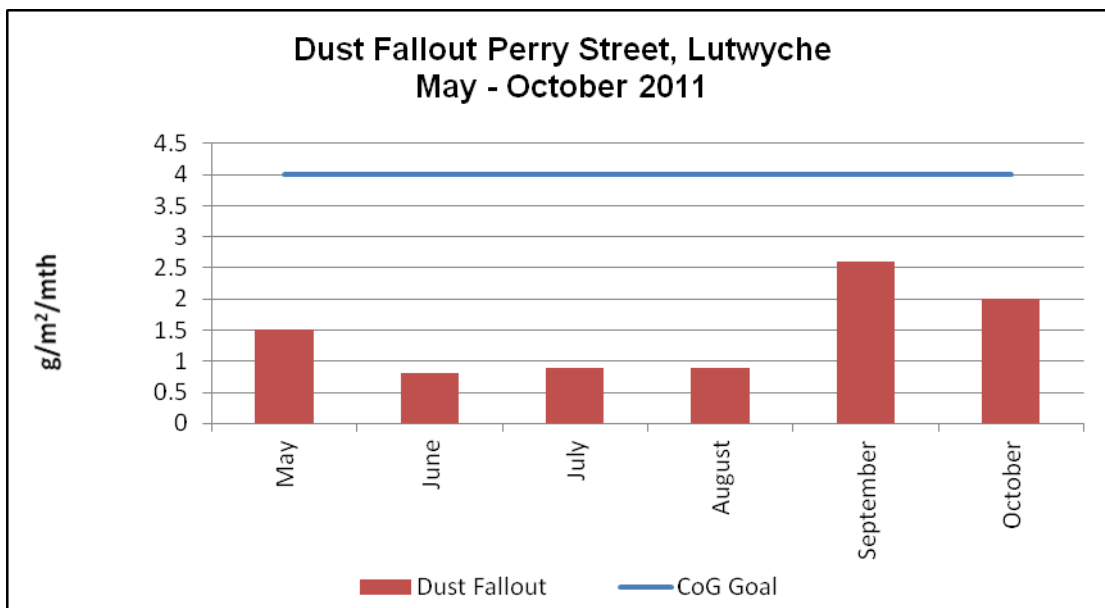
Figure 4.3.12: Perry Street, Lutwyche Dust Fallout May – October 2011 (for monitor location see figure 2.4 – A3)

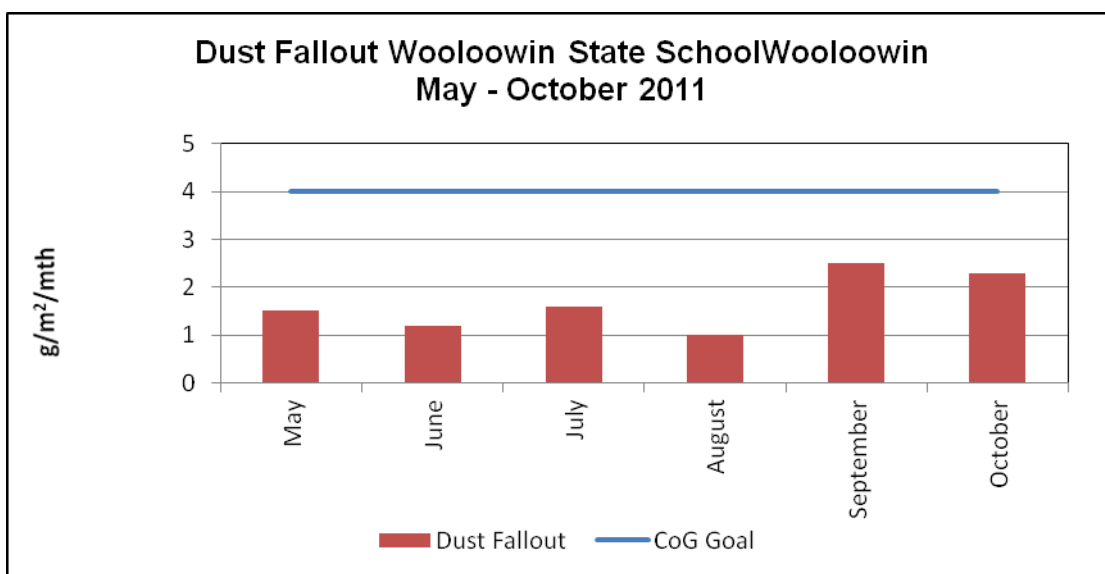
Figure 4.3.13: Woolloowin State School, Dust Fallout May – October 2011 (for monitor location see figure 2.4 – A4)

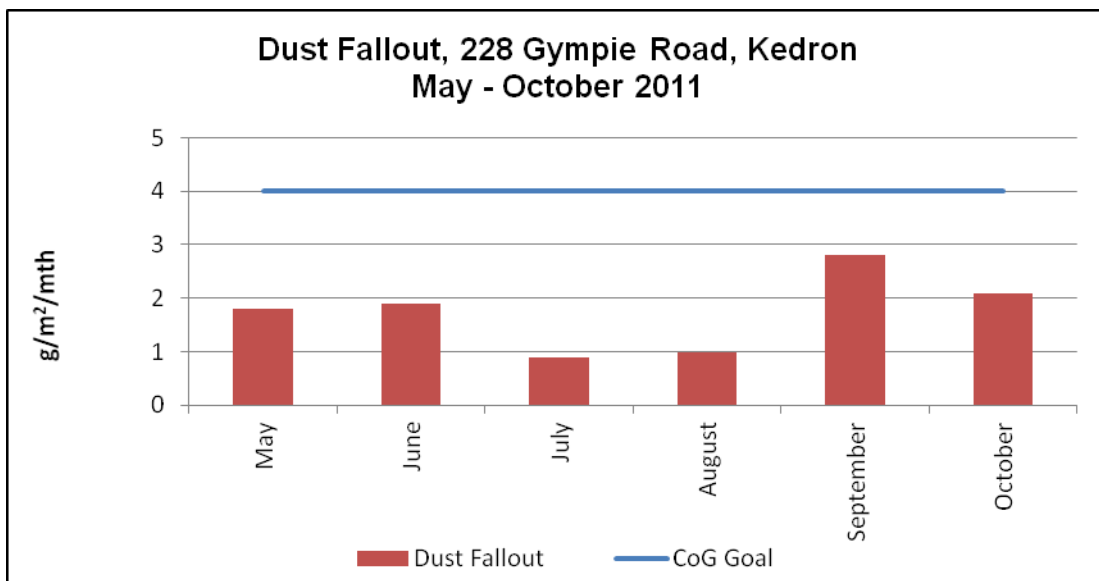
Figure 4.3.14: 228 Gympie Road, Kedron Dust Fallout May – October 2011 (for monitor location see figure 2.4)

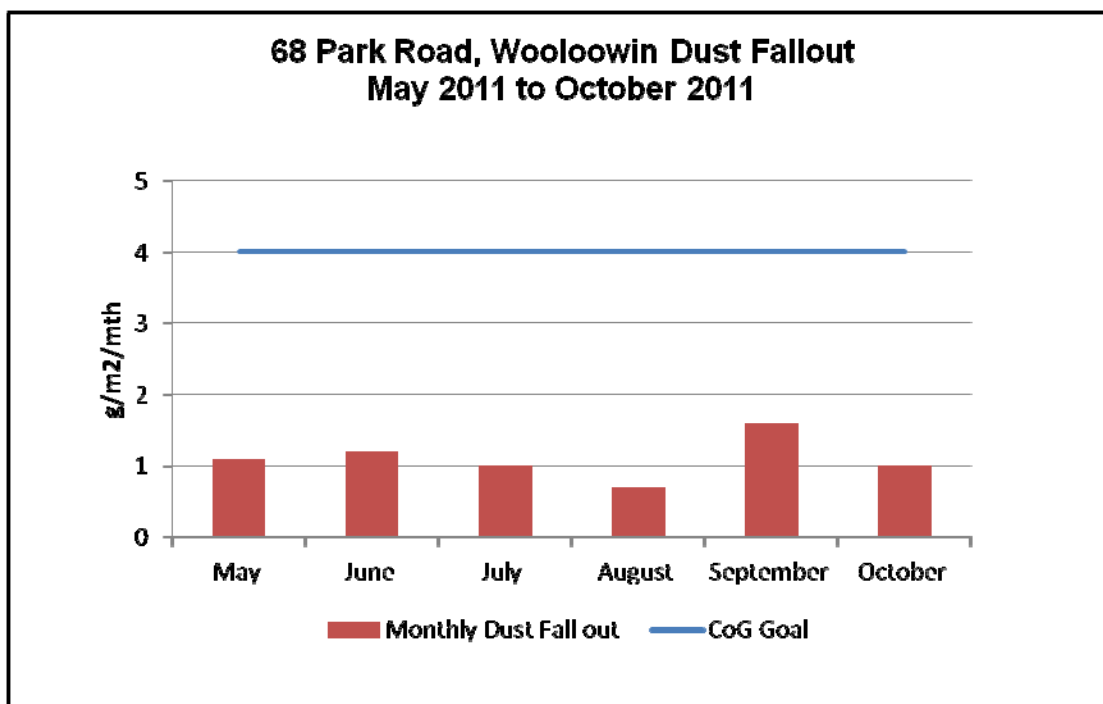
Figure 4.3.15: 68 Park Road, Wooloowin Dust Deposition Results (for monitor location refer to figure 2.1)

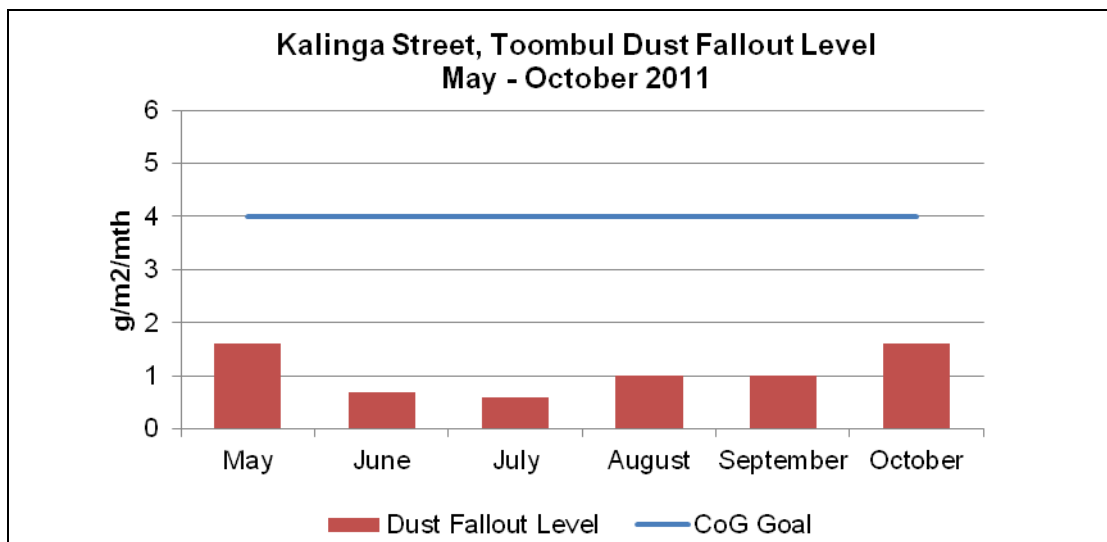
Figure 4.3.16: 56 Kalinga Street Toombul, Dust Fallout (location refer to figure 2.6 – D1)

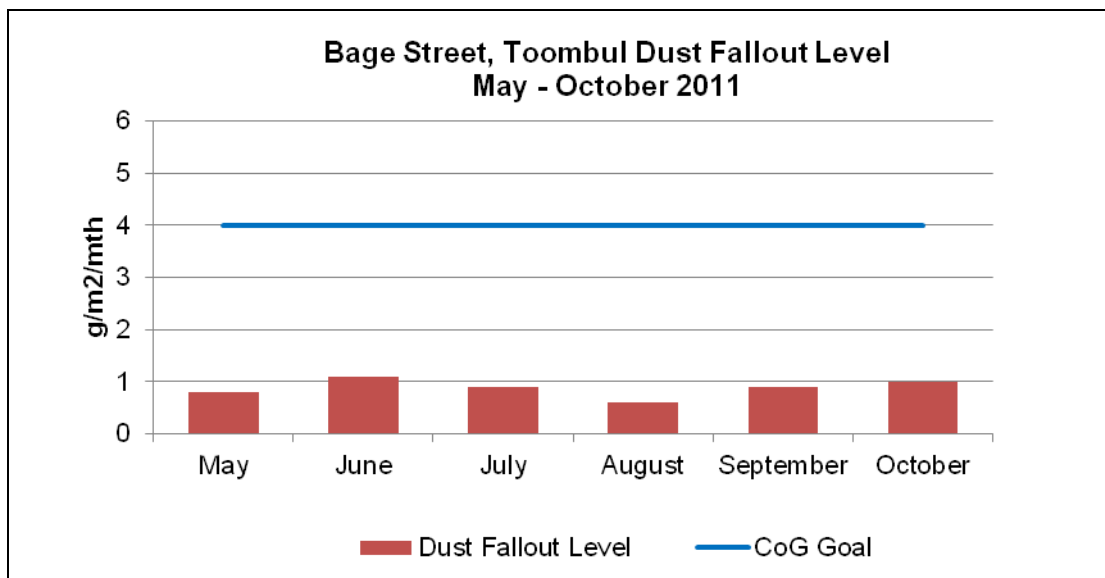
Figure 4.3.18: Bage Street Toombul, Dust Fallout (location refer to figure 2.6 – D3)
